BUFFALO NATIONAL RIVER

THEME IDENTIFICATION
CONTEXT STUDIES
AND
PROPERTY EVALUATIONS
SOL: N6068030063

Thomason and Associates
Preservation Planners
Nashville, Tennessee
And
Hawkins Partners
Landscape Architects
Nashville, Tennessee

September, 2004

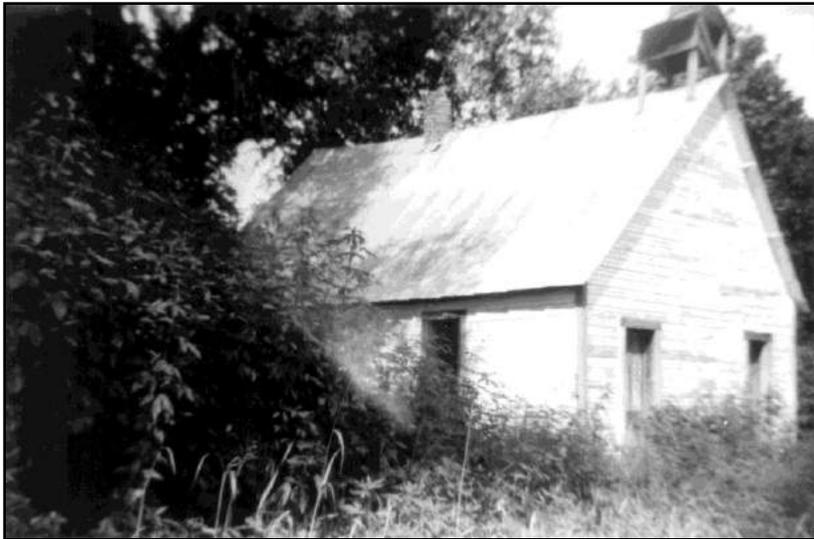
Figure 19: Brown School along Calf Creek was constructed ca. 1915.
(Source: NPS, *Buffalo National River*.)

The oldest surviving school building remaining in the Buffalo National River is the Brown School along Calf Creek. Built ca. 1915, this frame, one-room schoolhouse features weatherboard siding and a small belfry at the roofline. Brown School has been unused for several decades and suffers from deterioration; however, the setting aptly conveys a sense of time and place from the school's period of significance and the school retains a sufficient amount of its original form, materials, and design to meet the registration requirements for rural schools established in the Multiple Property Documentation Form, "Public Schools in the Arkansas Ozarks, 1920-1940."

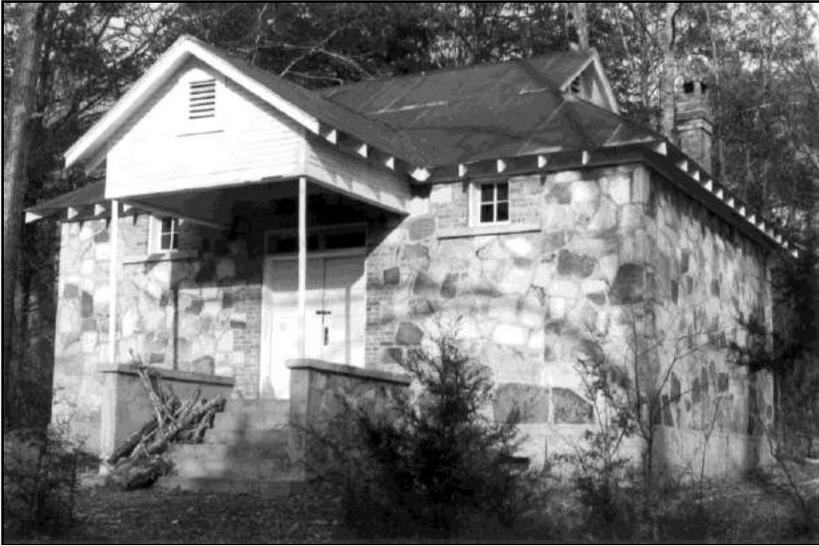
Figure 21: Cold Springs School.

Cold Spring School is a stone veneer Craftsman influenced school building constructed ca. 1935 by the WPA. The school was the first modern school building in the area and reflects the craftsmanship and design of WPA-built structures. The Cold Springs School remains in good condition and possesses integrity of location, design, and materials. The school was listed on the National Register of Historic Places in 1992 under the Multiple Property Documentation Form, "Public Schools in the Arkansas Ozarks, 1920-1940."

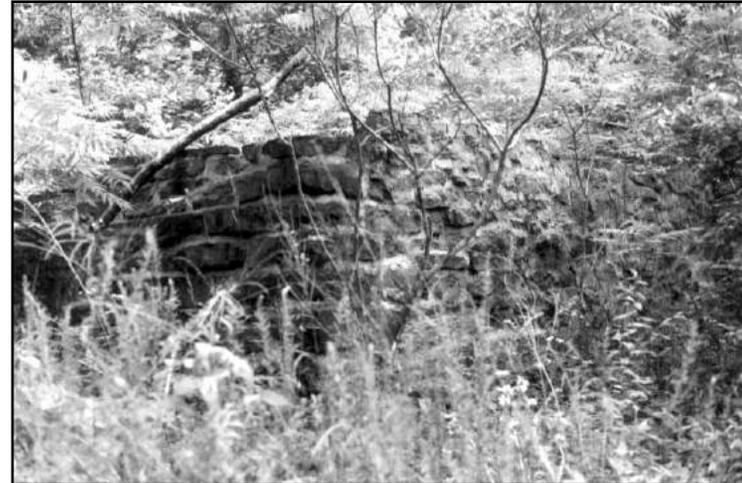
Figure 24: Whiteley School Foundations.

Comments: The Whiteley School was destroyed by fire in 1997. All that remains are the stone foundations, which are quickly being engulfed by the surrounding vegetation.

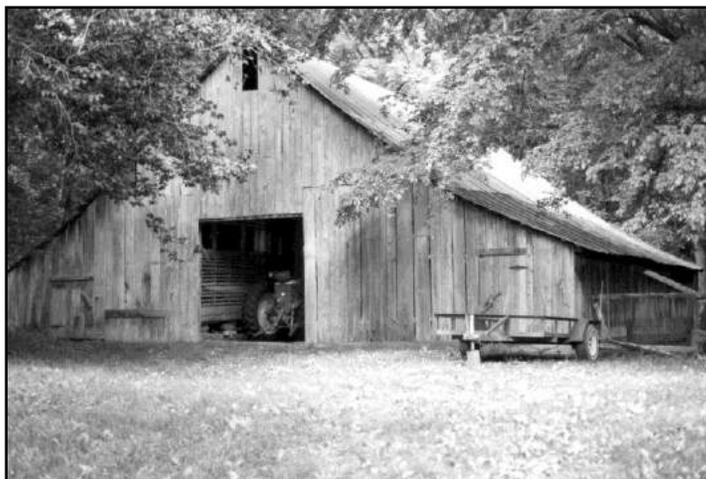
Figure 25: The barn on the Doy Edgmon Property in Boxley.

<u>LCS ID</u>	<u>Structure #</u>	<u>Condition</u>
Feedhouse/ Cattleshed	23251	1B	Fair
Barn	23252	1C	Good
Rock Wall	23253	1D	Fair

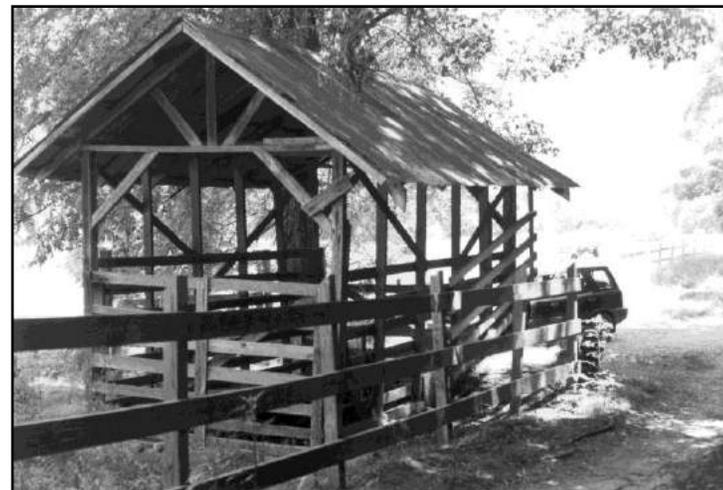
Figure 26: The Stock Scale of the Luallen Property in Boxley.

<u>LCS ID</u>	<u>Structure #</u>	<u>Condition</u>
House Site	23258	2A	Poor
Fruit Cellar	23259	2B	Poor
Barn	23262	2E	Good
Scale House	23264	2F	Fair

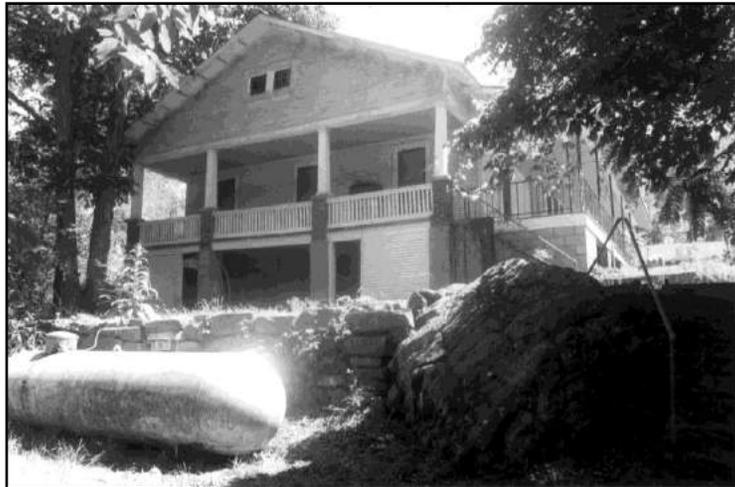
Figure 27: The Troy Fowler House.

<u>LCS ID</u>	<u>Structure #</u>	<u>Condition</u>
House	23265	3A	Good
Barn	23266	3B	Good
Saltpetre Kettle	60855	3H	Poor
Stone Walls	60854	3G	Fair

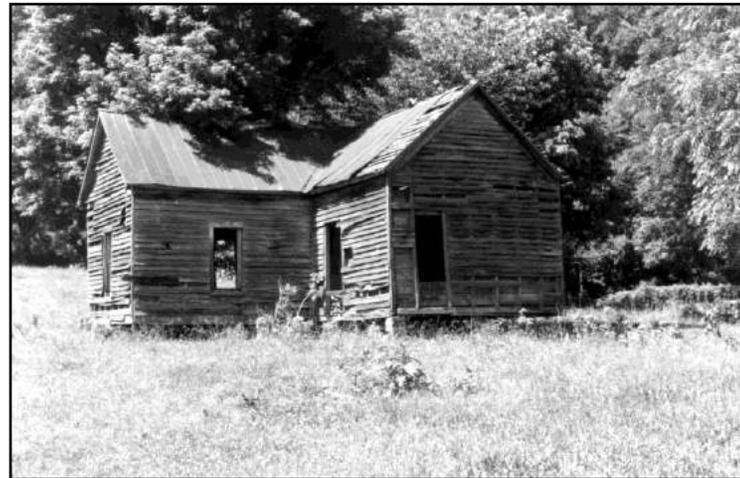
Figure 29: The Caretaker's House on the Edgmon/Fowler property in Boxley.

<u>LCS ID</u>	<u>Structure #</u>	<u>Condition</u>
House	23267	4A	Good
Old Barn	23268	4B	Good
Store/Garage	23306	4C	Good
Granary	23307	4D	Poor
Caretaker's House	23308	4E	Poor

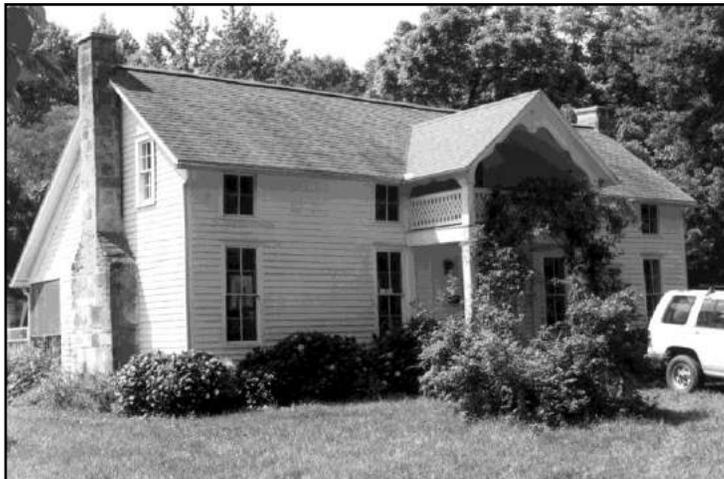
Figure 30: The Casey-Clark House.

Comments: The Casey-Clark House was expanded in 1996 with a rear addition. This addition is in keeping with the dwelling's historic character and does not detract from its integrity. A hay barn associated with the property (LCS ID 23318, Structure # 7I) and a garage (LCS ID 23316, Structure # 7G) are no longer extant.

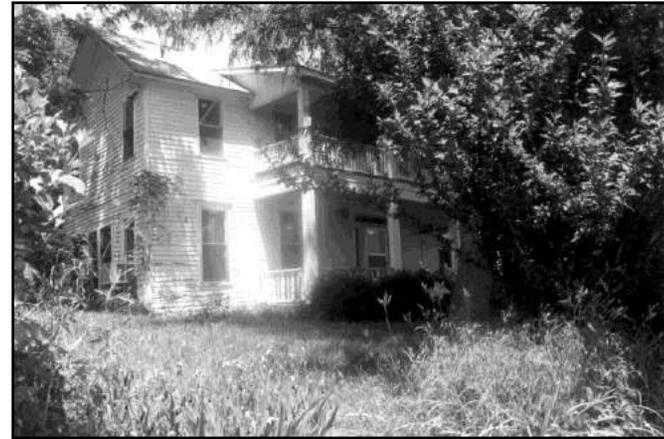
Figure 33: The Orphea Duty House.

Comments: Also located on the Orphea Duty property are a shed, privy, pumphouse, and well. None of these structures are listed on the LCS. All are in poor condition.

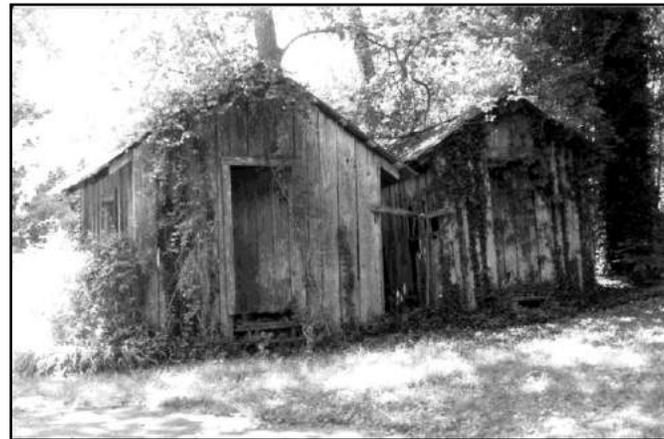
Figure 34: The washhouse and smoke house on the Orphea Duty property.

<u>LCS ID</u>	<u>Structure #</u>	<u>Condition</u>
House	23347	10A	Fair
Barn	23348	10B	Poor
Granary/Stable	23349	10C	Poor
Wash House	23350	10D	Poor
Smokehouse	23351	10E	Poor
Brooder House	23352	10F	Poor
Garage/cellar	23353	10G	Fair
Old House/shed	23354	10H	Poor
Barn in field	23356	10J	Poor

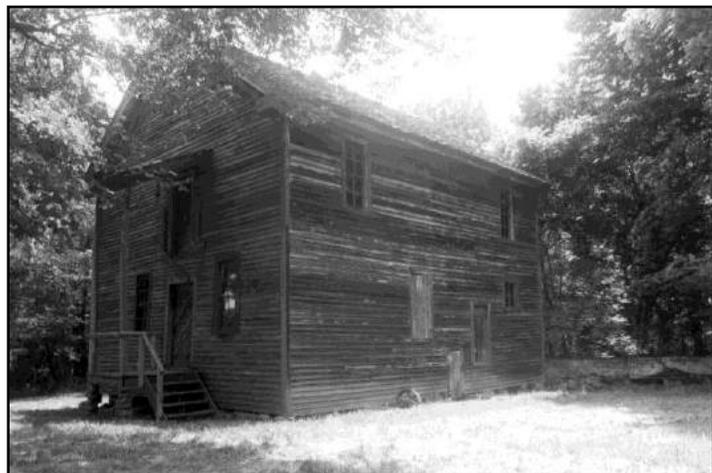
Figure 35: The Boxley Mill.

<u>LCS ID</u>	<u>Structure #</u>	<u>Condition</u>
Mill	23358	11A	Fair
Race	60827	11L	Fair
Pond	60826	11K	Fair

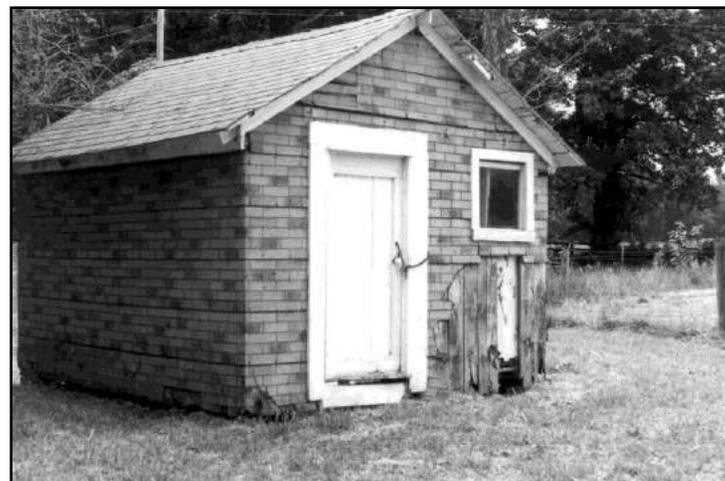
Figure 36: A fishing cabin on the Clyde Villines property.

Comments: LCS Reports lists 3 fishing cabins on this property. There are currently only two that remain. Barn B also is no longer extant.

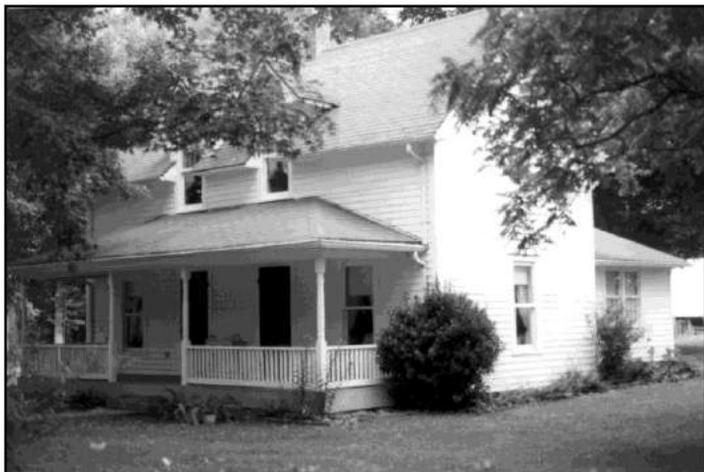
Figure 37: The Scroggins House.

Comments: The smokehouse/toolhouse on this property has been moved since it was last surveyed in 1987. It originally sat immediately to the rear of the house. It is now positioned directly

behind the garage, facing south. The outhouse on the property has been rebuilt.

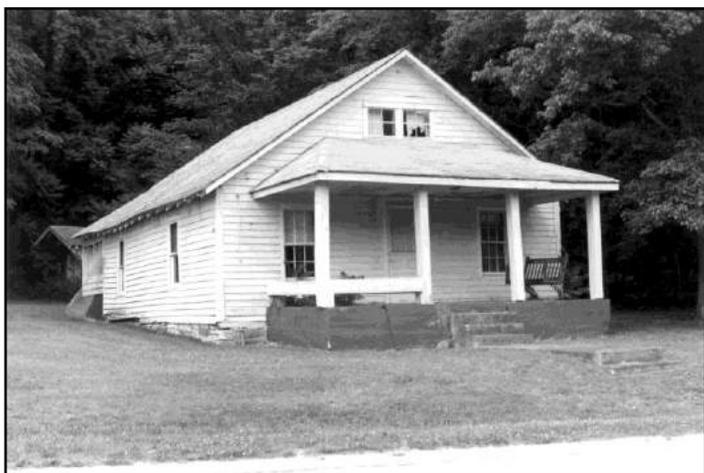
Figure 39: The Scroggins-Fowler House.

Comments: This property has been vacant for some time and is in very poor condition. The interior of the house has many collapsed floors and ceilings. The surrounding area is becoming overgrown and heavy vegetation is beginning to cover the shed and pumphouse. Two other outbuildings– a root cellar and a second shed – are not listed on the LCS but are on the premises. These outbuildings are located to the rear of the dwelling, and are covered with vegetation and barely visible.

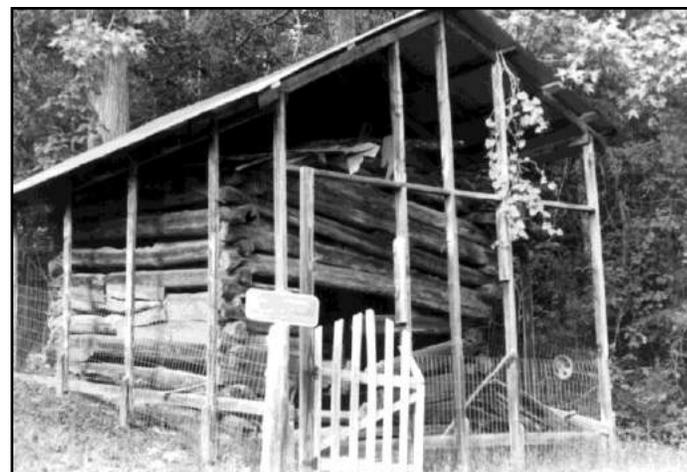
Figure 42: The Beaver Jim Villines corn crib.

Comments: The smokehouse and corn crib on this property are in poor condition, but have been stabilized and protected with a metal gable roof supported by wood posts, and a wire fence surrounds the wood posts.

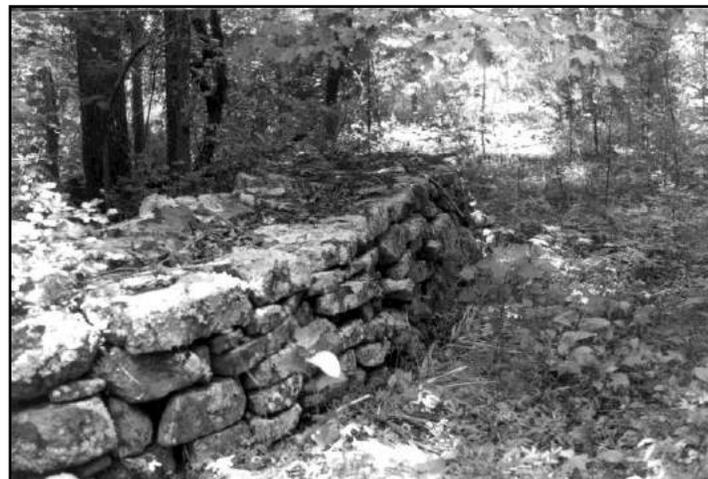
Figure 43: Several stone fences remain intact on the Pickle Edgmon property in Boxley valley.

Comments: This property is located in a Wilderness Area near the river at the southern end of Boxley Valley. The property is heavily overgrown; however numerous stone walls remain intact and in fair condition. Also on the property is the house site of a 1960s dwelling. The site consists of stone foundations and two standing stone chimneys.

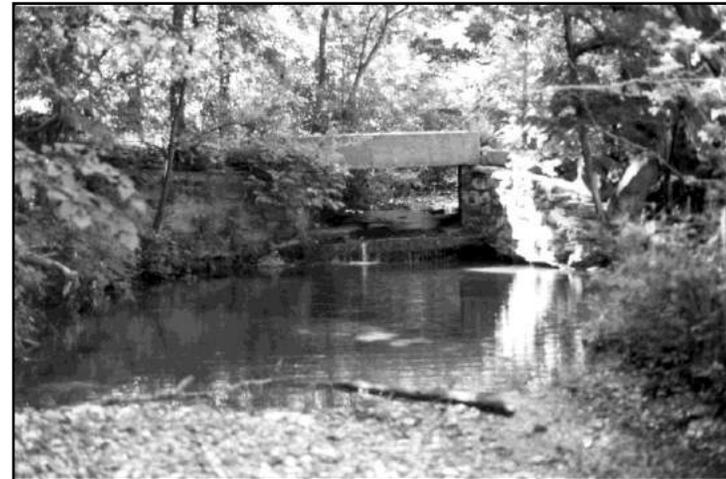
Figure 45: The Leatherwood Culvert in Boxley.

<u>LCS ID</u>	<u>Structure #</u>	<u>Condition</u>
Ponca Low Water Bridge	23309	41A	Good
Leatherwood Culvert	60846	41B	Fair

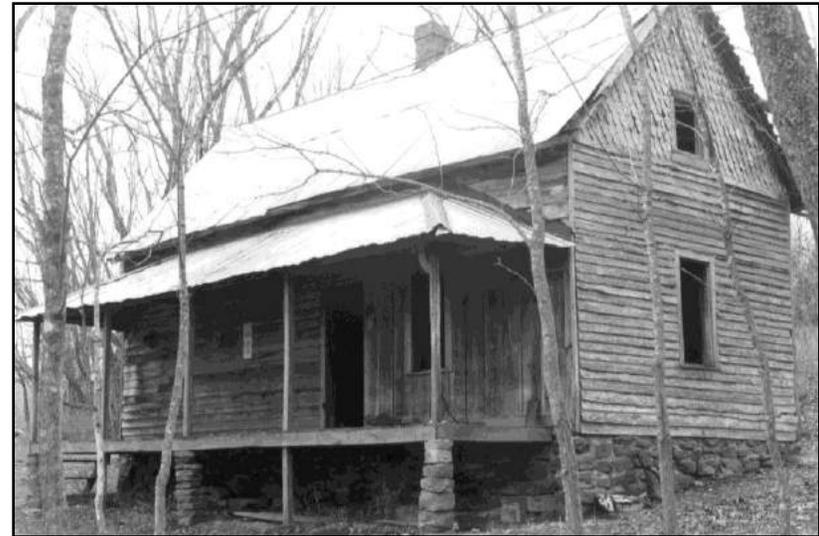
A barn associated with the property is now in ruins. The logs have half dovetail notching, but most logs are deteriorated. The logs have adze marks. Surrounding the log ruins are sections of the metal roofing material. The shed south of the house is now on the ground with some sections of metal roof in the vicinity. The hog shed is extant and has vertical board siding, and a shed roof with a metal surface. The two sheds north of the house are no longer extant and only a few foundation stones remain.

Figure 47: The Granny Henderson House.

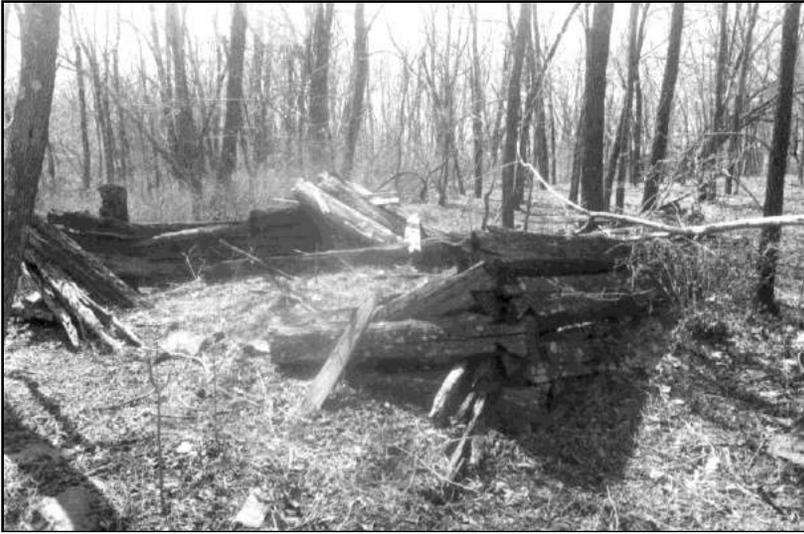
Figure 52: Ruins are all that remain of the Charlotte Mahoney Cabin.

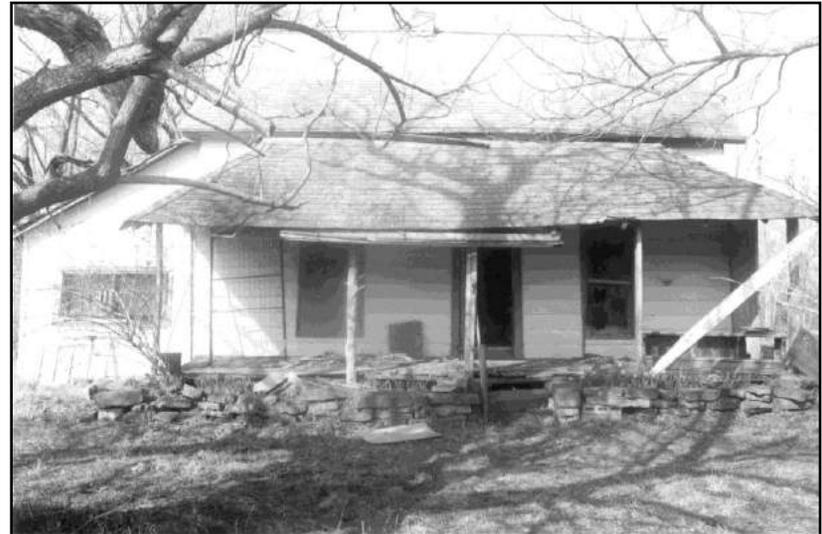
door. The interior of the house has been remodeled with added ceiling panels, carpeting, and wall paneling. The house was built in a double-pen plan with a rear wing containing a kitchen and mud room and side wing with a bathroom. The upstairs has an open floor plan with a bead board ceiling.

Figure 53: The Armor House was constructed ca. 1940.

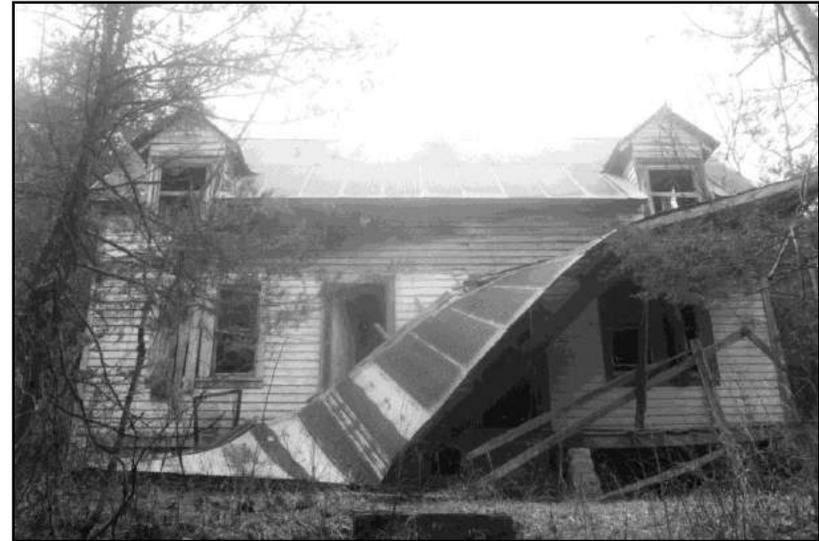
To the south of the house are the ruins of a frame smokehouse with horizontal boards and metal roofing on the ground. To the east of the house across a small creek are the ruins of a ca. 1950 blacksmith shop with vertical board walls, a shed roof of corrugated metal and interior horizontal board siding. Much of this is collapsed and with sheets of corrugated metal roof on the ground.

Figure 54: The Evans-White House.

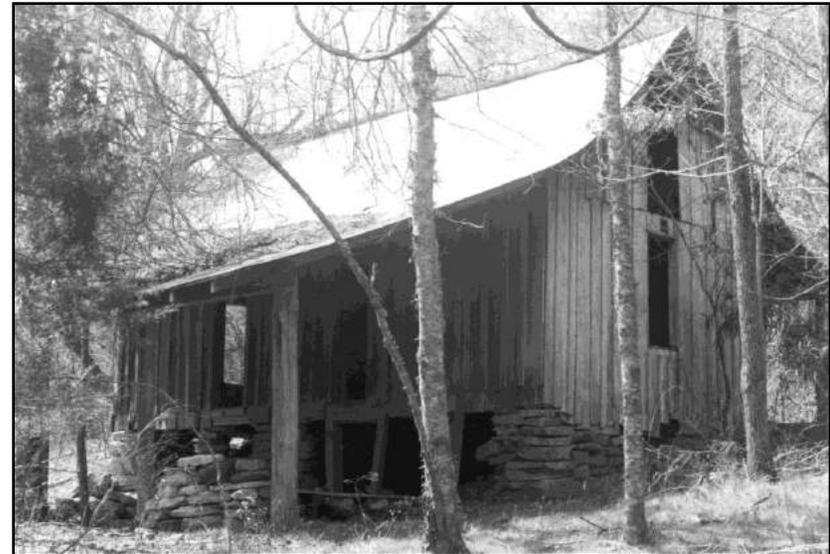
This dwelling is a common house form of the early 20th century and there are no other historic associated outbuildings. The property does not possess sufficient architectural distinction to meet National Register criteria.

Figure 55: The Arbaugh House.

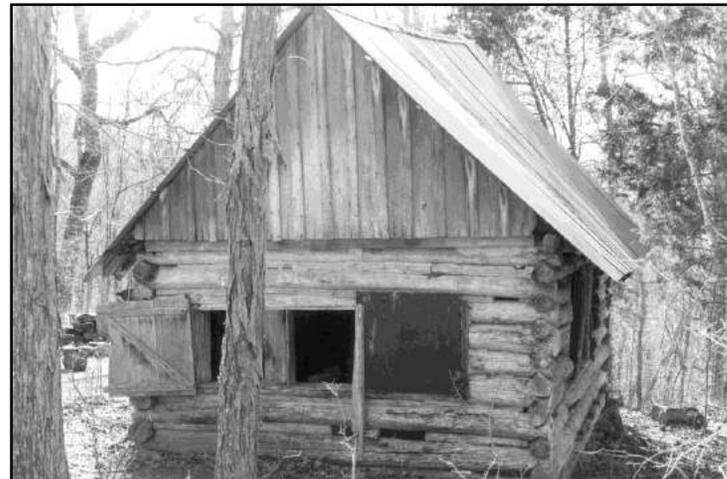
Figure 57: The Flowers Cabin.

The Flowers Cabin is a one-story, single-pen, log dwelling built ca. 1925. The building has a stone foundation, gable roof of corrugated metal, and an exterior of hewn and unhewn logs. Most logs are unhewn and the corners have V notching. The hewn logs have adze marks. On the main (east) façade is an entrance that is now missing its door. The north façade has a tripart window opening with added shutters. A large open window opening has been cut into the west façade of the building. On the south façade there is no fenestration. The building has some wood slat and concrete chinking but most chinking is no longer extant. In the gable fields is vertical board siding. The interior has some added wall paneling over the logs, a wood floor, and a partially intact wood rafter ceiling and loft area. A tree trunk was moved into the center of the building to provide access to the loft space. In the southeast corner is a cast iron stove.

This dwelling appears to have been used as a hunting cabin during the early 20th century. It is located on the side of a steep slope and there are no nearby agricultural lands. The dwelling has been altered with added windows and substitute materials and does not meet National Register criteria.

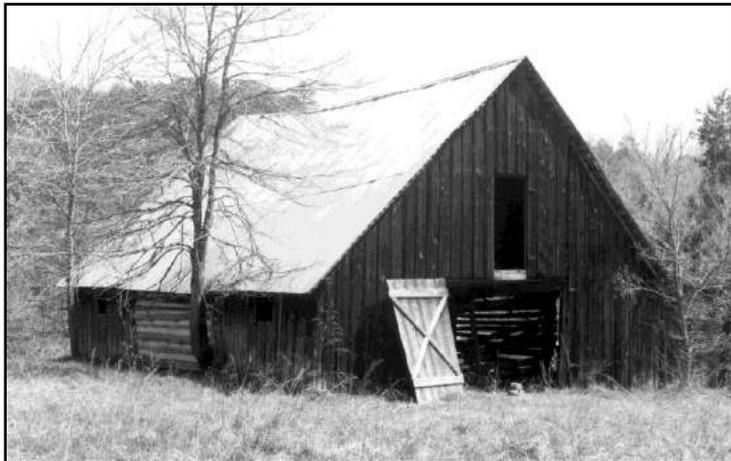
Figure 58: Lockheed Barn.

On this tract is a frame and log barn that appears to have been rebuilt in the late twentieth century. The barn has a single log pen that was built with logs from a previous structure using concrete chinking. A larger frame barn was built around the log pen and appears to date to the 1960s. Located on this same tract, but across the river are the foundation remains of a ca. 1945 cabin. This site is situated in a small clearing within a wooded area adjacent to the riverbank and consists of a few stone piers. This barn was rebuilt in the 1960s –70s and does not possess its original design or integrity.

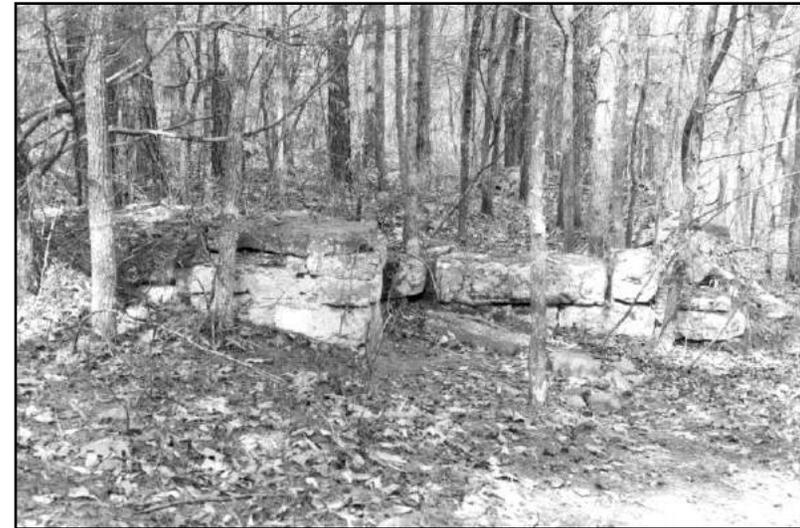
Figure 59: Foundations of the Center Point School.

The last school constructed on this site was built ca. 1930 and was of frame construction. Following its closure in the late 1940s, Center Point School fell into ruins and all that remains are foundation stones. The foundation is of cut stone and measures 36' 6" x 21'. Stones within the foundation measure up to 2' in width and 3 1/2' in length. The remainder of a porch is also visible and measures 5' x 9' 8". The porch foundation is of stone and has a concrete cap.

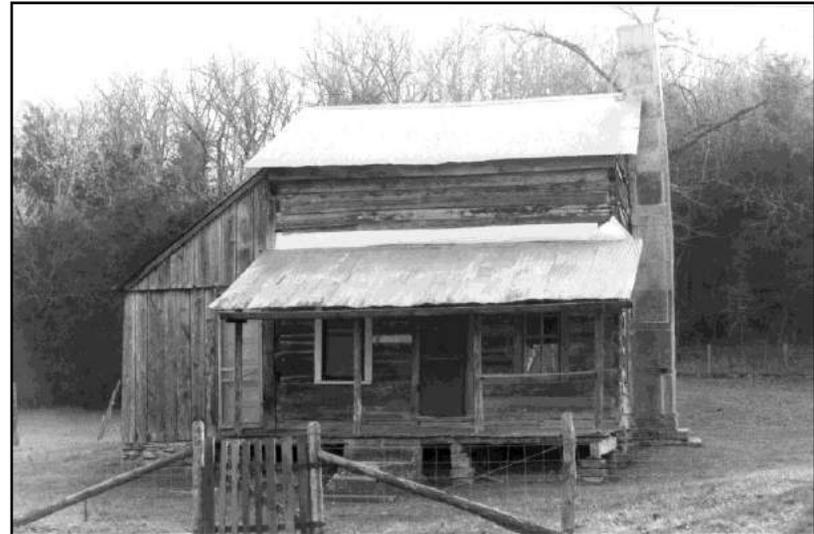
Although the exact builder of the house is unknown, the Parker-Hickman House dates to the mid-nineteenth century and the ownership of the Parker family who originally settled the land in the late 1830s. The house exhibits signs of superior craftsmanship, and it is believed that Greenberry Parker and his descendants were capable wood craftsmen. Later owners added the frame wings, which demonstrate the evolution of building techniques as well as the property's history. The Parker-Hickman House is an excellent example of traditional building styles of the Arkansas Ozarks.

Figure 64: The Parker-Hickman House is one of the oldest structures in the Buffalo National River.

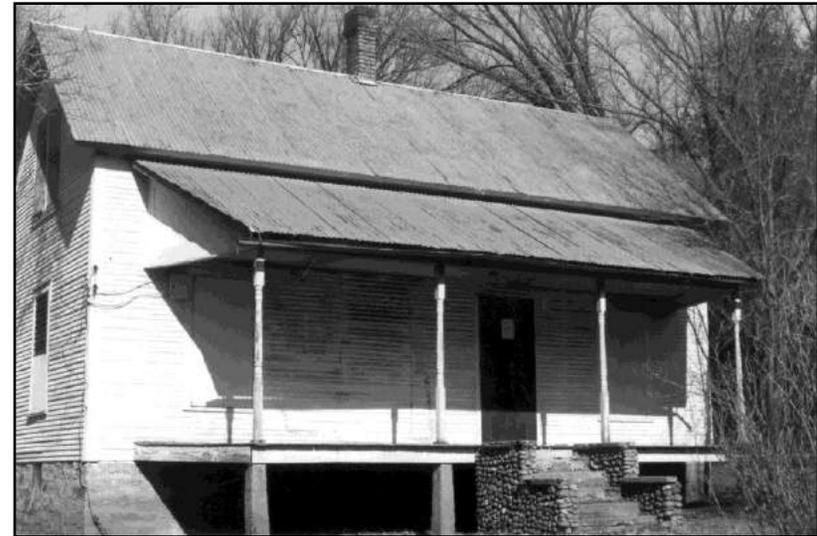
Several domestic plantings were noted at this site. A Lilac shrub and multi-trunked Crape Myrtle are growing in front of the house between the house and the road. A Rose is growing against a mature elm tree on the fence line west of the house. Along most of the entirety of the fence line surrounding the house are mature shade trees, including Catalpas, Elms, and Walnut trees. The Northern Catalpa tree is native to this region and adaptable to a range of soil and moisture requirements. The wood was commonly used for fence posts and railroad ties.

Figure 67: The Jones House was built in 1922.

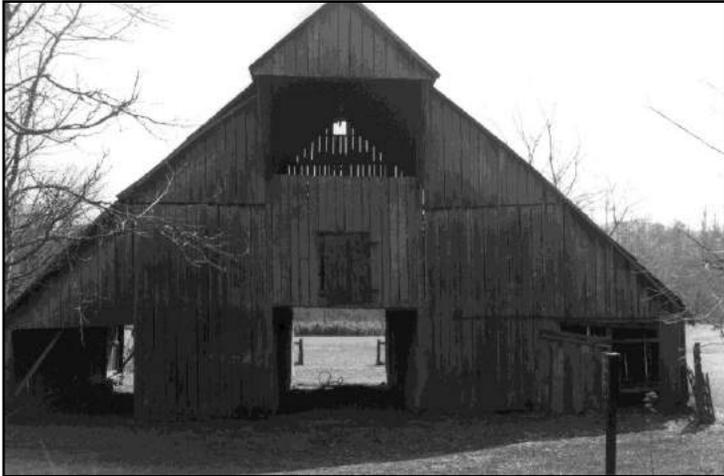
West of the dwelling is a large frame barn built ca. 1913. A dirt road extends in front of the dwelling and leads to the barn and associated fields. The barn has a stone foundation, a vertical board exterior, and a gable corrugated metal roof. The barn has a central drive-thru bay shed roof wings on either side. The central bay is divided into stock pens and cribs. Interior steps lead to the loft area. There is some use of diagonal board on the interior of the barn. The pens have triangular cutout openings that access feed bins. A fence line runs behind the barn's west wall and large fields that are still in use are located to the south and west of the barn.

Figure 67: The barn on the Jones Farm is an excellent example of an early 20th century agricultural building.

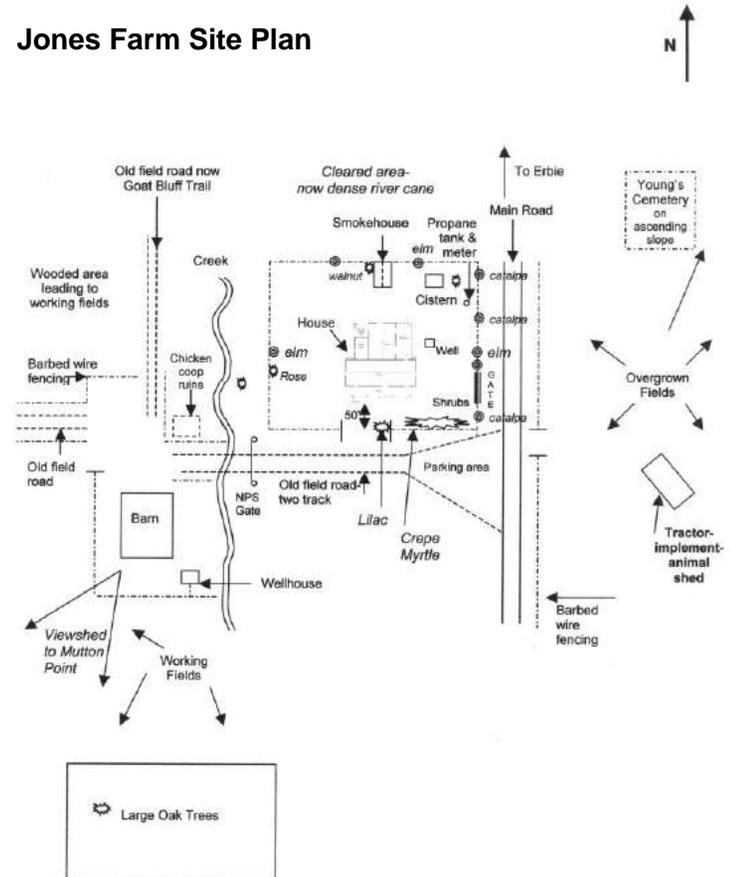
Figure 71: Site Plan for the Jones Farm.

The Jones Farmstead is an excellent example of an early twentieth century farm. The dwelling, barn, and springhouse remain in good condition and have been unaltered from their construction in the 1910s and 1920s. The majority of the fields associated with the farm remain in use and are leased to local farmers. The setting is largely unchanged from the farm's period of significance and fencerows, ponds, and farm roads help to convey the cultural landscape. The Jones Farmstead possesses a strong degree of integrity of feeling and association as well as setting, location, design, materials, and workmanship.

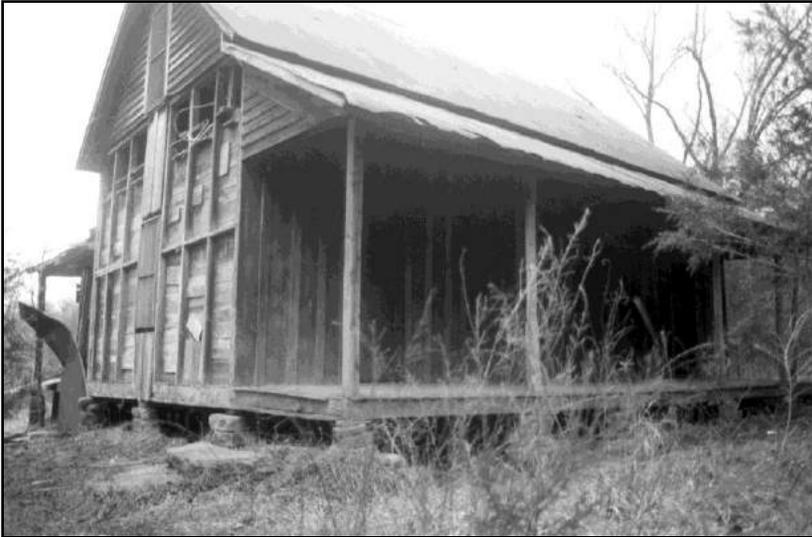
The interior of the dwelling is divided into three rooms with the rear T wing being the kitchen. The cabinetry in this room is in ruins. There is some use of linoleum and “wood paneling” wallpaper. Interior boxed steps lead to two rooms in the half story. A brick flue has openings to both front rooms. The interior has original wood floors. A wood post and wire fence runs north-south approximately ten feet in front of the house. Opposite the fence is an old roadbed that now serves as an NPS hiking trail.

Figure 72: The main dwelling on the Farmer Farmstead.

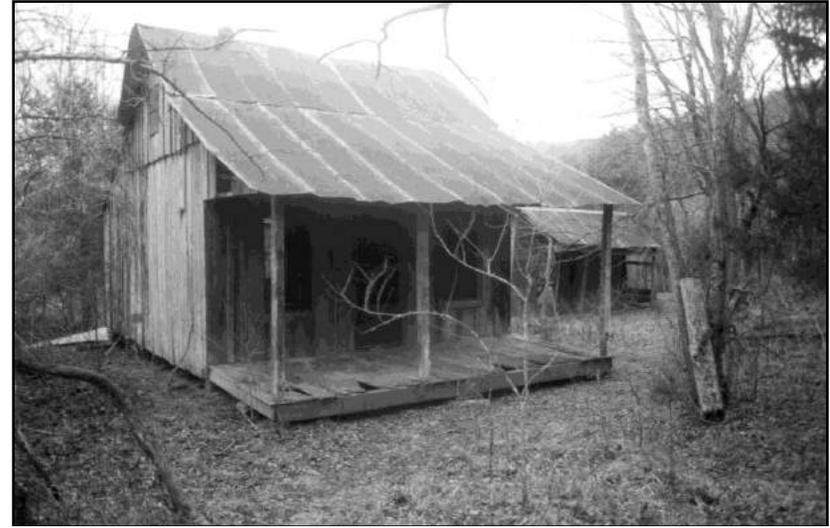
The second dwelling on the Farmer Farmstead is situated approximately sixty feet southeast of the first dwelling. This is a one-and one-half story frame cabin built ca. 1910. It has a gable roof of corrugated metal panels, a stone pier foundation, a board and batten exterior, and an interior metal flue. On the main (west) elevation is a full-width shed roof porch with square wood posts and a wood floor. The dwelling has a central entrance flanked by two windows, all of which have metal mesh screens. The rear (east) elevation has an original shed roof wing with a board and batten exterior and stone pier foundation. The rear (east) wall of this wing is gone except for support posts. The interior of the house has one main room plus the rear wing room. The interior has wood floors and remnants of wallpaper. Interior steps slant down from the attic/loft area. This dwelling is in very poor condition. It has lost some roof panels and the entire rear is exposed due to the missing wall.

Figure 73: The second dwelling on the Farmer Farmstead.

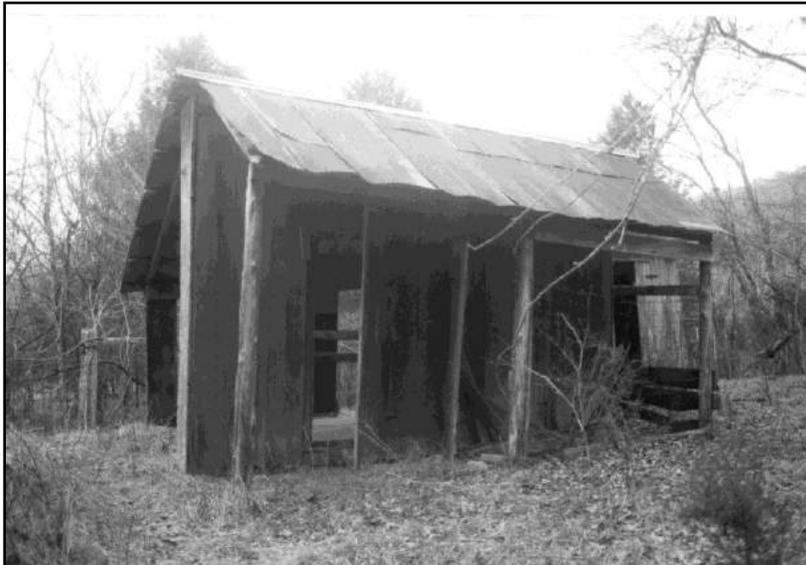
The fence line continues behind these outbuildings and meets with another one that extends in front of the house. The fences form a loose triangle in which the dwelling, feed house, and privy are located. The two fences do not join, but allow for a small opening to access the adjacent field.

Figure 74: The Feedhouse on the Farmer Farmstead.

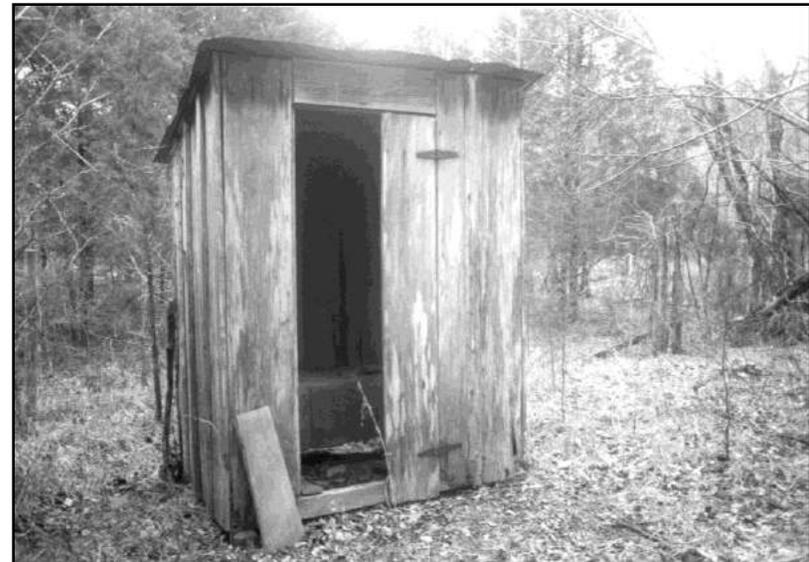
Figure 75: The privy on the Farmer Farmstead.

Two or three feet south of the feed house is a frame ca. 1910 privy. The privy has a corrugated metal panel shed roof, a vertical board exterior, and a stone pier foundation. The privy is a two-seater and has a vertical board door, a portion of which is missing.

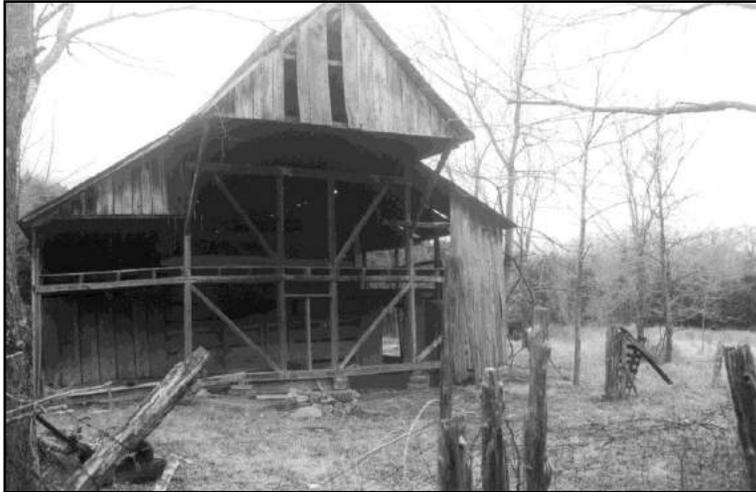
Figure 76: The large barn on the Farmer Farmstead has two interior log cribs.

A large barn is located about 150 feet east of the main Farmer House. The barn dates to ca. 1900 and has two interior log cribs on stone pier foundations. The north crib has unhewn logs with V notching and the south crib has hewn logs with half dovetail notching. A portion of the south crib has collapsed. A central drive thru (east-west) extends between the log cribs. A frame structure was built around the log cribs and has vertical board siding, a gable corrugated metal panel roof, and a stone pier foundation. The barn has a loft area and most of the exterior walls of the frame portion of

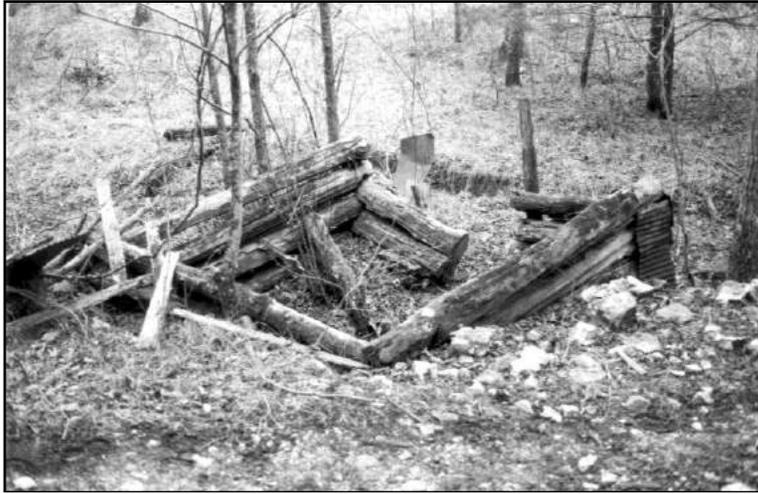
Figure 78: The log springhouse on the Farmer Farmstead has collapsed.

North of the house along a stream and adjacent to the path are the remains of a ca. 1900 log springhouse. This structure was built with unhewn logs with V notching and measures 5' 6" x 7'. The springhouse is situated over the creek and set on rock. The roof of the building has collapsed.

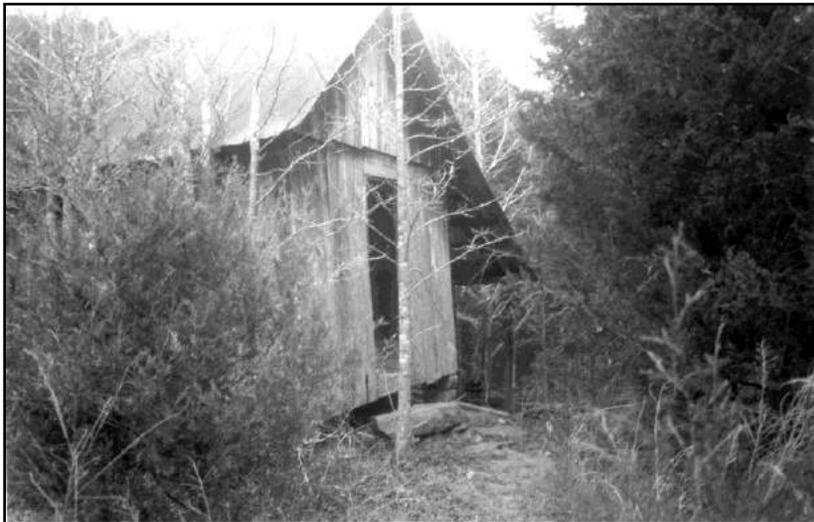
Figure 79: Farmer Farmstead smokehouse/tool shed.

Approximately thirty-five feet west of the barn is a frame ca. 1900 smokehouse/tool shed. This building has a vertical board exterior, a corrugated metal panel gable roof, and a stone pier foundation. A large stone provides a step into the building. On the north elevation is a shed roof wing that is open on the east side. This appears to have been a garage or storage area. The interior has a wood floor and one main room with two storage areas near the entrance.

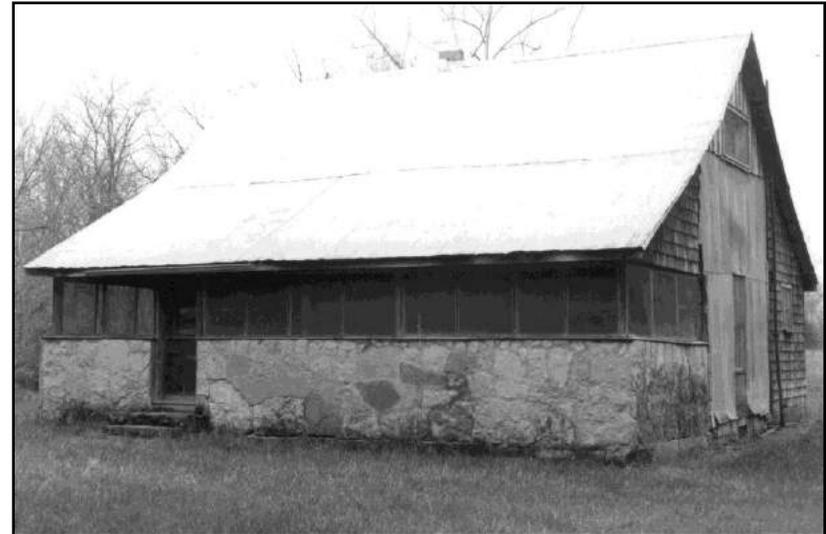
Southeast of the dwelling is a stone well that is rectangular in shape. The concrete cap has an extended rectangular trough or basin. A wood post and wire fence line encloses the yard around the cabin. A collapsed stone wall fence is south of the cabin. Remnants of outbuilding foundations appear opposite the fence line north of the cabin. The foundations are of stone and measure 7' x 12'. Also nearby are remnants of a frame or log outbuilding. Within a 5' x 4' area are rotted logs with nails, boards, and metal debris. Southwest of the house is a large concrete slab foundation measuring approximately 17' x 12' with an additional foundation line or edging extending another 10'. Northwest of the house is a frame feed pen with corrugated metal roof panels and a vertical board exterior.

Figure 82: The Reavis Cabin was constructed ca. 1918.

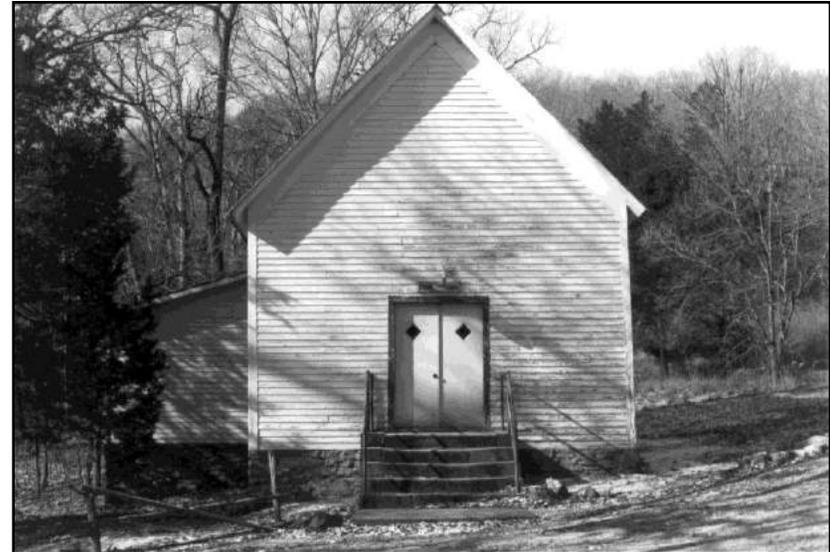
is a small shed roof wing built ca. 1930. This wing has exposed roof rafters and at the basement level has a vertical board entrance. The church has original four-over-four wood sash windows that appear on the side elevations. There is no fenestration on the rear elevation.

Figure 84: The church at Erbie was in use until the early 1990s.

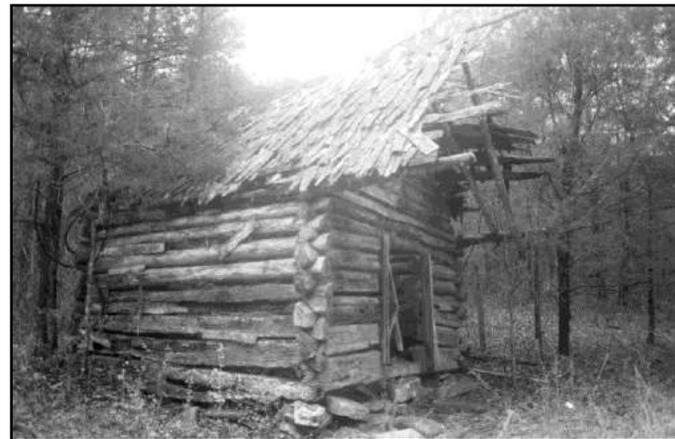
According to local informants, this single-pen log structure was built in the 1930s from logs salvaged from a previous nearby dwelling. The building was used for storage. NPS personnel refer to the building as the “shake roof cabin” due to its roofing material. It is located south of the Lane House Site and east of the Parker-Hickman Farmstead. It is of log construction with the bottom four logs hewn and the upper four logs are unhewn. There is no chinking between the logs. The structure has a gable roof of wood shake shingles, which has largely collapsed. The roof has a large overhang above the entrance. The building has a stone foundation and horizontal boards in the gable field. A central entrance is beneath the gable end and is missing its door. Metal hinges remain intact. The interior has no flooring. The building is deteriorated and in poor condition. Some of the bottom logs are rotting and many roof shingles are gone. A wood, post and wire fence runs along the south side of the building.

Figure 86: The Shake Roof Cabin was built of “recycled” logs.

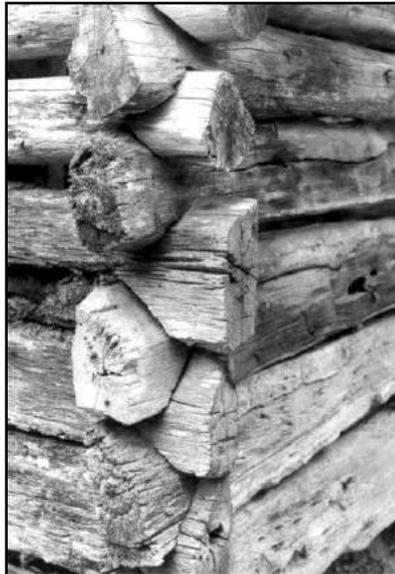
Figure 87: Detail of the log construction of the Shake Roof Cabin.

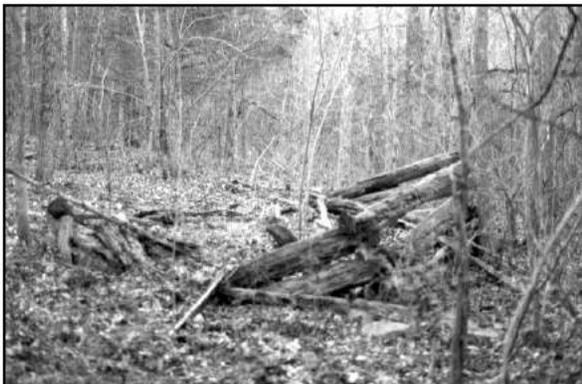
This house site is tucked into a mature forest of White Oaks, Walnuts and Hickories, which was probably not cleared much at the time of construction. The site consists of eight stone pier foundations that are two to three feet in height and measure 24' x 32'. At the southwest corner is a pile of stone possibly where a couple of foundation piers have collapsed. The site is heavily overgrown. Approximately twenty-five feet west of the house site are the remains of a log smokehouse, which measures 14' 2" x 10' 2". The building is in ruins. Its roof caved in during the mid-1980s and only a few logs remain visible.

Figure 89: Remains of the log smokehouse on the Hickman House site.

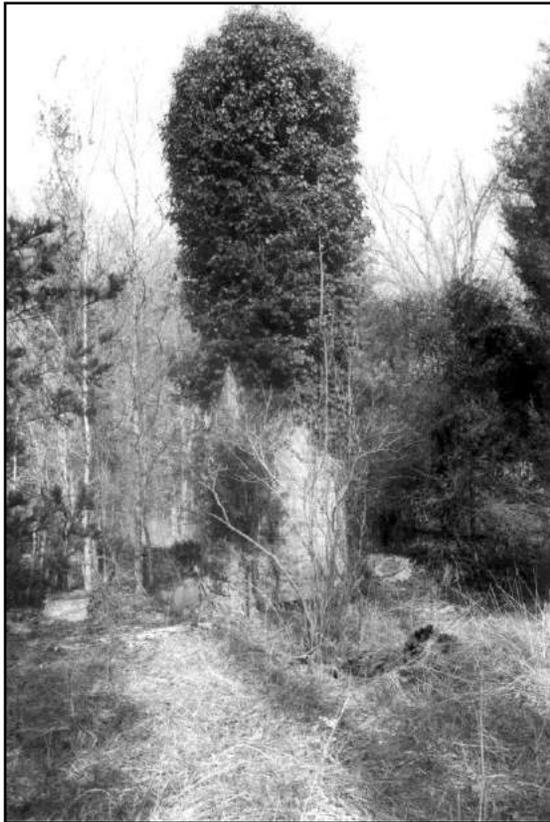
pins remain in the foundation. Nearby is a metal commercial soft drink cooler.

Figure 92: A stone chimney remains intact at the Huchingson House Site.

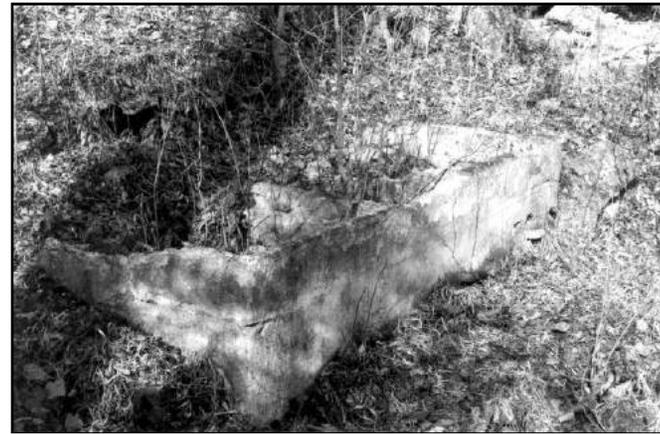
rectangular depression on the top about three or four feet in from the edge. Along the spring is a three-bay, concrete tank that is 2' 6" in height and measures approximately 4' x 11' 6". Curved metal pipes extend out from the bottom of the tank. East of the dam over the stream are two large flat stones that were placed here to form a foot bridge over the stream. The bridge has built up stone underneath and a dirt path leads to it on either side.

Figure 93: Minnow tank at the Hutchingson Spring.

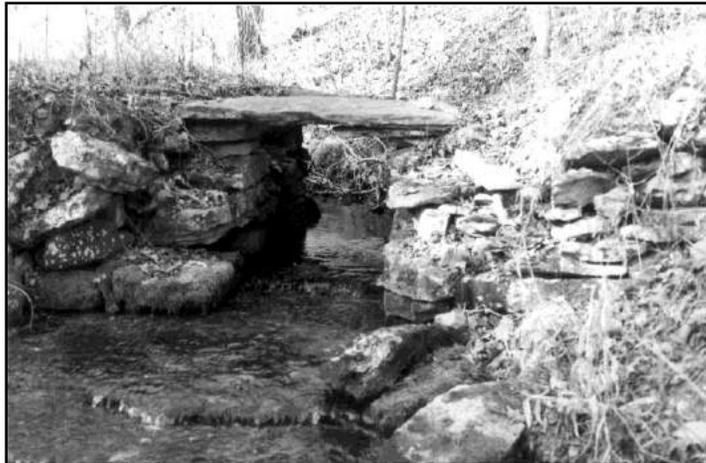
Figure 94: Rock bridge structure on the Huchingson property.
