BUFFALO NATIONAL RIVER

THEME IDENTIFICATION
CONTEXT STUDIES
AND
PROPERTY EVALUATIONS
SOL: N6068030063

Thomason and Associates
Preservation Planners
Nashville, Tennessee
And
Hawkins Partners
Landscape Architects
Nashville, Tennessee

September, 2004

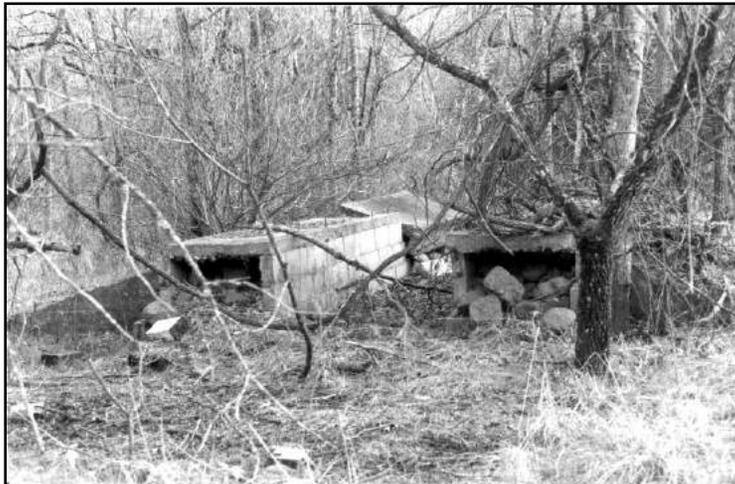
At this site are the concrete foundations of an early twentieth century barn and milkhouse. The barn foundations are of concrete and measure 53' x 41'. Approximately 100 feet southwest of the barn foundation is the foundation of the milkhouse. This foundation is of concrete block with rock infill and is around three feet in height. The foundation is long and narrow and has concrete ramps on both the north and south sides, and pairs of concrete steps appear on the east end of the foundation.

Figure 96: Remaining foundations of the Tinsley milkhouse.

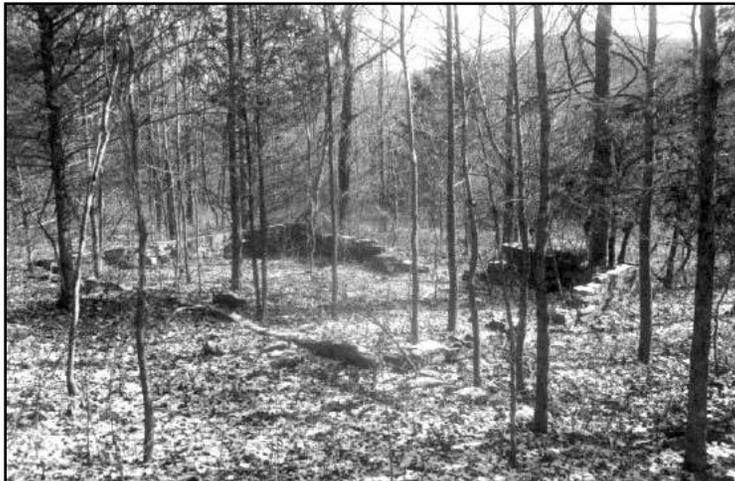
This House Site is located approximately 0.75 mile east of the Erbie town site. Fields along the road leading to the property are no longer in use and are beginning to become overgrown with tall grass, brush, and some saplings. The house site is located twenty feet east of the road and retains the foundations of a ca. 1931 dwelling. The stone foundations measure approximately 18' x 26' and the stone ranges from 6" to 3' in height. The house site is surrounded by young trees and a number of saplings are within the foundation. A fairly old Pear tree (~25-30") is growing near the northwest corner of the house foundations. A large grapevine just north of the foundation appears to be a natural occurrence rather than a domestic planting. Approximately ten feet north of the house foundations is an earthen depression that measures 5' x 2'. A lead pipe protrudes from the ground in this area and appears to connect to the house site.

Figure 98: Foundation Remains on Tract 50-105.

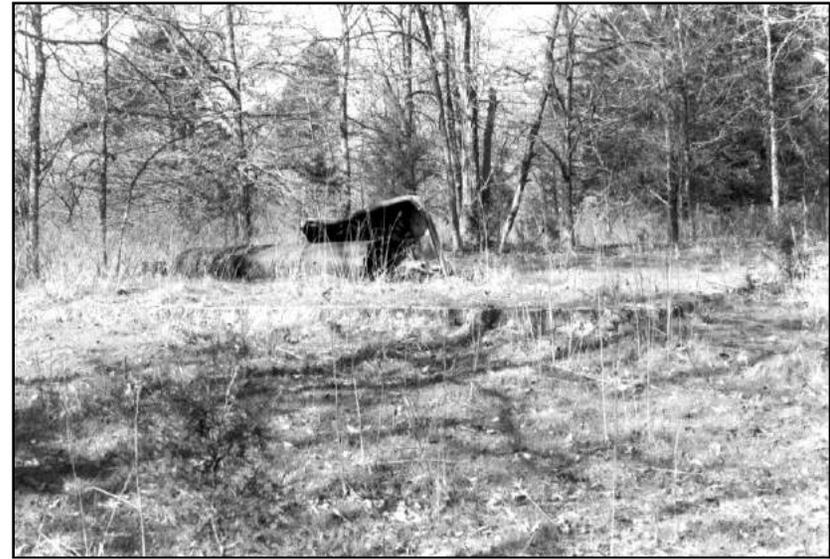
at the end of the stone stack. A 2' x 10' "sidewalk" leads from the main trail toward where the ground is disturbed near the root cellar.

Figure 100: Remaining foundations of the Taylor dwelling.

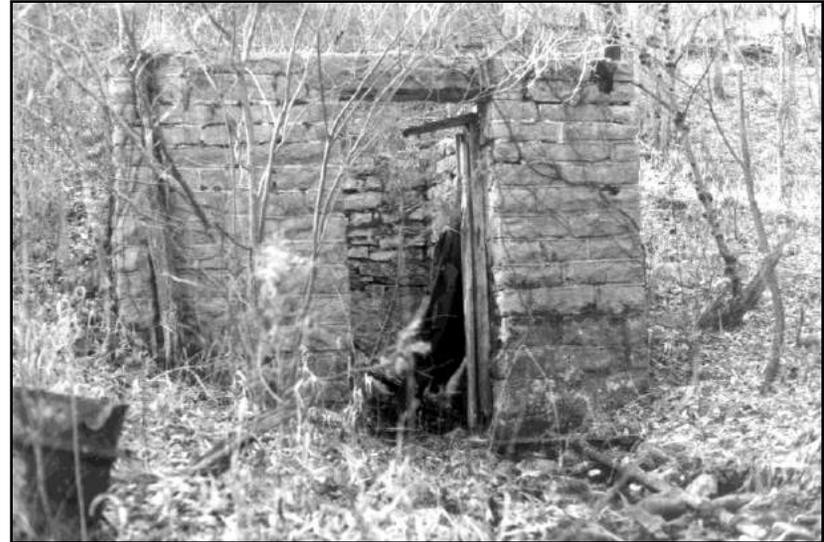
Down the hillside on the opposite side of the drive is a stone springhouse that measures 10' 3" x 12' and is approximately 6' in height. The springhouse is of cut stone with concrete mortar. The entrance to the springhouse is about three feet high and is missing its door. The roof of the structure has caved in and there are pieces of corrugated metal and remnants of roof framing and asphalt shingles in the area. The spring leads to a large oval pond. Adjacent to the springhouse is a large thicket of river cane that is about 30 feet tall. Midway up the hill are the remnants of a stone retaining wall and a wood post and wire fence. Close to the top of the hill is a fenced area that measures 20' x 10'. Within the fencing is a collapsed animal pen. There are boards and metal roofing fragments in the area.

Figure 102: Springhouse remains on the Taylor property.

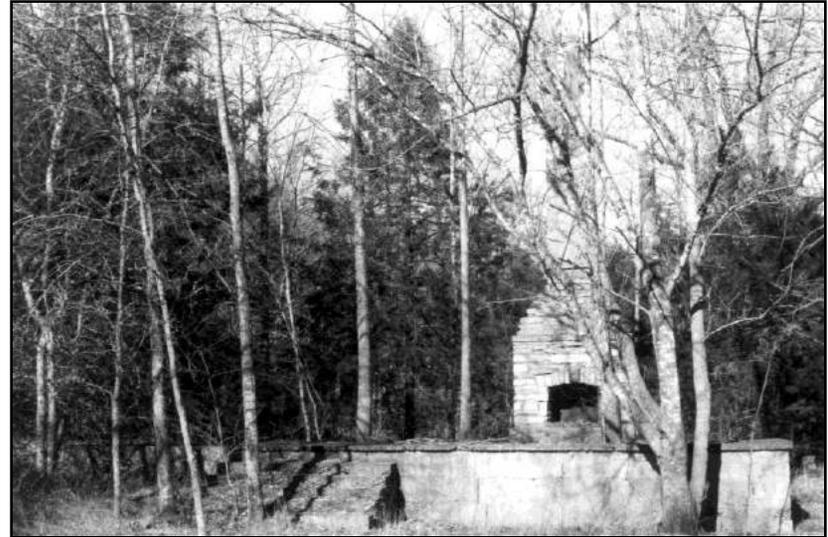
Figure 105: Foundations and chimney at the Angle House Site.

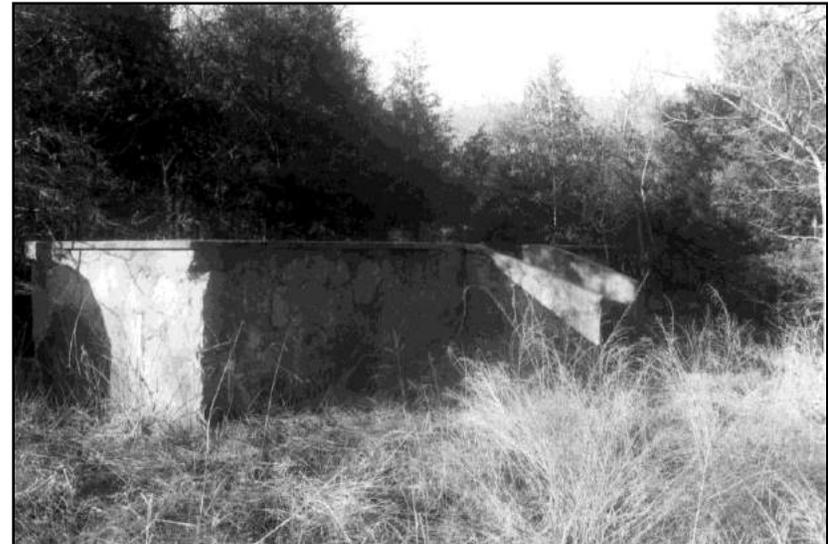
Figure 107: Remaining foundations at the McFadden House Site.

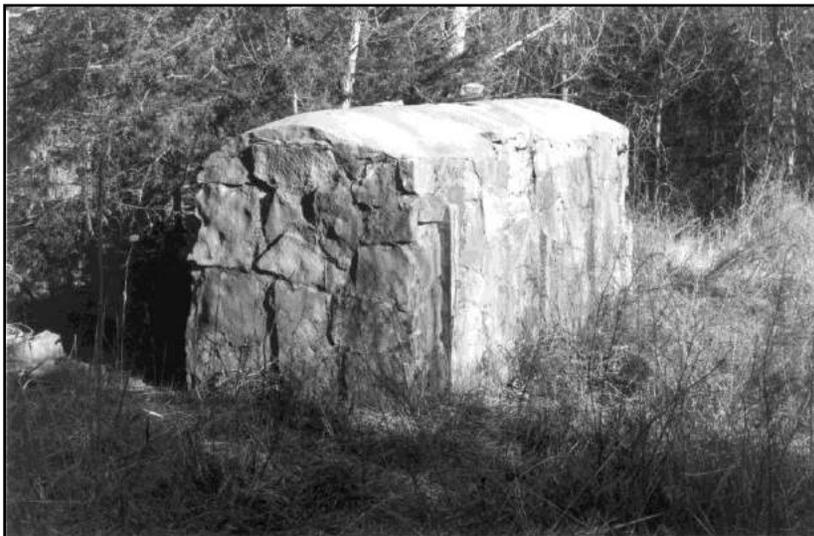
Adjacent to the house foundations approximately four feet to the west is a stone or rock reservoir with a rounded top. In front of the reservoir is a well area of poured concrete that measures 10' in length and 2' in width. To the rear of the house foundations approximately fifty feet are the ruins of a log barn. The building was constructed of unhewn logs with saddle notching and measured approximately 10' x 20'. A wood post and wire fence is nearby. A rock-lined depression sits about twenty feet southeast of the log ruins and measures 3' x 4'. A discernible driveway leads to the area near the outbuilding ruins. Across the road are the remains of a barn foundation. A single foundation line of poured concrete extends for about 28' and there is some rock scatter throughout the site. The surrounding area is wooded.

Figure 108: Rock reservoir at the McFadden House Site.

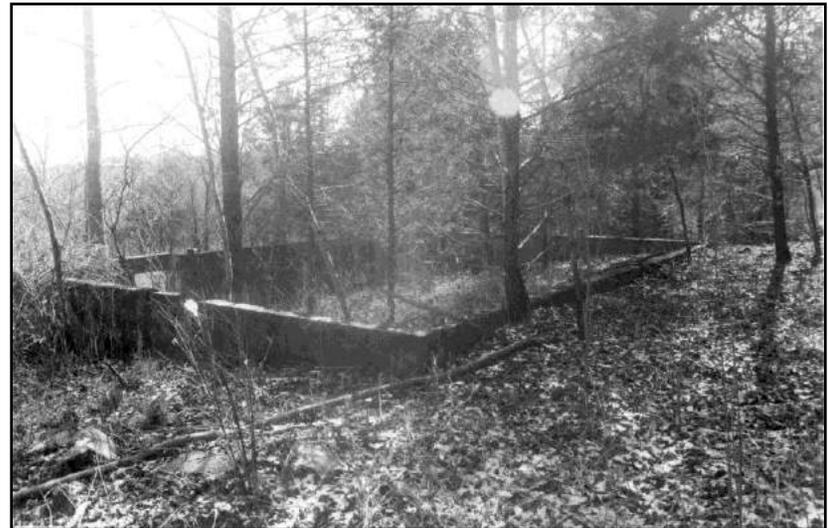
This site consists of a poured concrete foundation situated approximately 100 feet south of the road. The foundation measures 9' 6" x 28'. A hollow concrete block and poured concrete foundation continues another 36' 10" to the west then 33' north down a slope. North of this are nine square poured concrete columns or piers. These are around five feet in height and three have fallen to the ground. The dwelling appears to have been built on a slope and had a half basement level and possibly a deck. A 4' high foundation wall remains with small square window openings. Historically the house might have had a view of the river, but this area is now overgrown with a number of mature trees. South of the house site about fifteen feet is a poured concrete and hollow concrete block foundation that measures 5' x 4'. The remnants of a loose stone wall appear on the hill south of the house site. There is an opening in the wall about twelve feet parallel to the house site and is possibly where the driveway was located. Around 100 feet northwest of the house site and 50 feet from the road is a well opening. Along the roadside are nine or ten large boulders placed to block the entrance to the drive. A wood post and wire fence runs along the road.

Figure 110: House Site on Tract 50-102.

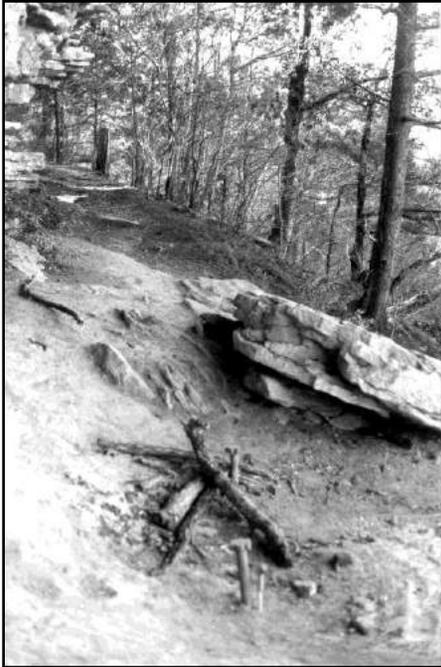
Local residents constructed a swinging bridge across the Buffalo River in the Erbie area during the late 1930s. The bridge eased access to the village and allowed people to get to the school, church, and store, and have greater contact with one another. The NPS dismantled what remained of the bridge in 1986. The bridge was located approximately one quarter mile downstream from the Parker-Hickman Farmstead. What remains at the site today is an iron axle shaft that is driven into the bedrock ledge on a bluff south of the river. On the north side of the river is a decayed A-frame that supported the bridge's north end.

Figure 111: The anchor pins of the Erbie swinging bridge.

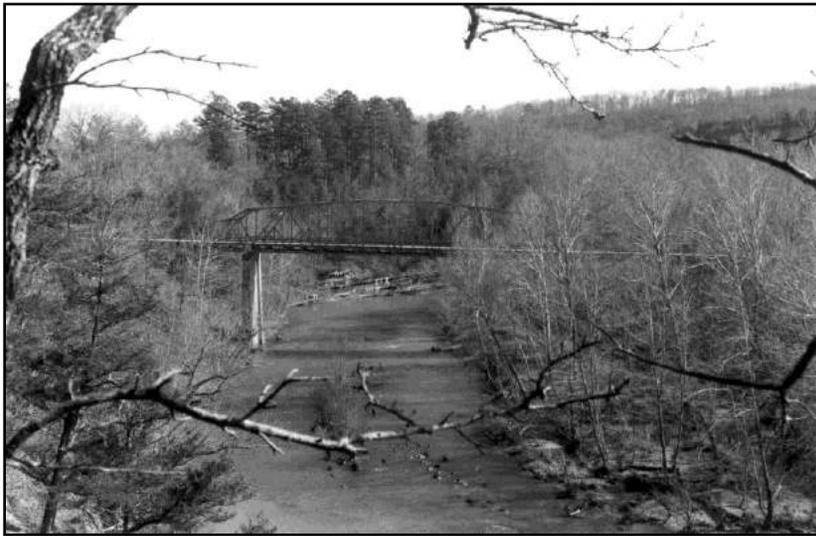
The bridge spanning across the Buffalo River along Highway 7 at Pruitt is a steel truss bridge constructed in 1931. The bridge has three large and one small poured concrete supports and contains a modern two-lane asphalt highway. The bridge has a concrete open railing at each end. A plate on the bridge acknowledges Fred Lutjohann as the contractor and the Virginia Bridge and Iron Company of Roanoke, Virginia as the builder of the structure. Lutjohann was a little known figure, but was involved with a number of Arkansas bridges constructed during the 1920s and 1930s.

Figure128: The Highway 7 Bridge spans the Buffalo River.

A number of steel truss bridges were constructed throughout the state during the early twentieth century as the modern highway system evolved. These bridges provided greater access and improved transportation to rural areas throughout the state. The Highway 7 Bridge across the Buffalo River is an excellent example of this type of bridge design and is the only surviving early twentieth century bridge in the Buffalo National River. The bridge remains in good condition and was listed on the National Register under the Multiple Property Documentation Form “Historic Bridges of Arkansas.”

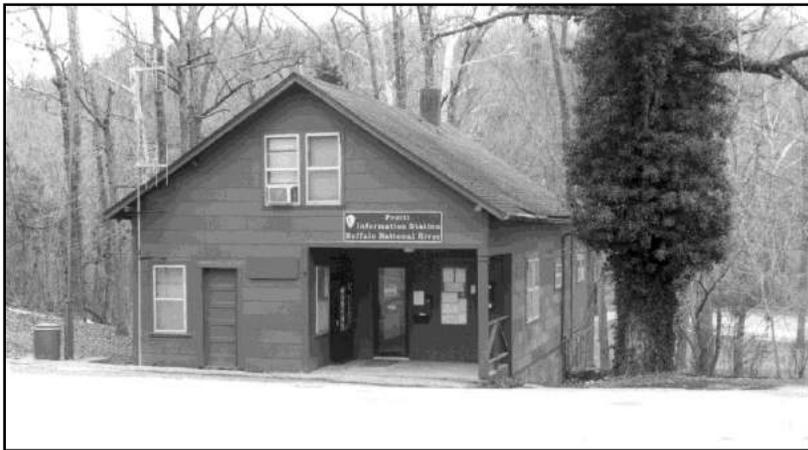
The building is a one- and one-half story, frame structure with a gable front roof of asphalt shingles, a concrete foundation, an interior concrete chimney, and an exterior of asbestos panels. On the main (east) façade is a partial-width incised porch with a square wood corner post and a poured concrete floor. The main entrance leading to the porch has a ca. 1970 glass and metal door. A second entrance on the main façade has an original five-panel wood door. Windows in the building are original one-over-one wood sash with exterior storm panels. The building has exposed rafters at the roofline of the side elevations. On the south elevation is a small, frame, shed roof addition with a vertical wood panel exterior and a concrete block foundation. This addition has a solid metal door on the south elevation. At the rear is a flat roof addition with one-over-one horizontal metal windows and a concrete exterior. This addition has a basement level of concrete block and on the north elevation at the basement level are paneled metal doors to a garage/storage area.

Figure 130: The Pruitt Ranger Station originally housed a store for a tourist camp.

The Hammons Store/Pruitt Ranger Station was the center of a sizeable tourist camp in the 1930s and 1940s. The building has been altered from its original design with two late twentieth century additions, and the interior has been remodeled to serve as a ranger station. The surrounding area no longer resembles its early twentieth century recreational development. The cabins and tourist camp and associated properties were razed in the 1970s following NPS acquisition of the site, and no above ground evidence of these properties remain. The Hammons Store/Pruitt Ranger Station does not possess sufficient integrity or historical significance to meet the requirements of the National Register.

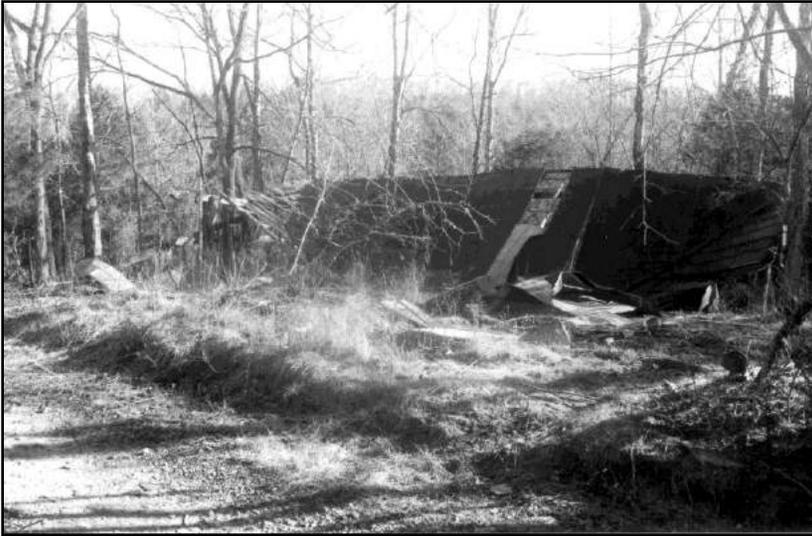
This tract originally contained a ca. 1940 frame dwelling, a ca. 1930 frame barn with an interior log crib dating to ca. 1900, a frame and log chicken house, and a frame shed and privy. Presently the site consists primarily of the ruins of the barn, which lie east of the gravel drive that leads to the site. A portion of the standing seam metal roof as well as a few frame support posts are all that remain of the structure. The surrounding area contains scatter of metal roof panels and various wood and metal debris. One log on the ground has saddle notching. There are no other logs in the vicinity.

Figure 131: Remains of a barn at the Josephine Hamilton House Site.

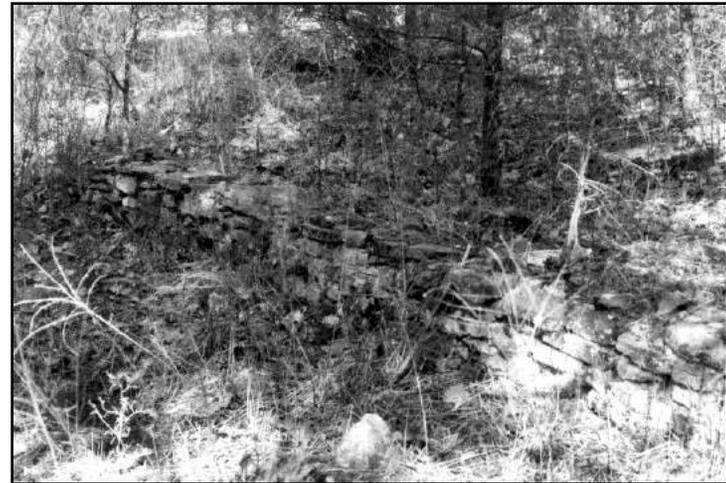
South of the house site approximately 15' is a portion of a rock retaining wall that runs about 30 feet. Approximately 20' south of this are the stone foundations of what was probably the storage building. These measure 13' x 22'. Approximately two feet to the rear (north) of the house site is another stone retaining wall that extends around 40 feet. Directly behind the house site are rock outcroppings.

Figure 133: Dry Stack Stone Retaining Wall on Tract 12-107.

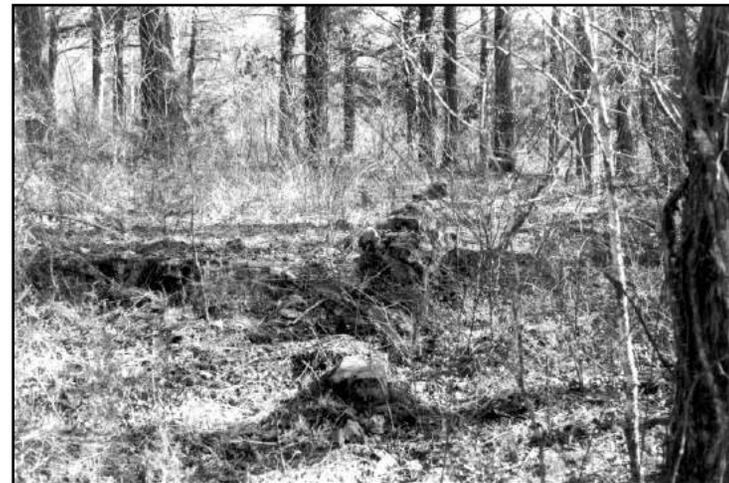
East of the house site approximately 100 feet are the foundation remains of the barn and attached garage. The barn foundations are of native stone and measure roughly 25' x 13'. The garage was attached to the east side of the barn and its foundations are of concrete block and measure 23 ½' x 39'.

Figure 134: Outbuilding Stone Foundations on Tract 12-107.

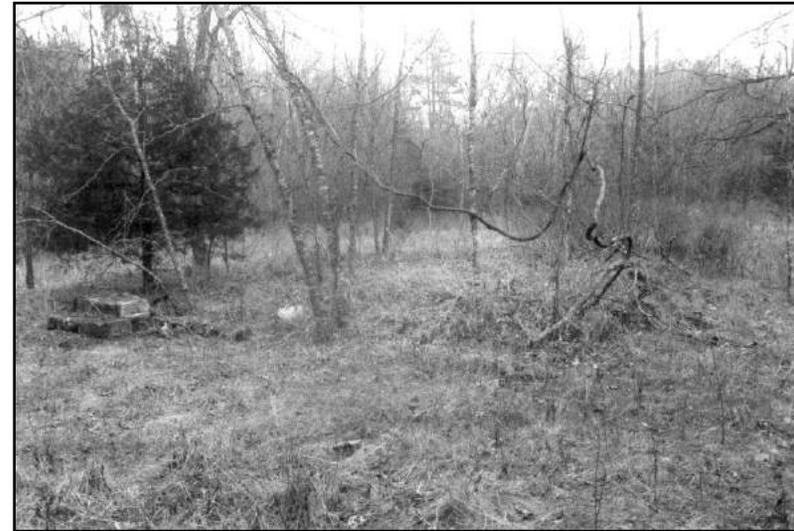
The Eaton property originally contained a ca. 1920 dwelling and smokehouse and a ca. 1960 metal shed and a ca. 1970 horse corral. Foundations of the house remain and are located approximately 200 feet north of the road. A dirt/grass driveway leads to the site from the road. The site is located just east of a small creek that extends from the Buffalo River. The house foundations are of stone, and three stone steps capped with concrete remain standing on the south elevation. The foundations measure approximately 25'4" x 29' 5". Brush and small trees have grown within the foundations. A large depression within the foundation measures about 4' x 7' and is lined with stone on the south end.

Figure 135: The Clarence Eaton House Site.

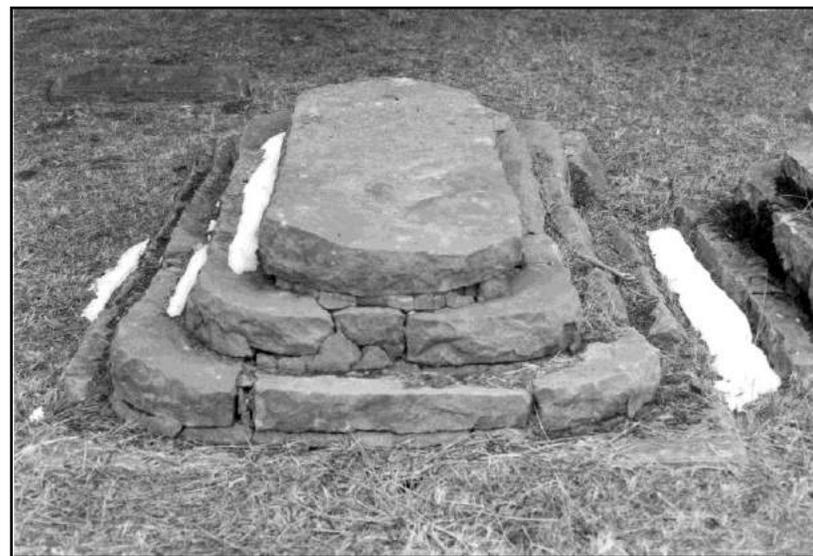
The most significant feature of the Collins Cemetery are ten tiered boxed vault graves that are centrally located in the graveyard. These graves feature three tiers of large slabs of native stone with rounded edges that cover the length of the grave. None of these graves have headstones or are dated. One has the name Mary Tennison Armstrong hand carved on a small stone on top of the grave, and it is assumed the graves are those of the Armstrong family. Five of the

tiered box vault graves appear to be those of adults and the other five are children, one of those an infant. The stones are in excellent condition and are an unusual type of grave design. A few examples of tiered stone graves exist in other cemeteries within the Buffalo National River as well, but none match the style, size, or quality of those found in the Collins/Armstrong Cemetery. The majority of other examples are in poor condition and do not have the rounded corners. The Collins Cemetery contains the largest collection of this grave type and its examples remain in very good condition. The cemetery is distinctive in the used of this folk grave tradition and is notable for its artistic merit. The cemetery reflects a significant local mortuary tradition and meets the criteria of the National Register.

Figure 141: Tiered box vault grave in Collins Cemetery.

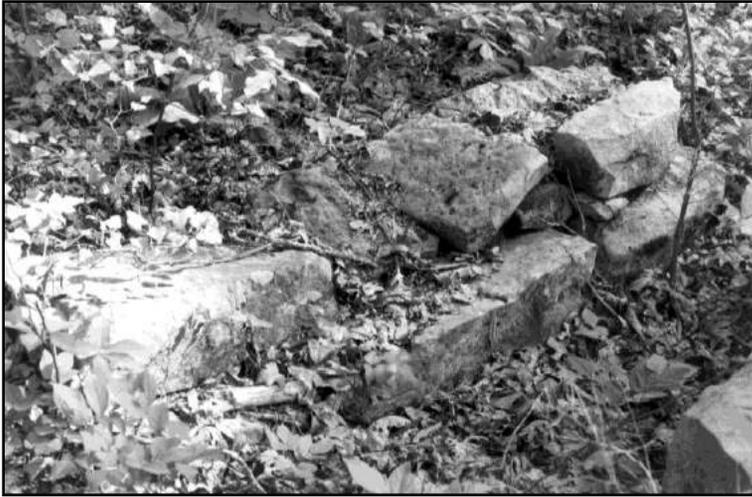
Figure 143: This tiered box vault grave in Deffenbaugh Cemetery has deteriorated substantially.

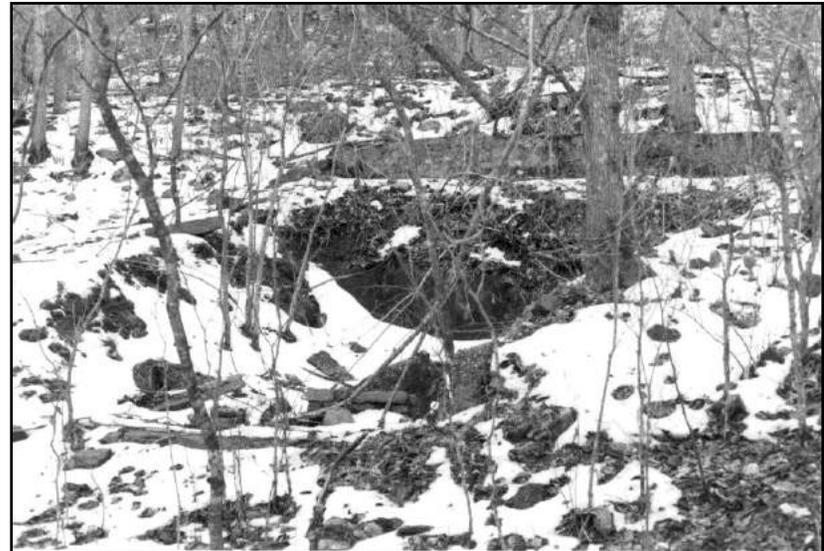
No buildings remain extant on the site, but some foundation remnants remain. These include the remains of what the tract records termed a “bunkhouse.” This appears to have been a stone root cellar banked into the hillside with a frame building erected on top. The NPS files note that the interior of the structure had linoleum and carpeted floors and was heated with a gas heater. What remains of this structure is a poured concrete and stone foundation that is banked into the hillside. Portions of the cellar walls remain. In front

of the bunkhouse remains is a single concrete block pier where the modern house was located. The surrounding lot is heavily overgrown and contains a number of saplings. Adjacent to the bunkhouse is the concrete block foundation of a small shed that measures 3’ x 4’. A large metal pipe sticks out of the ground within the foundation.

Figure 144: Bunkhouse Ruins at the House Site on Tract No. 86-105.

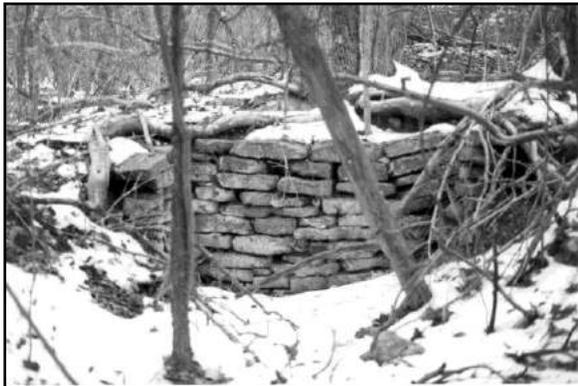
This site is located just north of the Highway 123 bridge over the Buffalo River in the Carver community. The site is west of the road and consists of the foundations of a 1914 dwelling. The foundations are visible from the highway and are about 300 feet north of the bridge. The foundation is of dry stack stone and is about three feet high. It is long and narrow measuring roughly 12' x 50'. The area is heavily overgrown with trees and brambles. Several large yucca plants and daffodils are near the site. Approximately 200 feet north of the house foundations are foundation remnants of another building. This foundation is also of cut dry stack stone. It is banked into the hillside and has a wall 3 ½' high and 6 ½' long. Outer walls extend from this wall approximately one and one-half feet and then fade. NPS tract files indicate a shed and chicken coop were on this property; however this second foundation appears to be more substantial. Remnants of pavement are throughout the area. This is possibly remnants of a driveway or the old alignment of Highway 123.

Figure 145: The remnants of a foundation on the Walter Eddings property.

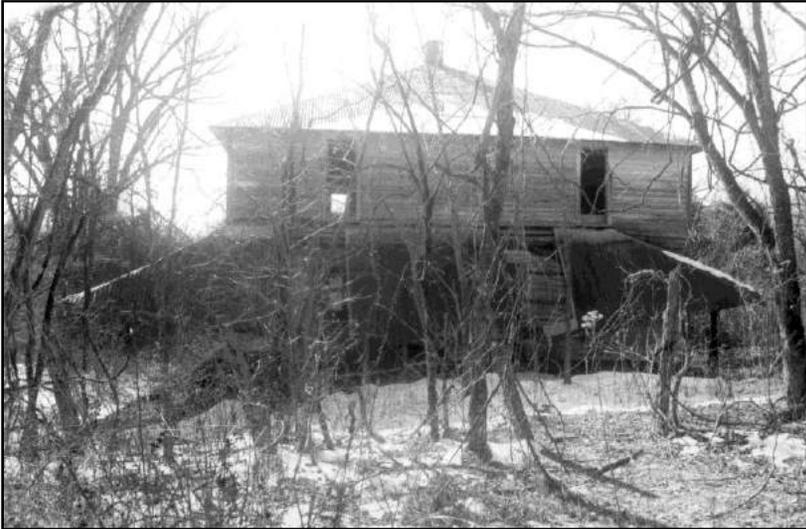
Figure 148: The Mays House has deteriorated significantly after several decades of disuse and neglect.

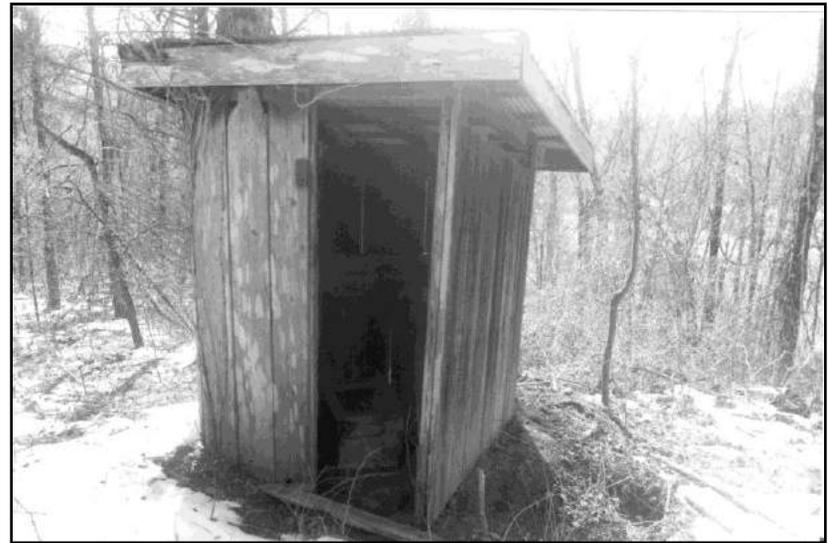
Figure 149: The privy at the Mays House was likely constructed by the WPA during the 1930s.

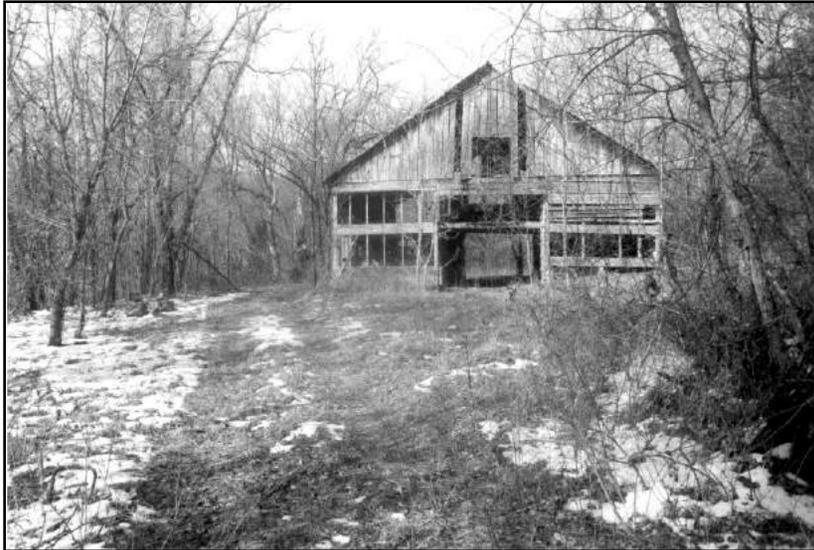
Figure 150: The barn on the Mays property has also deteriorated.

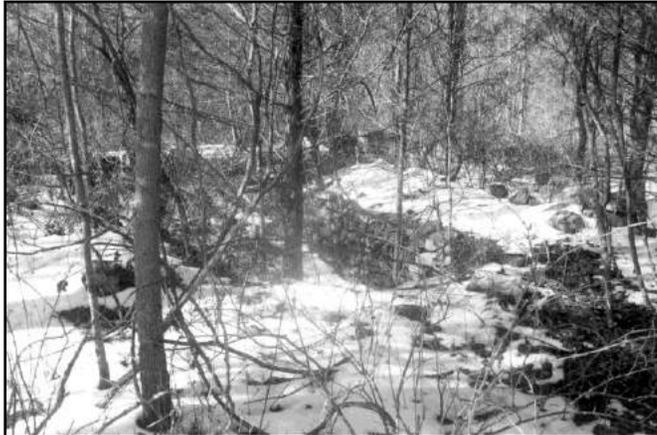
The house foundations measure approximately 35' x 15'. Within the foundations is a pit that is roughly 5' x 10' and is 5' deep. This was possibly a cellar beneath the dwelling. At the east end of the foundations is the base of a well or cistern based on dry stack stone approximately 1 ½' in height. The cistern is in the northeast corner of the foundation and is approximately 2' 4" high. The top of the cistern is carved "Earl Sullivan, Nov 30 1941, Made By G.W. Henson." Various metal debris and automobile parts are scattered throughout the area. A number of daffodils appear south of the house foundations.

Approximately 15 feet east of the cistern are foundation remnants of a log shed. These measure roughly 7' x 10' and consist of a few stone piers and three deteriorated logs. Remnants of a wood post and wire fence run north-south along the eastern border of the property. Southwest of the house foundations are some stone piers that were possibly the foundations for the barn.

Figure 151: The remaining foundations on Tract No. 60-100.

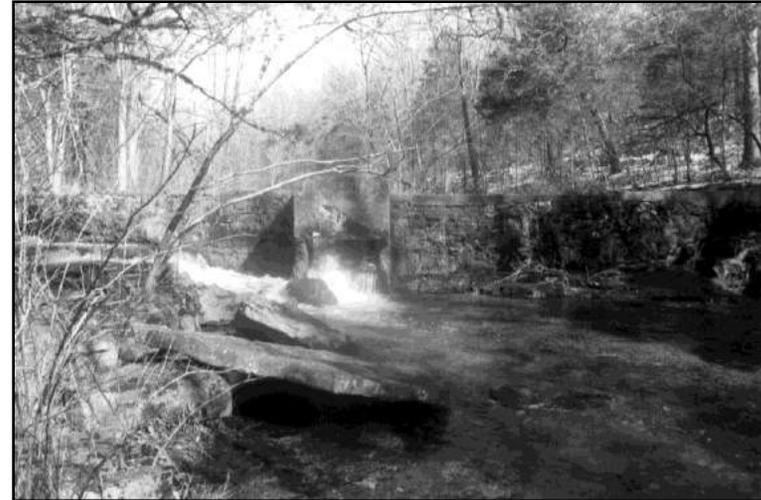
Along Mill Creek in the Mt. Hersey area is a stone, brick, and concrete dam that appears to date to ca. 1930. The dam is largely of cut stone with brick at one end, and is topped with poured concrete. In the center is a poured concrete gate. The dam has deteriorated on the west end and water flows around it here. This area possibly was a mill race for a mill at the site. There is no evidence of a mill or other building remains on the site.

Figure 152: Mill Creek Dam-Lower View.

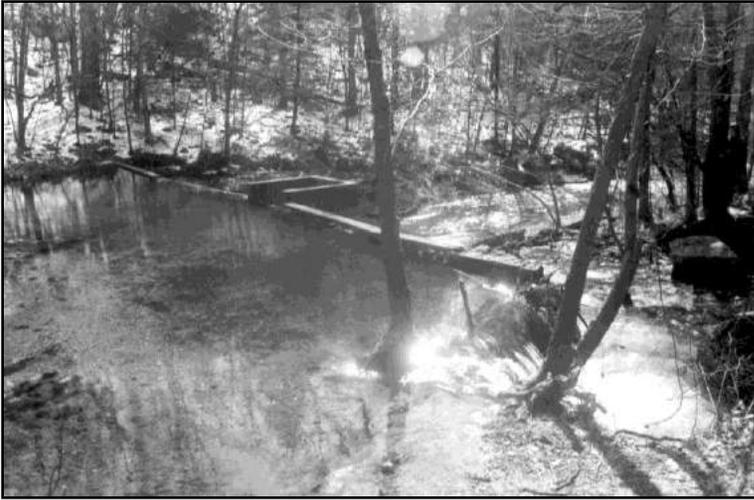
Figure 153: Mill Creek Dam-Upper View.

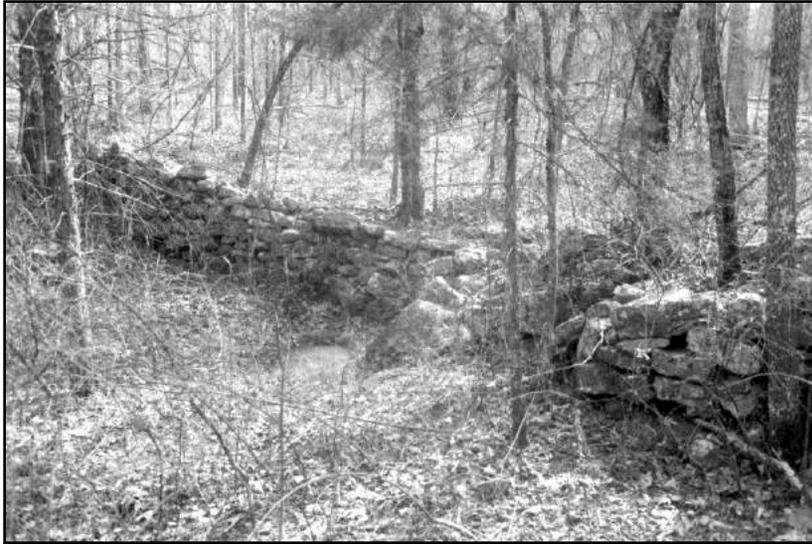
Figure 158: Dry Stack Stone Retaining Wall at John Reddell Property on Tract 59-101.

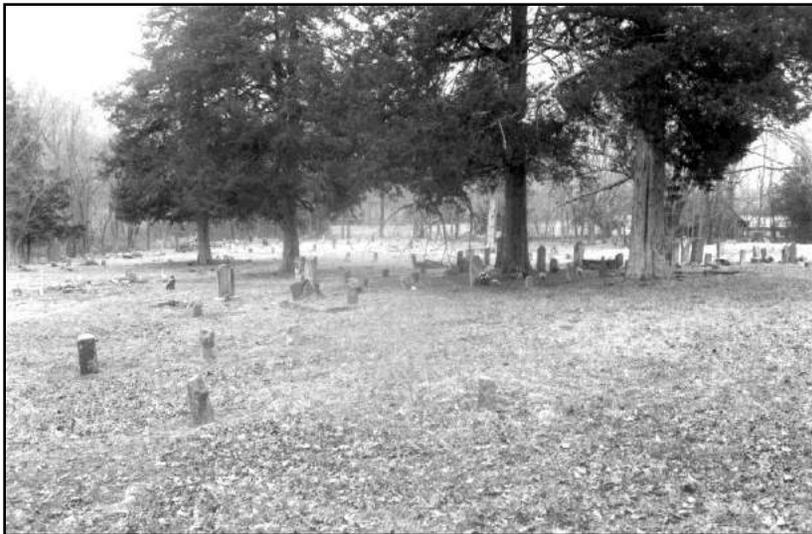
Figure 160: General view of Hall Cemetery.

contained within a metal post and wire fence and measures roughly 400 feet by 800 feet. The south end of the cemetery has a new wooden rail fence. At this end of the cemetery is a ca. 1990 pavilion with a poured concrete floor, and a gable metal roof supported by metal posts. The cemetery is located in Richland Valley approximately two miles north of the community of Eula along County Road 12. The cemetery is sited at the base of a wooded hill to the east. Cattle fields and Richland Creek lie to the west.

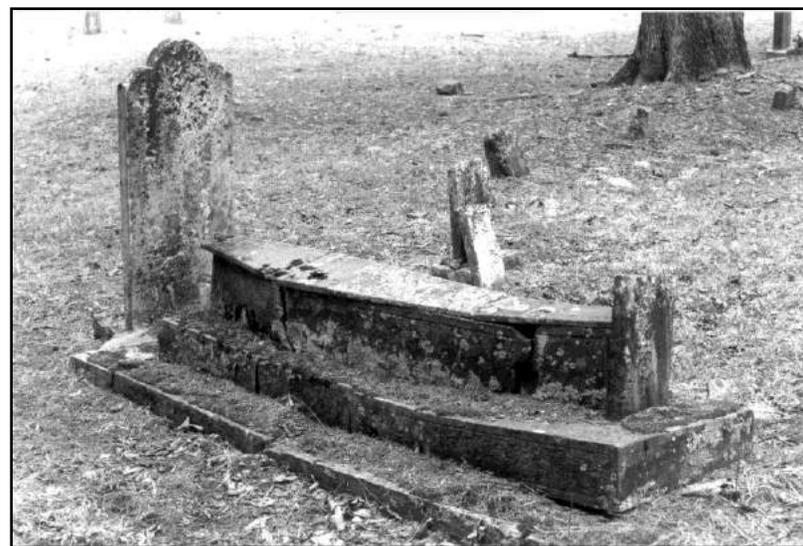
Figure 161: Coffin Grave at Hall Cemetery.

There are a variety of headstones and markers in Hall Cemetery. Simple tablets are most common and decorative motifs include clasped hands, doves, bibles, finger pointing toward heaven, drapery, lambs, and the gates of heaven. There are also stones inscribed with the Masonic symbol. Hall Cemetery also contains two examples of tiered box vault graves, family plots, and individual stone-lined graves. The most distinct graves are four coffin graves, also known as body stones. This grave type features a coffin-shaped stone box atop a raised stone platform. Hall Cemetery contains both adult and child examples of this grave type. Two of the coffin graves are more stylized and have pented tops where the other two have flat tops.

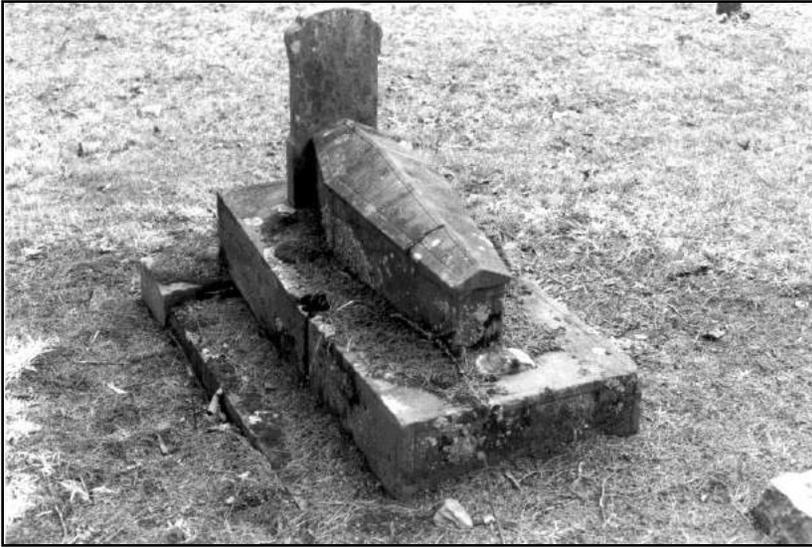
Figure 162: Child's Coffin Grave at Hall Cemetery.

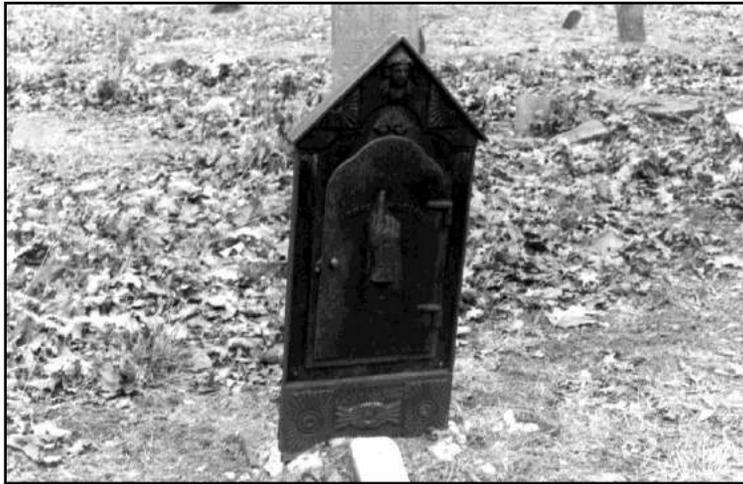
Figure 165: Metal marker with embossed detailing at Hall Cemetery.

Another interesting marker is that of Jimmie Baker. This grave is marked with a metal marker that is approximately three feet high and has a pointed arch top. The marker has a hinged door in the center with a finger pointing to heaven and inscribed "In God We Trust."

Above the door under the "gable" is a female relief flanked by sunburst patterns. The door opens and inside is a tablet with the deceased name, birth and death dates, and his parents' name. Water damage has caused the marker to rust and make most of the writing illegible, but a birth date of December 1894 can be discerned and the death date is also in the 1890s, although the last digit is illegible. Above the writing is an oval that contained a portrait. The outline of the figure is barely visible.

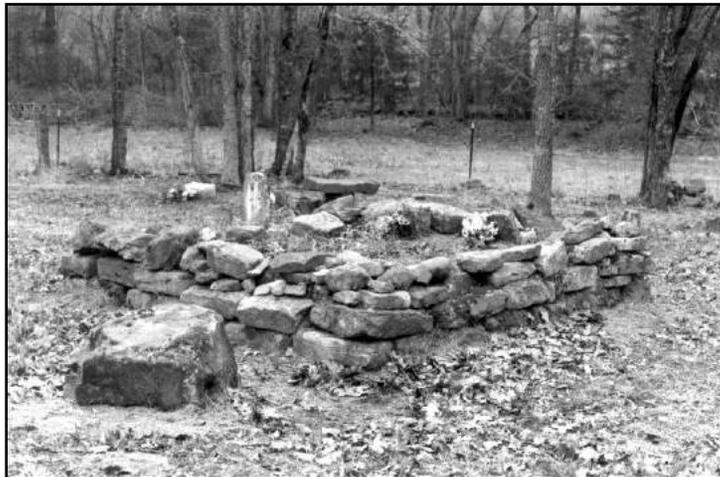
Figure 166: A stone-lined grave at Hall Cemetery.

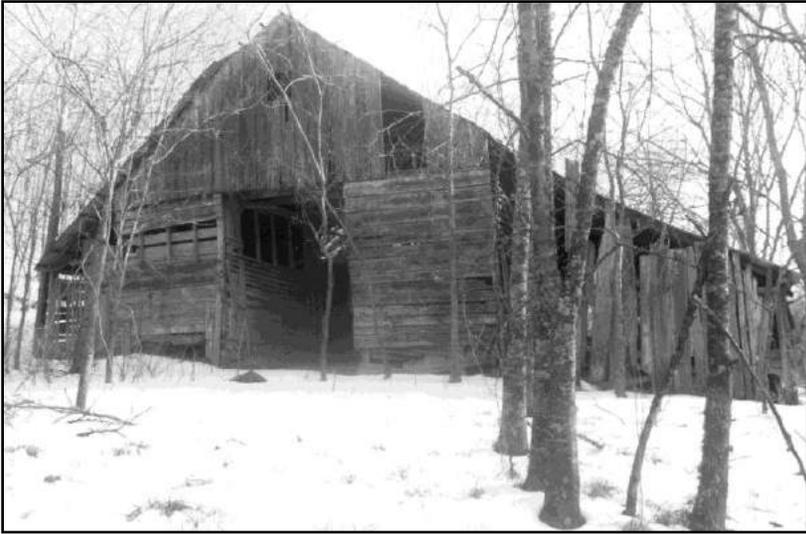
Figure 167: The Barn on Tract No. 52-119.

This property is located just north of Woolum east of County Road 14. It contains a large frame, gable front barn built ca. 1930. The barn sits well off the road, between 300 and 400 feet and is surrounded by woods comprised mostly of new growth trees. A dry creek bed runs between the barn and the county road. The barn has a metal standing seam roof, a stone pier foundation, and a horizontal board exterior with vertical board in the upper loft area. There is a central drive-thru bay and shed roof wings on both side elevations. The interior has three or four stock pens on either side. The side wings have two stock pens each. The barn has a large loft area. A wood post and wire fence line runs behind the barn and opposite the fence is an old farm road.

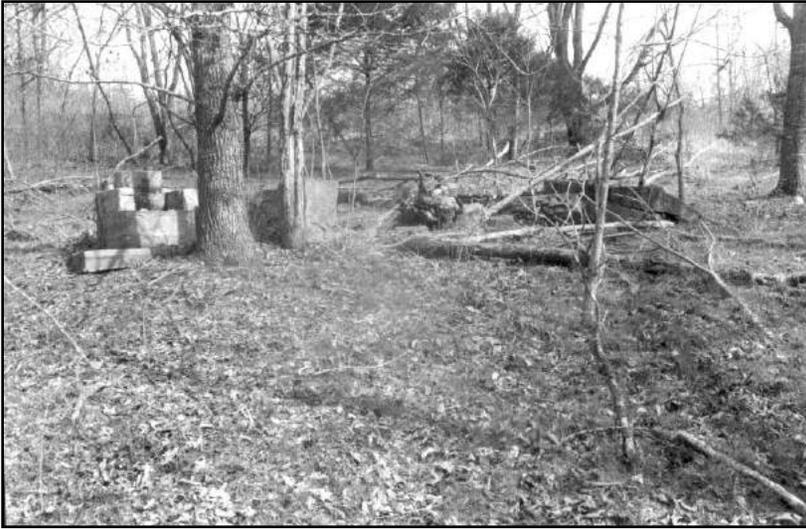
Figure 168: Ruins at the Manes House Site on Tract No. 10-105.

This site consists of the foundation remains of a 1930s dwelling. The site is approximately 50 feet west of the gravel road that leads off of County Road 13. A line of poured concrete over stone extends approximately 35 feet north-south, and remnants of the foundation also extend to the west of this line. The south and west lines of the foundation are not well defined. There is some scatter of stone, but nothing discernible. Poured concrete steps remain on the north and south ends of the foundations. Steps on the south end lead to a poured concrete walkway that is 2 feet wide and extends 8 feet. Within the center of the foundations is a large depression lined with cut stone. It is roughly 8' x 10' and about 4' deep. The walls have partially collapsed and the area has standing water in it. A tree has fallen over the top of this area, which was possibly a cellar. There is a scattering of brick at the northwest corner of the foundation.

A concrete block well/cistern is located on the northwestern corner of the foundations. The well sits on a concrete slab and is about 10 feet deep. It is uncapped. A fence line runs east-west about 15 feet north of the well and a number of daffodils are sprinkled along both sides of the fence. Another portion of an east-west fence line exists approximately 10 feet south of the house site. Daffodils also line this fence.

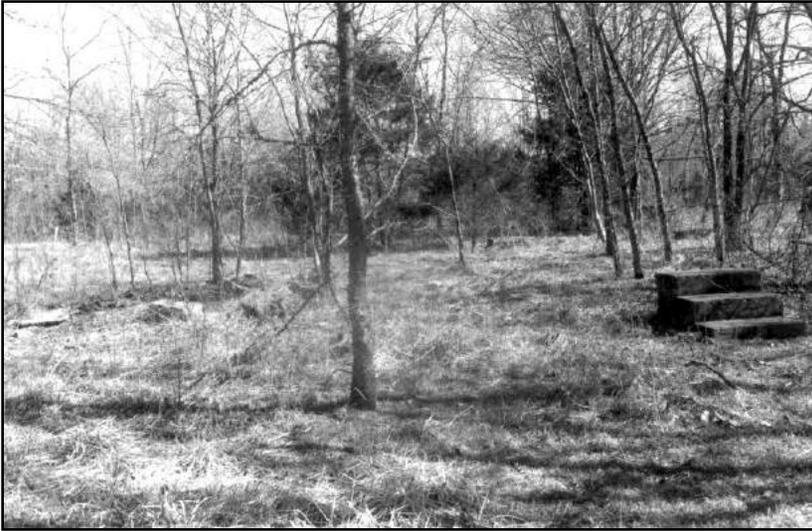
Figure 169: The remaining foundations of the Brewer House.

The Brewer House Site is east of the road that leads to the fields and is approximately 200 feet off the road. There are no discernible foundations; however there are three sets of steps that remain as well as a brick pile (possible chimney fall) and a well. Two sets of steps near the well are stone and poured concrete. Each has one long step and then a shorter second step. These set of steps are about ten feet apart. The well is located approximately 8 feet east of the southern most step. The well is circular and constructed of stone and poured concrete. It is currently filled with dirt. Two unhewn wood posts flank the well and support a third across the top.

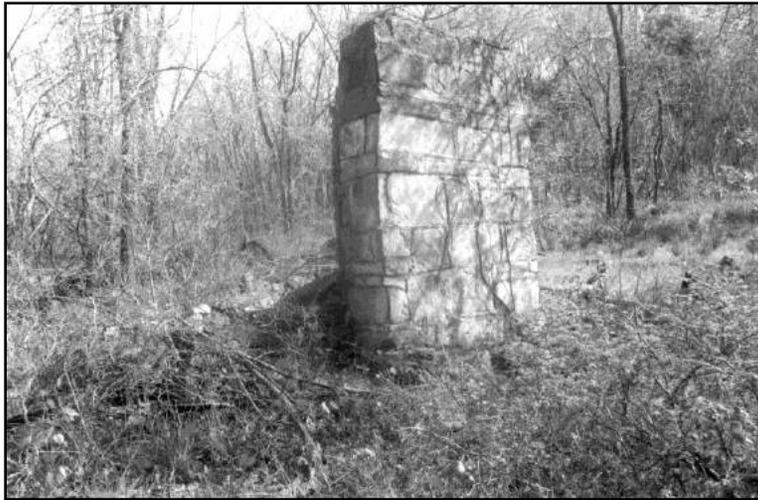
Figure 170: A portion of a chimney still stands at the house site on Tract 55-101.

A portion of a stone chimney and fireplace remain at the house site. The chimney is approximately 9 feet tall and sets on a stone foundation. A chimney fall lies directly to the north and extends several feet. A number of corrugated metal roof panels are in the immediate area. On the west side of the chimney, a small portion of a stone wall remains intact and is about 1 ½' tall and 4 ½' long. A portion of a stone foundation is visible on the west side of the house site. Another small portion of stone stack wall is directly north of the chimney about 30 feet. Ruins of an old metal stove are adjacent to the wall on the east, and an old metal sink lies southeast of the stove. A single stack of stones is to the west about two feet and stands about two feet high. The house site is roughly 30' x 50'. Directly west of the chimney is a large circular pit about 7-8 feet in diameter and 2-3 feet deep. A fence line runs north-south adjacent to the pit. Directly west of the pit on the other side of a small slope are the remains of what was probably a root cellar built into the hillside. The cellar measures approximately 14' x 15' and is constructed of dry stack stone walls. The rear or east wall is 3 feet deep and has a cement covering. The north and south walls taper down to ground level.

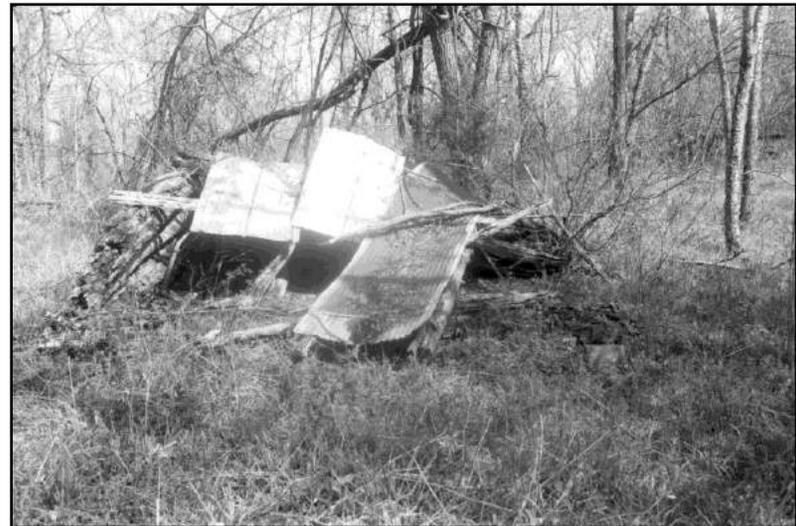
Figure 171: Ruins of a log outbuilding on Tract 55-101.

South of the house site and adjacent to the pond are the remains of a log outbuilding. Three or four logs remain intact, but the building is otherwise in ruins. Pieces of corrugated metal roof panels lie on top of the collapsed structure. It appears to have been a small rectangular form around 5' x 7' and had a stone pier foundation. Approximately three feet west of these ruins is a portion of unhewn wood post and wire fencing. Another 25 feet to the west down a slight slope are the ruins of a frame outbuilding. A line of stone about ten feet long marks the east foundation. All that remains of the building are a few sawn boards nailed together and a few pieces of metal roofing. A wood post and wire fence line runs west down the slope from the ruins' southwest corner. The area between the log and frame

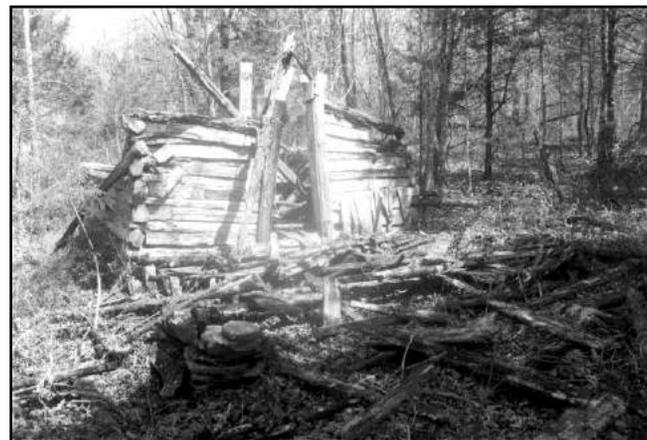
Figure 172: Log Cabin Ruins on Tract 53-109.

horizontal wood pieces nailed to the exterior of the building. Nails are flat head metal style. The building has a stone pier foundation and the roof has collapsed. The main (south) elevation has a central entrance. The door is missing and only the frame remains. The building appears to have had a porch on this elevation. Stone piers sit about 8 feet from the façade wall and the area between is filled with rotting logs and wood. The building measures 13' x 14' and the porch extends an additional 8'. The building sits directly adjacent of the hiking trail, approximately seven feet west of the wood post and wire fence line that runs along the trail.

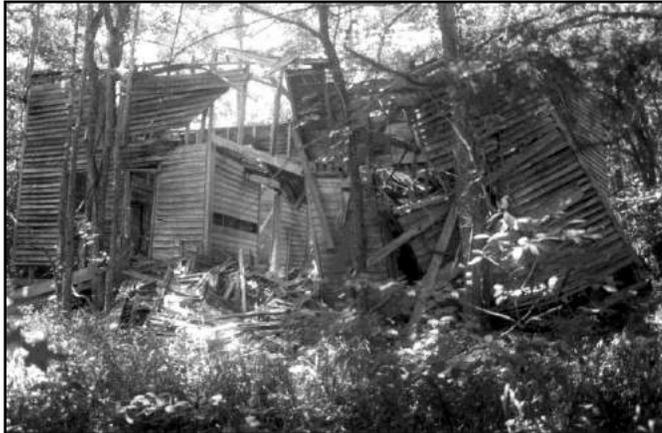
Figure173: The ruins of a two-story dwelling on Tract 55-103.

On this site are the ruins of a two-story, frame dwelling. The ruins are positioned west of the road about 100 feet. The house appears to date to ca. 1910 and has a stone pier foundation and an exterior of weatherboard siding. The roof is no longer intact. The dwelling had a central breezeway on the first floor and an exterior end cut stone chimney. Windows in the dwelling were one-over-one wood sash designs (frames remain, but panes are missing). Interior walls had horizontal boards. The interior floor has collapsed and caved inward. A wood post and wire fence surrounds the house and small yard. The house is difficult to detect even though it is close to the road due to the heavy foliage and growth. There appears to have been a porch on the main (east) elevation and remnants of vergeboard are located in this area. The house measures 40' 3" x 16' 5", and the dogtrot opening measures 7' 8". This appears to have been a substantial dwelling and was most likely associated with a prosperous farm in Richland Valley. The dwelling is now in ruins.
