BUFFALO NATIONAL RIVER

THEME IDENTIFICATION
CONTEXT STUDIES
AND
PROPERTY EVALUATIONS
SOL: N6068030063

Thomason and Associates
Preservation Planners
Nashville, Tennessee
And
Hawkins Partners
Landscape Architects
Nashville, Tennessee

September, 2004

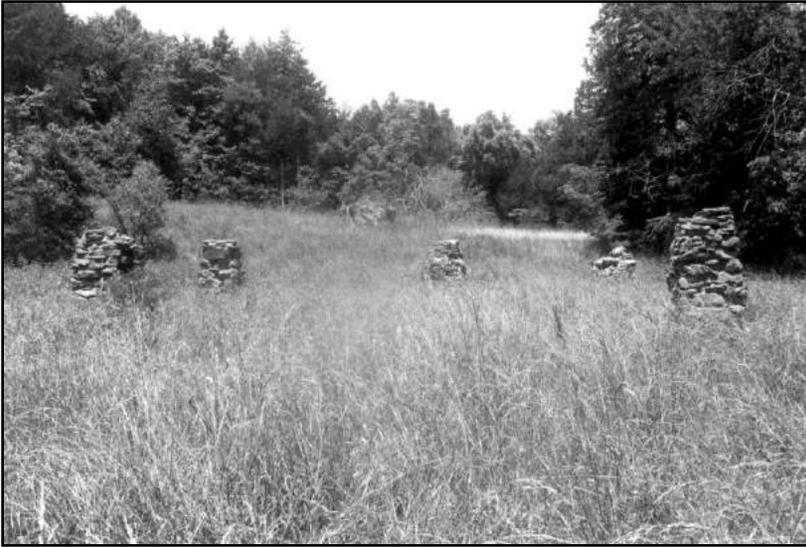
Figure 174: The stone piers of a turn-of-the-century cotton gin.

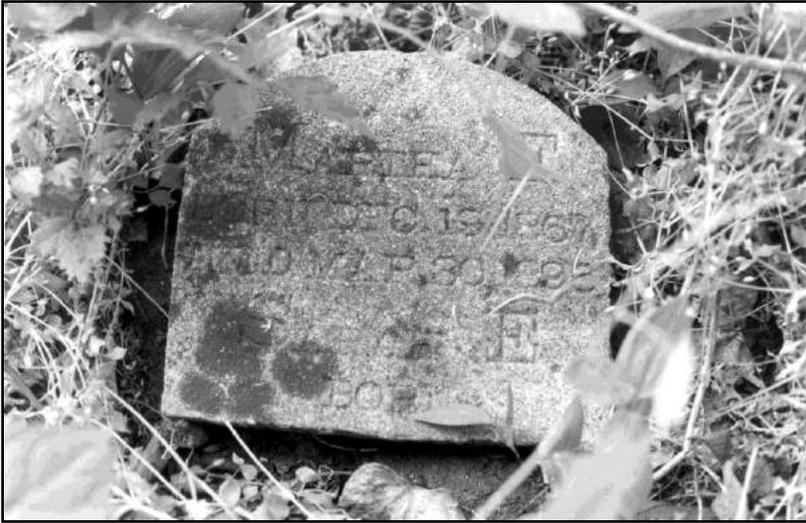
Figure 177: Broken Marker in the Hamilton Cemetery.

Hamilton Cemetery is a small cemetery located at the northern tip of Richland Valley just south of the Buffalo River below Woolum Ford. The cemetery is located in an open pasture and is enclosed with a new wood post and wood rail fence. There is only one legible headstone in the cemetery. It has two names inscribed on it Martha F. , Born Dec 18, 1867, Died Mar. 30, 1896, and Sarah E. The tablet is broken and the birth and death dates of Sarah remain unknown.

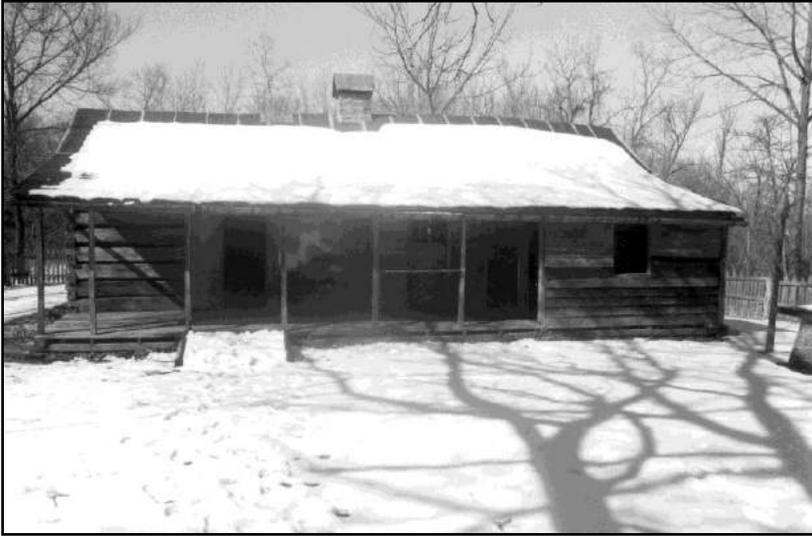
Figure 182: The Collier House was built in a double-pen plan.

The Collier Homestead consists of a dwelling, well, smokehouse, and barn. The Collier House is a ca. 1932 log dwelling originally built in a dogtrot plan. The dogtrot was later enclosed with sawn horizontal boards. The house has a gable roof of corrugated metal panels, a stone foundation, a central interior stone chimney, and an exterior of hewn logs with square notching. Weatherboard siding is in the gable fields. On the main (east) façade is a full-width shed roof porch with square wood posts and wood floor. A small portion of the porch at the northern end has been enclosed and served as a kitchen area. The enclosure has an exterior of weatherboard on the east elevation, horizontal boards on the south elevation, and vertical boards on the north elevation. The dwelling's south pen has a four-panel wood door. No other doors or windows in the dwelling remain extant. The interior of the Collier House has original wood floors and ceilings and horizontal board battens over the log walls. The south pen has a large stone fireplace/hearth. The back of the large stone chimney is in the enclosed dogtrot breezeway. This area was used as a pantry and contains wooden shelving adjacent to the chimney.

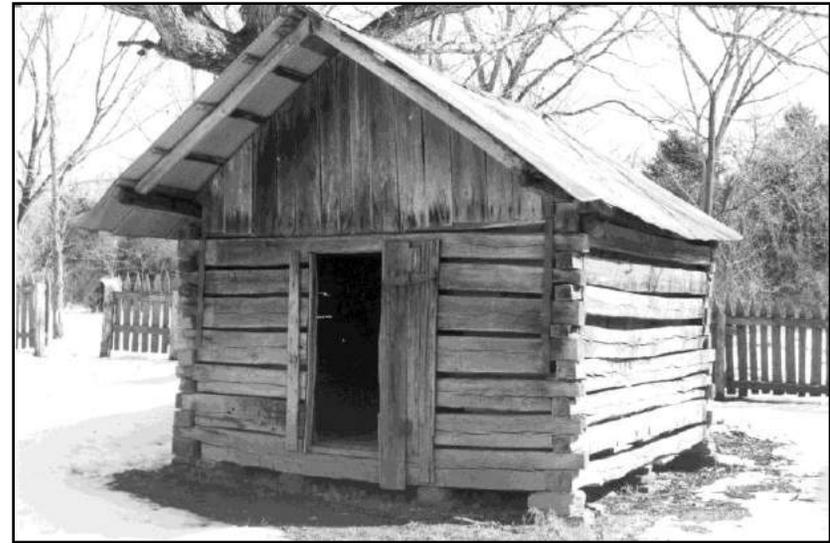
Southeast of the dwelling is a ca. 1932 log smokehouse with a gable front roof of corrugated metal panels, a stone pier foundation, and an exterior of hewn square notched logs. There is no chinking material between the logs. The building has a central entrance on the west elevation. A portion of a vertical board door remains at the entrance. The interior of the building has a wood plank floor, and there are horizontal wood battens on the log walls.

Figure 183: The log smokehouse on the Collier Homestead.

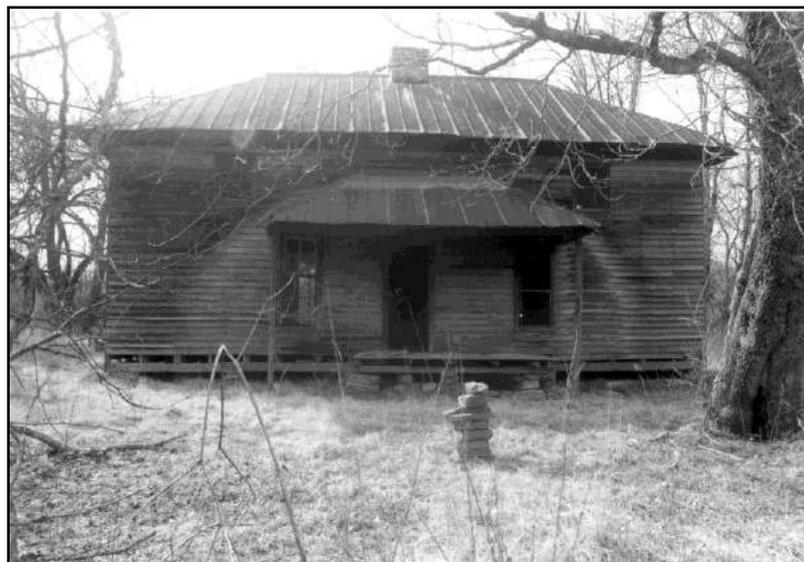
This property is located in the Cash Bend area of the Buffalo River and contains two dwellings. The first is the Valentine Williams House which is a two-story, frame, double-pen dwelling built ca. 1866. The dwelling has a hipped roof of metal standing seam, a central interior stone chimney, a stone pier foundation, and an exterior of weatherboard siding. On the main (east) façade is a hipped roof, partial-width porch with square wood posts. The porch posts are of recent decades and added to support the porch roof. The central entrance on the main façade has an original, four-panel wood door. Window openings are rectangular in form and have wire mesh screens. The dwelling had a rear T wing that was a later addition and has been removed. The foundation stones of the rear wing remain and are scattered throughout the area. The interior of the dwelling has wood floors, horizontal board walls, and two stone fireplaces, one in each room, from the central chimney.

Figure 184: The Mollie and Valentine Williams House.

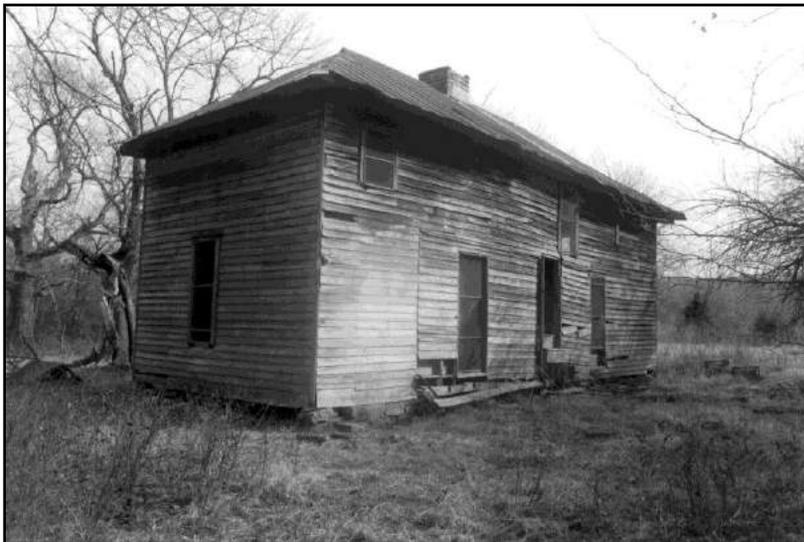
extant in the dwelling and a number of boards from the siding have fallen off. The house originally had a full-width incised porch on the main (east) façade. This porch is no longer extant. To the rear of the house is a well that sits on a stone slab and has square concrete walls. The well rises above the ground about 3' 6" and extends approximately 20' deep and is lined with concrete. The well is uncapped.

Figure 185: Rear and Side façades of the Williams House Site.

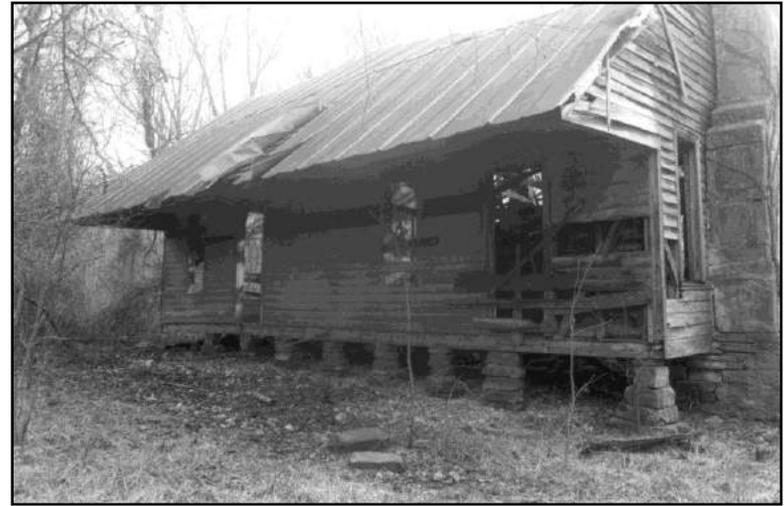
Also on this property is a one- and one-half story dwelling that is believed to have been constructed ca. 1900 by A. G. Smith, who owned the property following the Williams family. This house is in ruins and would be considered a non-contributing element to the National Register property. Most of the roof is gone and the entire rear of the dwelling has caved in. The house has a stone pier foundation, a weatherboard exterior, an exterior end stone chimney, and a gable metal standing seam roof. Doors and windows are not

Figure 189: The A.G. Smith House is in ruins.

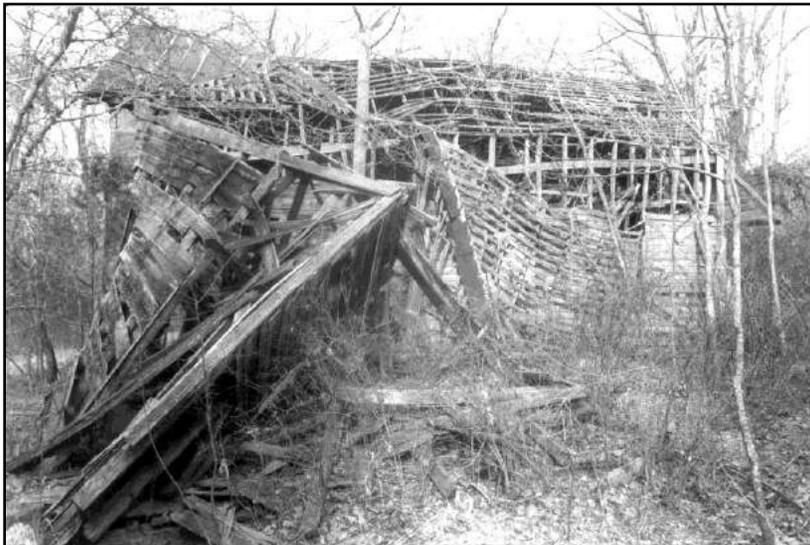
Figure 190: The A.G. Smith House rear façade.

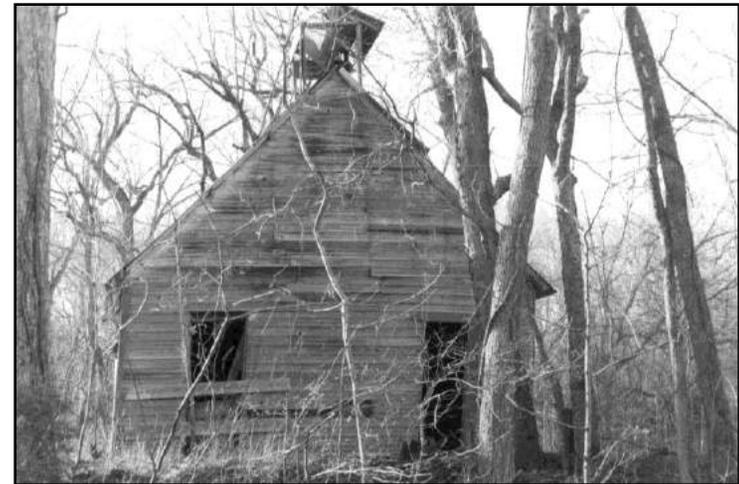
Brown School is a one-story, frame, one-room schoolhouse constructed ca. 1915. The building has a gable corrugated metal panel roof and an exterior of weatherboard siding. At the roofline are the remains of a small frame belfry for a school bell. Two entrances are located on the gable end and each of the two side elevations has two window openings. The building no longer retains doors or windows. A flood in 1982 moved the building off of its original rock pier foundation and turned the building approximately 90° until it wedged against a tree. The building is in poor condition. The interior retains original horizontal board walls and tongue-and-groove wood flooring. However, much of the ceiling has caved in and the wood floor has severely deteriorated and buckled. Brick and other debris are scattered about the floor.

Figure 192: Main façade of Brown School.

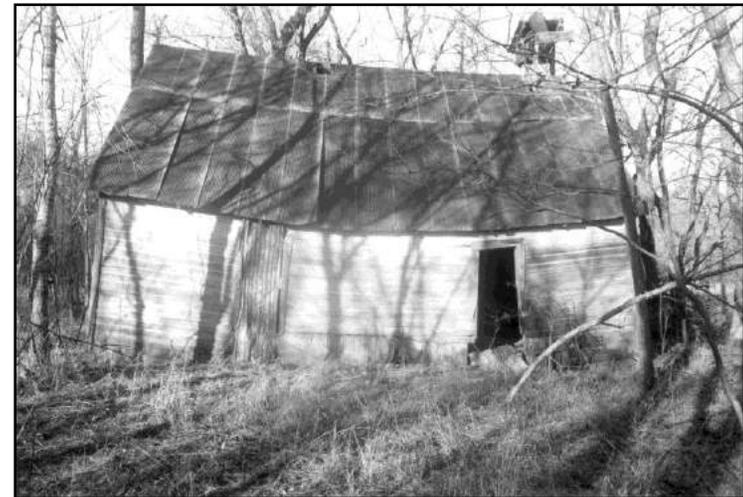
Figure 193: A side elevation of Brown School.

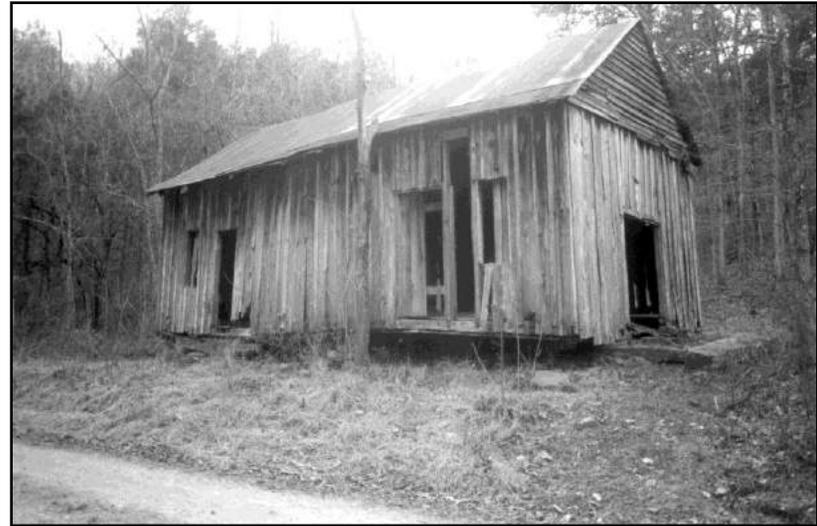
This dwelling is known as the double door house and is a frame, one-story dwelling built ca. 1900. It has a board and batten exterior, a

corrugated metal gable roof, and a stone pier foundation. The dwelling is divided into two rooms and has two parallel entrances on both the front and rear elevations. The house is very deteriorated.

Figure 194: The Arnold Double Door House.

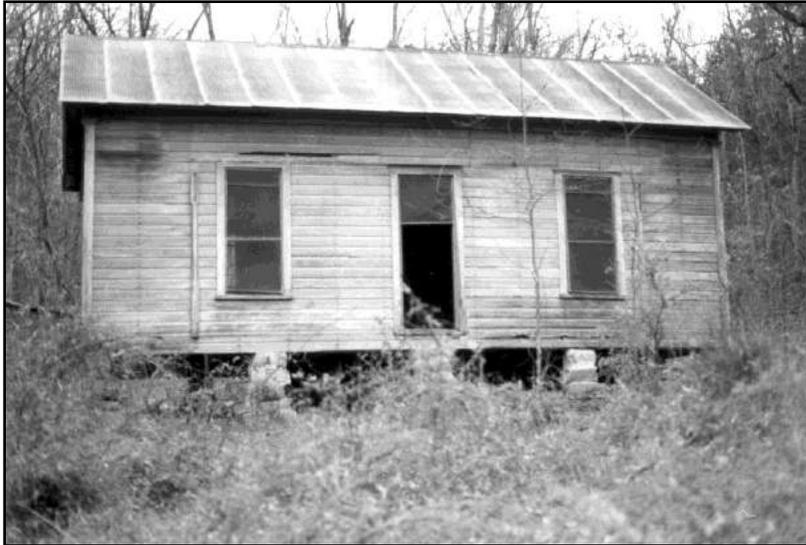
This dwelling is located south of the road that extends along the base of the hillside in the Arnold Bend area. The house is a one-story, frame dwelling constructed ca. 1910 and has a gable roof of corrugated metal panels, a stone pier foundation, an interior stone chimney, and an exterior of shiplap siding. The house has a central entrance on the main façade. On the rear elevation is an original T wing. On the west elevation of this wing is a shed roof porch, a

Figure 195: The Luther Arnold House-main facade.

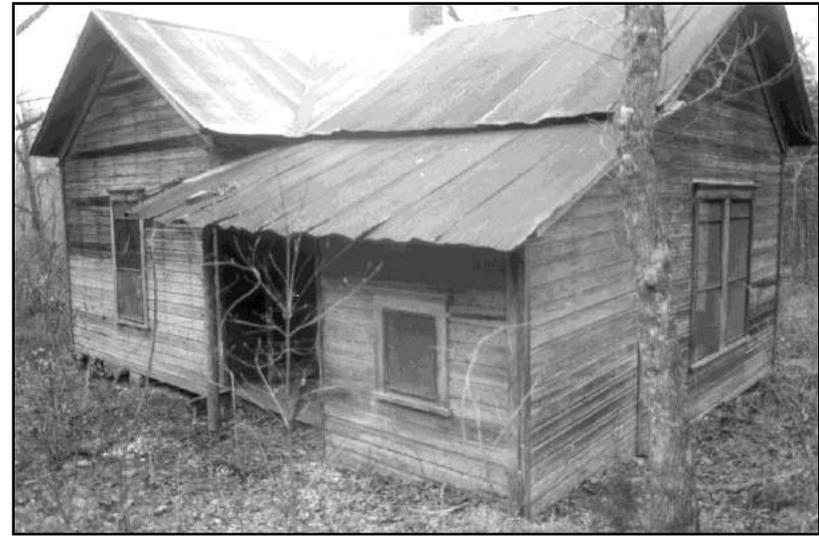
portion of which is enclosed. The interior of the dwelling has wood floors and horizontal board walls.

Figure 196: The Luther Arnold House-rear façade.

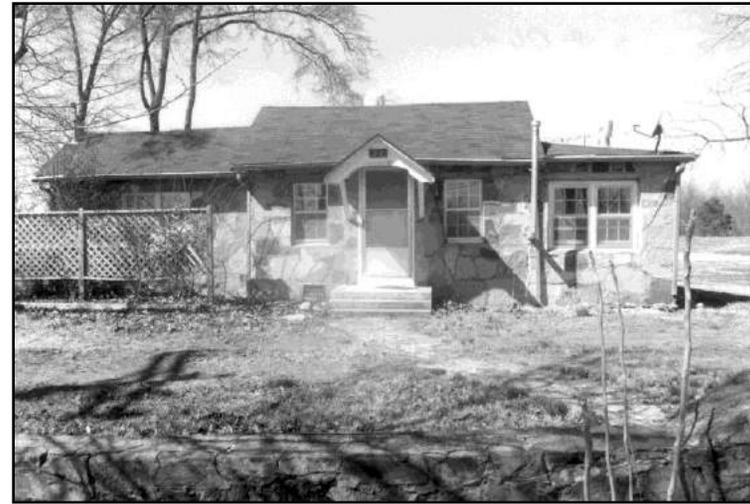
This dwelling is located on Highway 65 in the Silver Hill area near the entrance to the Tyler Bend Visitor's Center. The dwelling is a one-story, rectangular plan dwelling constructed ca. 1945. It has a gable asphalt shingle roof and an exterior of stone veneer. On the main (east) façade is a central entrance over which is a gable canopy supported by wood brackets. The entrance opens to a small concrete stoop. Windows in the dwelling are original six-over-six wood sash. The dwelling has a lateral gable roof wing on the south elevation and a hipped roof wing on the north elevation. The rear or west elevation has an enclosed shed roof porch. In front of the house is a short stone wall that extends approximately 250 feet. The fence has a central opening that opens to a stone walkway that leads to the dwelling's main entrance. South of the dwelling is a gravel driveway which extends west off of Highway 65 and leads to a garage, which is positioned to the rear (southwest) of the dwelling.

Figure 197: Dwelling on Tract No. 06-125-main façade.

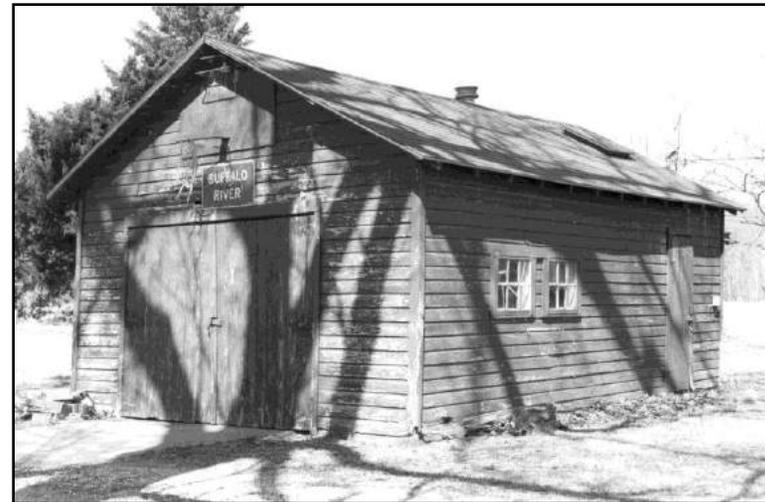
The garage was built ca. 1945 with a gable asphalt shingle roof and an exterior of weatherboard siding. On the main (south) elevation are paired vertical board doors. On the east elevation is a vertical board pedestrian door. The garage has six-light frame and glass windows that are hinged at the top. On the rear elevation is a small ca. 1980 frame, gable roof wing with an exterior of vertical board siding. The dwelling is currently being used to house park personnel.

Figure 198: Garage on Tract No. 06-125.

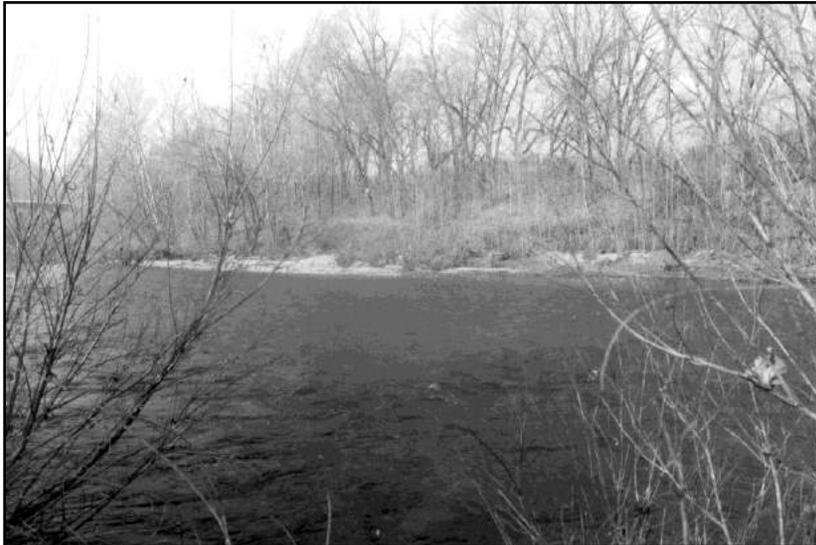
Currently on the north side of the river one can detect what appears to be an old roadbed/approach to the river which winds down the slope to the river bank. The area is thick with tree growth and is difficult to detect. On the south side of the river is a large sand bank and brush. The landscape here has changed and there are no discernible features of the ferry landing.

Figure 199: The north bank of the Buffalo River at the Grinder's Ferry location.

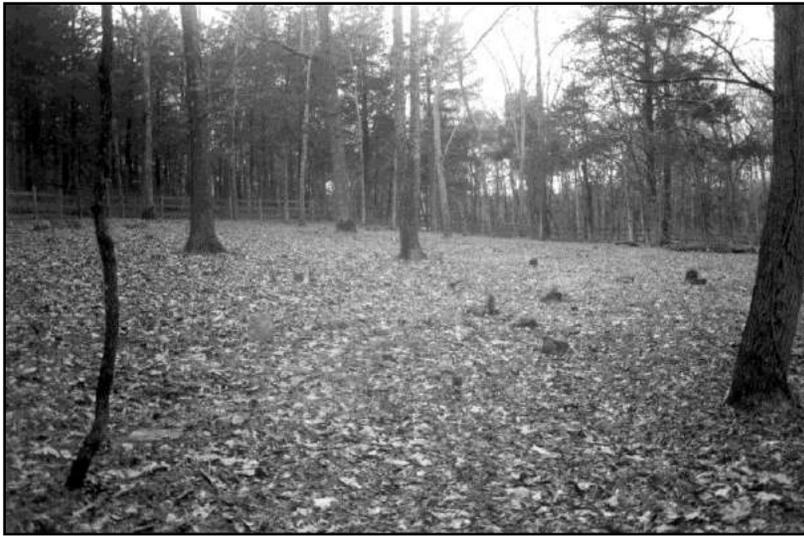
At the time of this survey the Old Arnold cemetery was well maintained. It is set within a wooded area and is enclosed by a new wood post and wood rail fence.

Figure 200: A general view of Old Arnold Cemetery

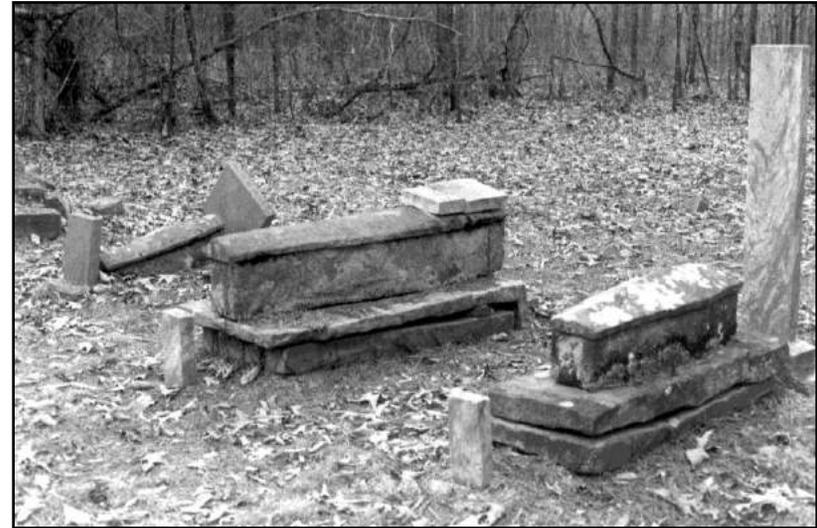
There are sixty-four discernible graves in the Arnold Cemetery, thirty-one of which have legible headstones. The earliest known graves are those of E. Wilson Brown and Member Arnold, both of whom died in September 1874. The last burial took place in 1938. Arnold Cemetery contains six tiered box vault graves that are tiered stone slabs placed over the length of the graves. These graves date to the 1870s and at least two of the graves are those of children. The cemetery also contains three coffin graves, all of which are children from the Arnold family. These graves date to 1882, 1883, and 1917.

Figure 200: Examples of coffin graves in Arnold Cemetery.

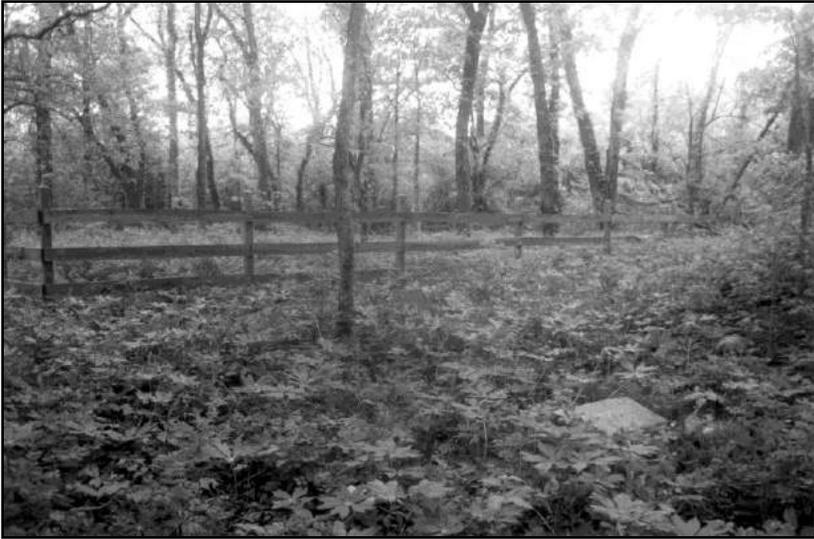
Figure 201: The White Cemetery is heavily overgrown.

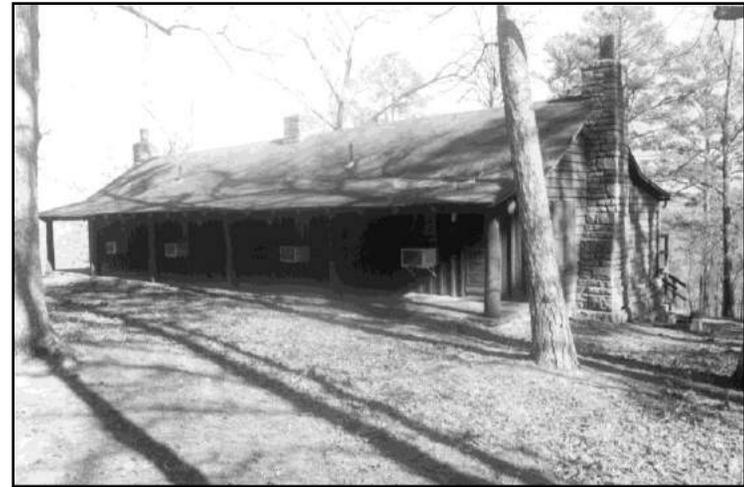
The lodge is a two-story, frame building with a gable asphalt shingle roof, one interior and two exterior stone chimneys, a stone foundation, and an exterior of weatherboard and board and batten. The building has a full-width shed roof porch on the west elevation that is supported by log posts. The east elevation also has a full-width deck with a wood floor and railing. Windows are original eight-over-eight wood sash designs, and entrances contain original three-horizontal-light and two-panel glass and wood doors. The building originally contained four units but was later remodeled to form two apartments and an office. The Buffalo River State Park Lodge remains in excellent condition.

Figure 203: The lodge at Buffalo River State Park.

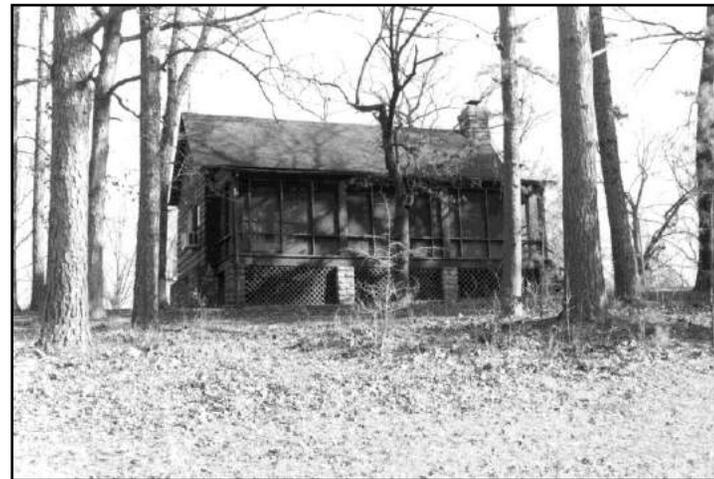
The park's six cabins are one-story dwellings of stone, frame, and log construction. They feature stone chimneys, full-width screened-in porches, and shed roof kitchen wings with a board and batten exterior. One cabin is of log construction with square notching and concrete chinking. The others have a combination of stone and rough-cut weatherboard on the exteriors. Some of the cabins are located on a hillside and large stone columns support the porches, which extend out over the embankment. The cabin interiors feature stone fireplaces and pairs of French doors that lead to the screened-in porches. The cabins remain in good condition and retain their historic character.

Figure 204: The cabins at Buffalo River State Park were constructed by the CCC.

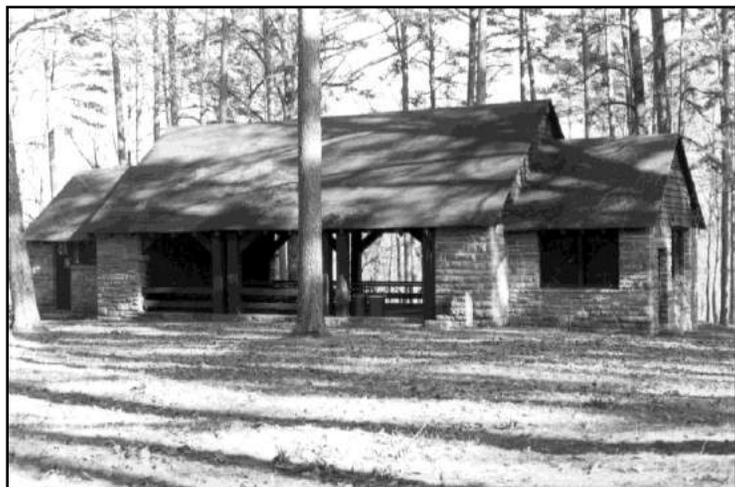
The CCC Picnic Pavilion at Buffalo River State Park is a large open shelter of stone construction with large timber frame support posts and roof beams. At each gable end of the Pavilion is an enclosed gable-roof wing with a stone exterior. In the gable fields is rough-cut weatherboard. The main central section of the Pavilion is open and contains numerous picnic tables. The wings at either end contain restroom facilities and a storage area. The Buffalo River State Park Picnic Pavilion is an excellent example of the types of ancillary park structures built by the CCC during the 1930s and early 1940s.

Figure 205: The CCC Picnic Pavilion at Buffalo River State Park.

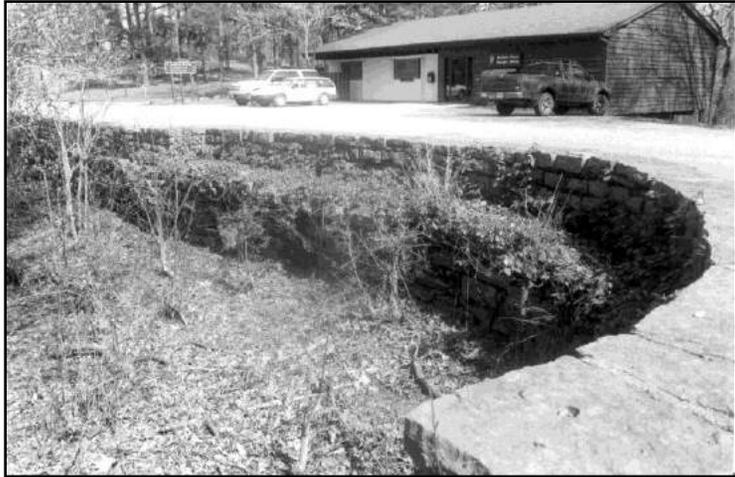
The park also includes dry stack stone retaining walls and a stone culvert constructed by the CCC. A retaining wall extends along the main road leading into the park and the access road to the cabin sites. The wall is of native stone and is characteristic of CCC design and workmanship. A similar wall is located on the south side of the road leading into the park west of the current NPS ranger station. This wall is situated on a slope and is not readily visible from the road. A

Figure 206: The CCC also constructed stone retaining walls at the Buffalo River State Park.

The 1988 National Register nomination for the Buffalo River State Park neglected to include these structures. Landscape features such as retaining walls and infrastructure components like the culvert are important components of the overall park setting and reflect the overall development of the park. These structures also reflect the craftsmanship and design of the CCC, which is as well-known for its construction of park landscape features and infrastructure as it is buildings. The retaining walls, culvert, and utility features at Buffalo River State Park are significant aspects of the park landscape created by the CCC, and the National Register nomination for the park should be amended to include these structures. Also an area in the park near the picnic pavilion is believed to be a work area of the CCC. Further research and investigation is needed to document this area.

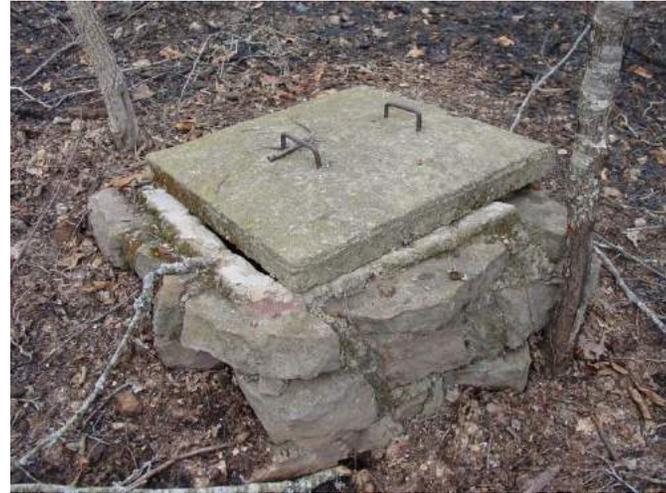
stone culvert is located at the south end of this retaining wall and is also of CCC construction. In addition to these structures, various utility features including the remains of a small stone utility building remain on the property. The utility building sits down the hill opposite the ranger station in a wooded area. The building lacks a roof but its stone walls remain intact.

Figure 208: Infrastructure features at Buffalo River State Park (*Photo courtesy of Buffalo National River*).

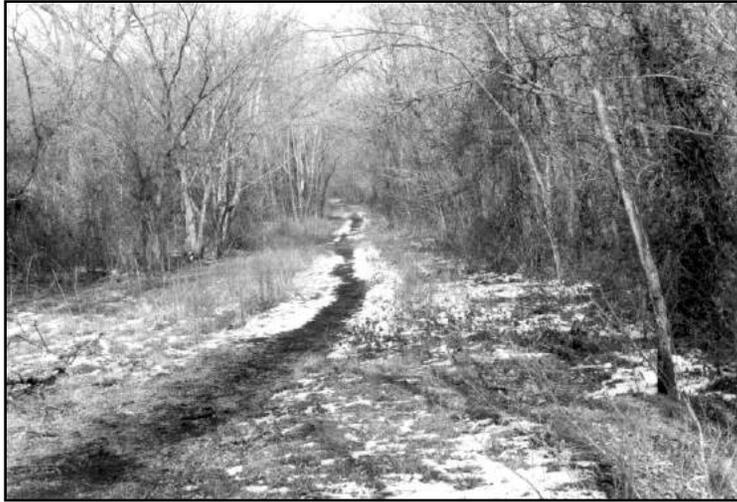
The existing railroad grade of the M&NA Railroad illustrates rail transportation in the Buffalo River valley. The grade is clearly visible and intact throughout its nearly two-mile length. The rail line was an important contribution to the lumber and mining industries and provided local farmers with improved access to regional markets. The grade, bridge abutments, and associated foundations retain a strong degree of historic character and integrity and meet National Register criteria for their role in the region's transportation history.

Figure 209: The M & NA Railroad Grade north of the Buffalo River near Gilbert.

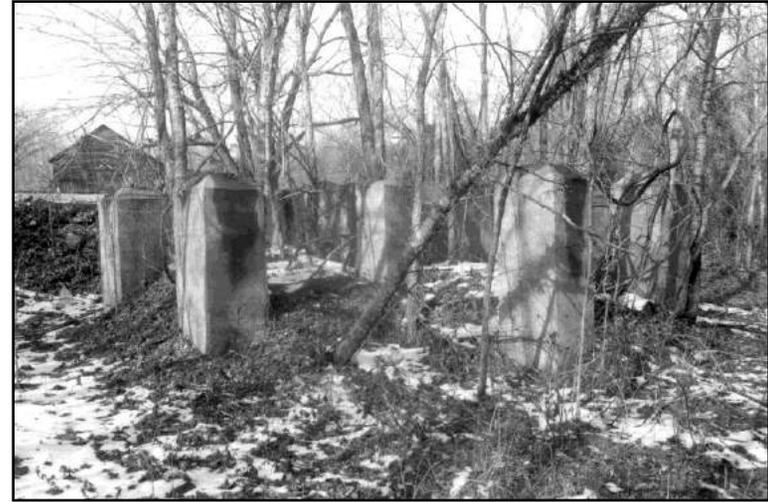
Figure 211: Concrete piers near the railroad grade at Gilbert.

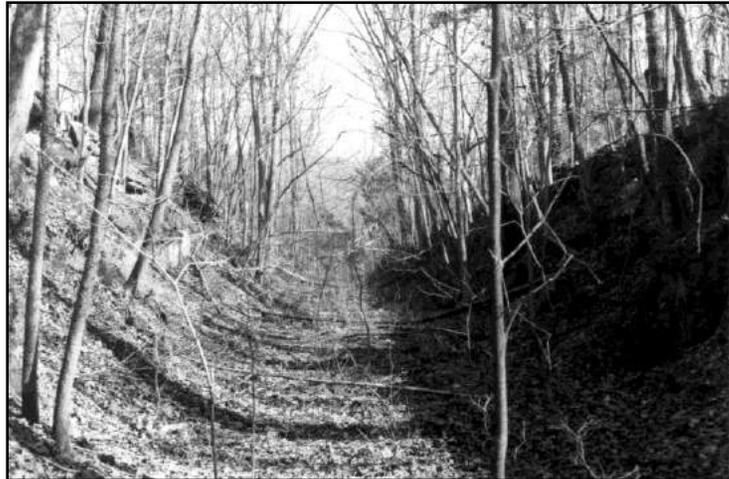
Figure 210: The railroad grade has deep embankments on either side as it continues south of the Buffalo River.

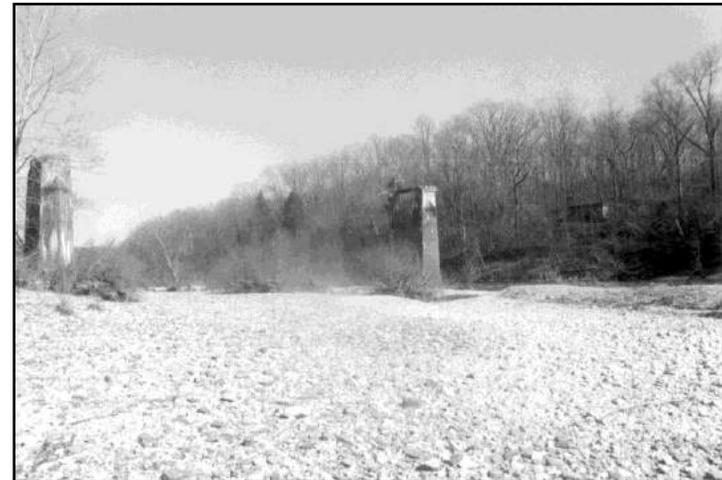
Figure 212: Railroad bridge abutments remain standing in the Buffalo River.

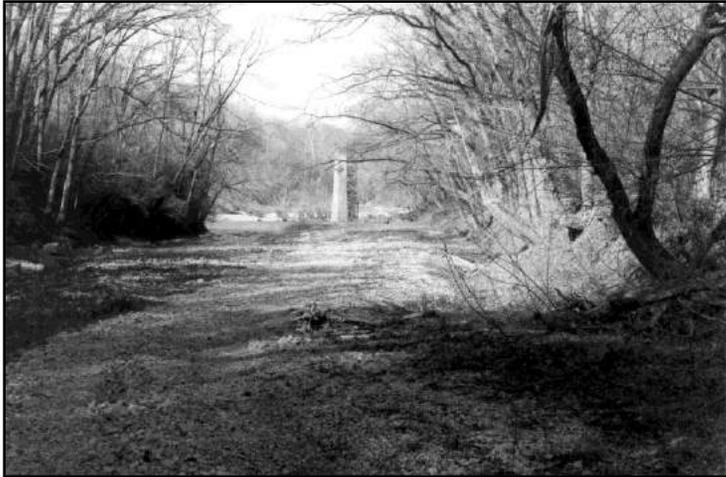
Figure 213: This view shows the railroad grade and bridge abutments looking north from the south side of the river.

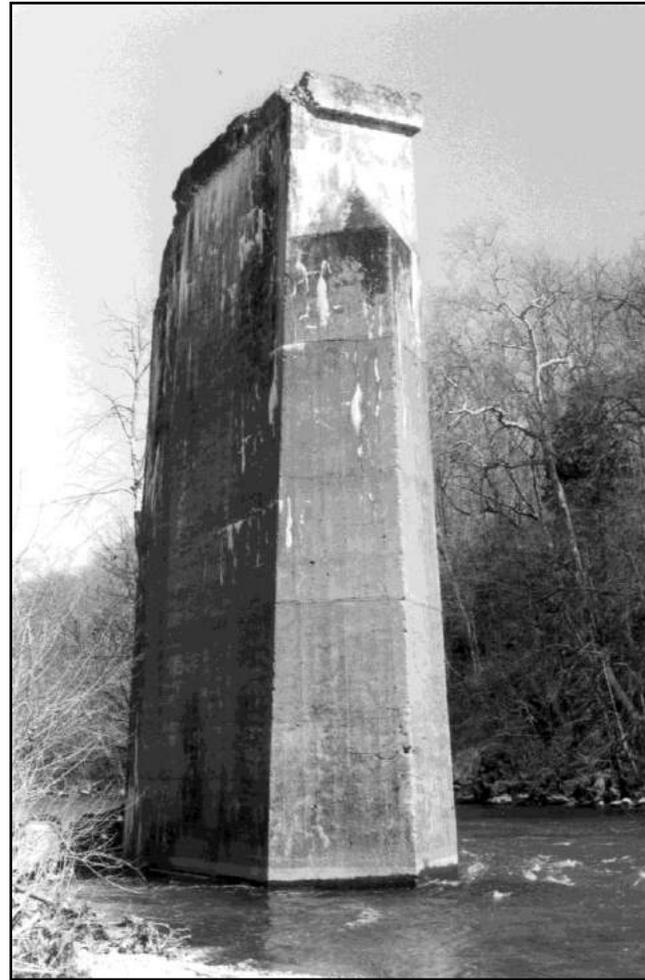
Figure 214: A close-up view of the railroad bridge abutments reveals their massive size.

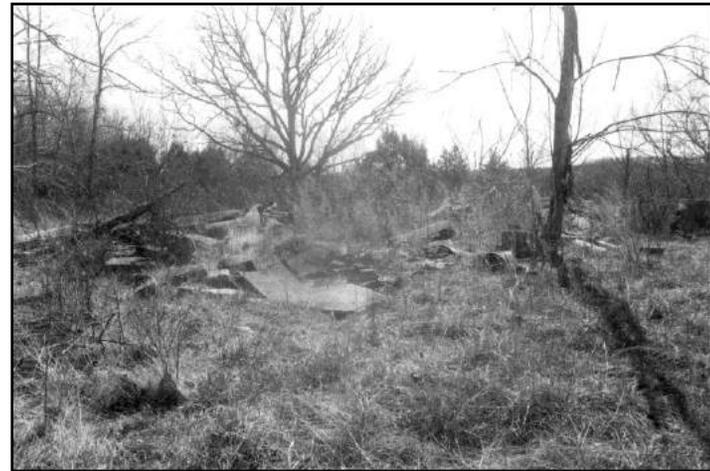
Figure 216: The Sanders House was destroyed by fire.

This property originally contained a ca. 1860 log dwelling that had been enclosed in a larger, T-plan, frame dwelling around 1950. The dwelling had a stone pier foundation and a gable roof. Associated with the dwelling were a frame storage shed, barn, privy, and a concrete root cellar all dating from the mid-twentieth century. This dwelling was destroyed by fire ca. 2001. Pieces of corrugated metal roof panels and some stone foundation piers are all that remain of the dwelling. Several charred pieces of wood and various metal debris are scattered throughout the site. To the rear of the house site is a small depression measuring approximately 12' x 6' with below grade stone foundations along three sides. Southeast of the house site is an

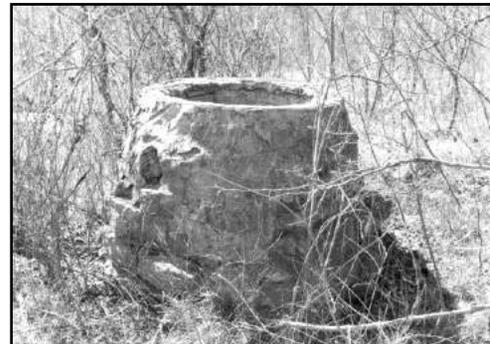
Figure 217:
The stone well
at the Sanders House Site.

in-ground root cellar of poured concrete. It has an arched roof and a vertical board door. Northwest of the house site approximately five feet is a stone and concrete circular well. The well rises around three feet above grade and twenty feet below grade. The well is uncapped. No above ground remains of the barn were detected. The Sanders (or Still) Cemetery is located on the ridgeline opposite the house site about 1000 feet southeast of the house site.

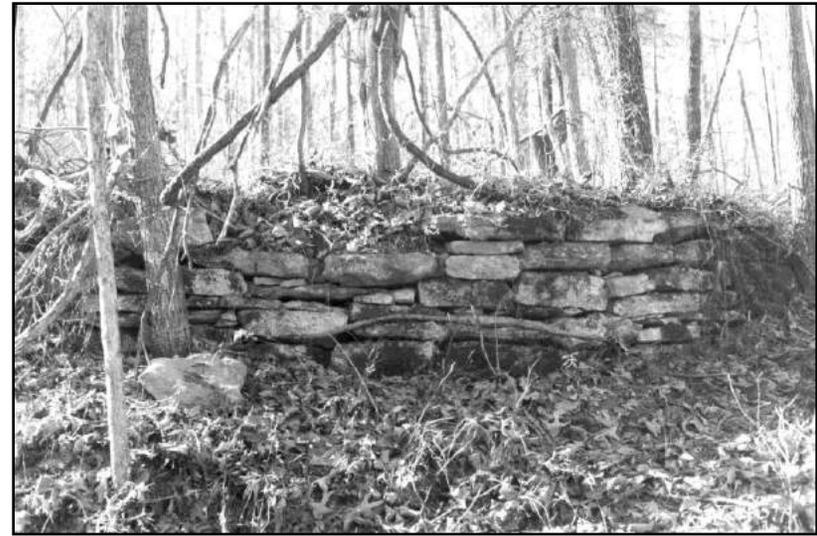
Figure 218: Dry Stack Stone Cistern located on the Ramsey Property.

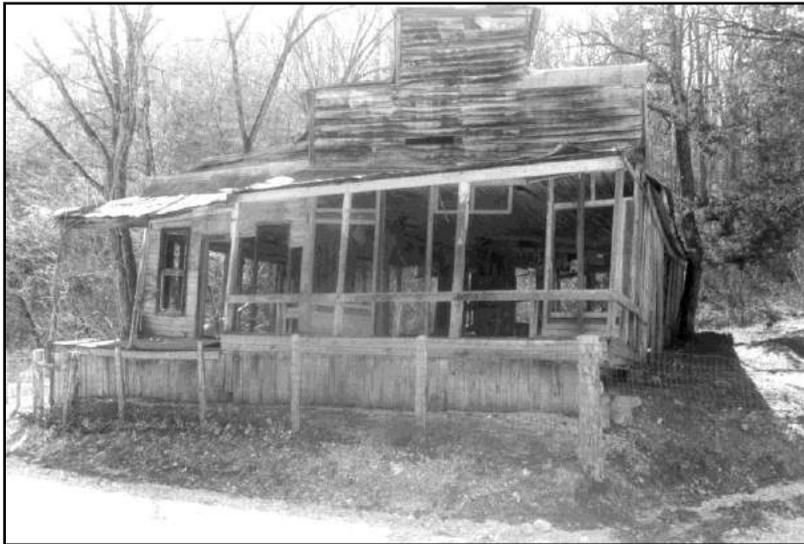
Figure 227: The Taylor-Medley Store in Rush is in poor condition.

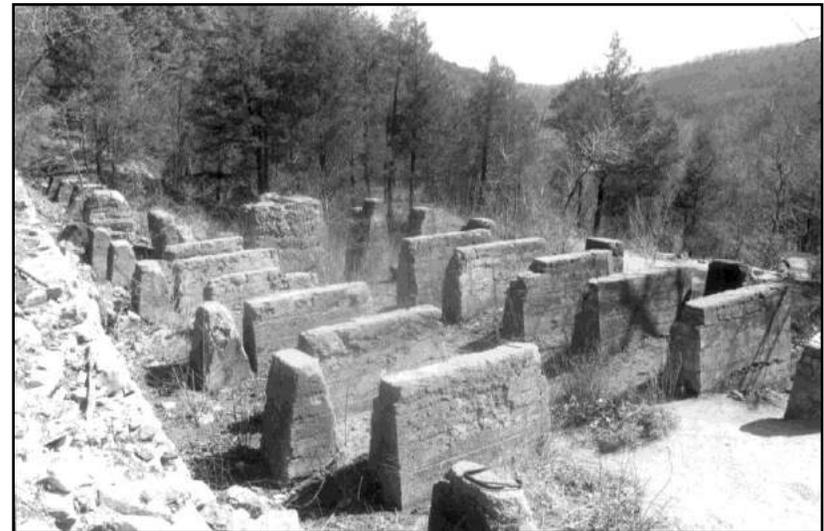
Figure 228: Features of the Morning Star Mine.

The properties of the Morning Star Mine Company remain much the same with the exception of the Morning Star Barn, which was lost to arson in 1998. A few foundation stones remain. The large smelter remains standing and in good condition. The Mill ruins, tram, mines, trails, and roadbeds are as they are described in the nomination. The same is true of the oil storage building, and Mining Office and Smith House ruins. The latter of these is heavily overgrown. The Blacksmith Shop remains in poor to fair condition. Some exterior boards are gone and it does not retain doors or windows. This building has been fenced off with a wood post and wire fence. The attached warehouse has collapsed and is in ruins. The pumphouse ruins adjacent to the roadbed near the large smelter have poured concrete walls that have partially collapsed. The footbridge pillar in this area is in fair condition. Small portions of the concrete exterior have fallen off.

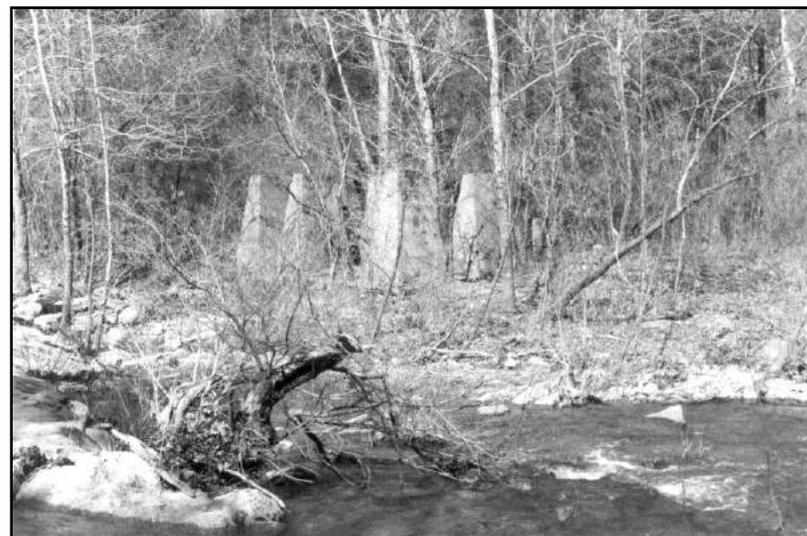
Figure 229: Concrete pilings stand on the northeast side of Clabber Creek.

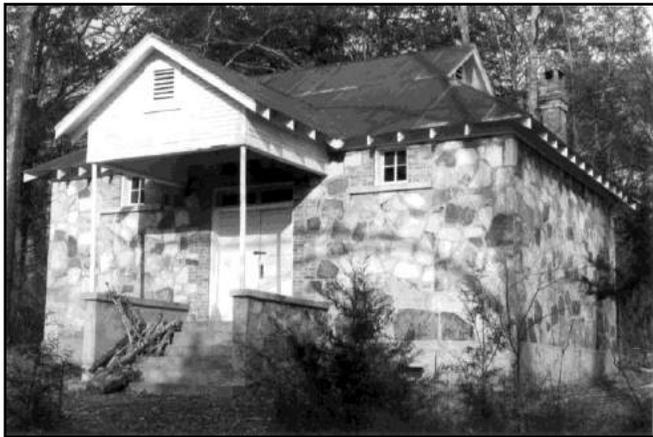
Figure 230: Cold Springs School.

Cold Springs School was constructed ca. 1935 by the WPA. The school exhibits influences of the Craftsman style and has a poured concrete foundation, a jerkinhead metal roof, and an exterior of stone veneer. The interior of the school retains its original wood floor, plaster walls and pressed metal ceiling. A five-foot wide sunken roadbed leads to the school along the bluff paralleling the NPS hiking trail.

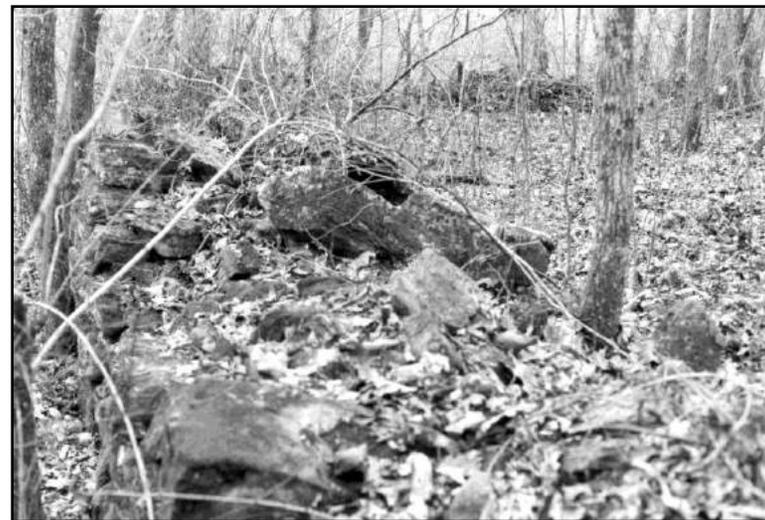
Figure 232: Remains of the Cedar Creek School.

This site contains the ruins of an early twentieth century school building and is heavily overgrown. The site does not retain sufficient integrity to meet the criteria of the National Register. The site of the former Cedar Creek School consists of two stone walls approximately three feet in height remain at the site and are 61' and 125' in length. Another small 10' foundation wall is parallel to the 125' wall. The site is heavily overgrown and is surrounded by woods. It is adjacent to a dirt road that leads to the river, which lies south of the school site.

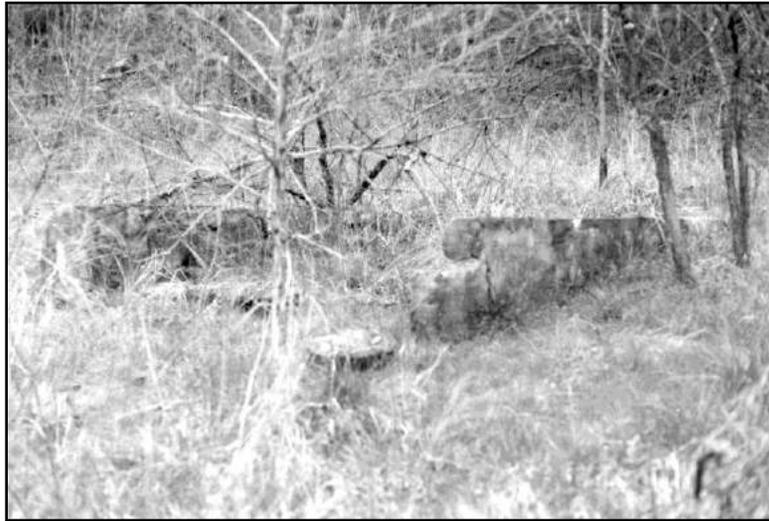
Figure 233: Garage Foundation at House Site on Tract 74-110.

River. There are no visible above ground remains of the house or barn left on the site. There are some flowers at the site. Across from the house site are stone and concrete foundations of what appears to have been a garage. The foundations parallel each other seven feet apart and are twelve feet in length.

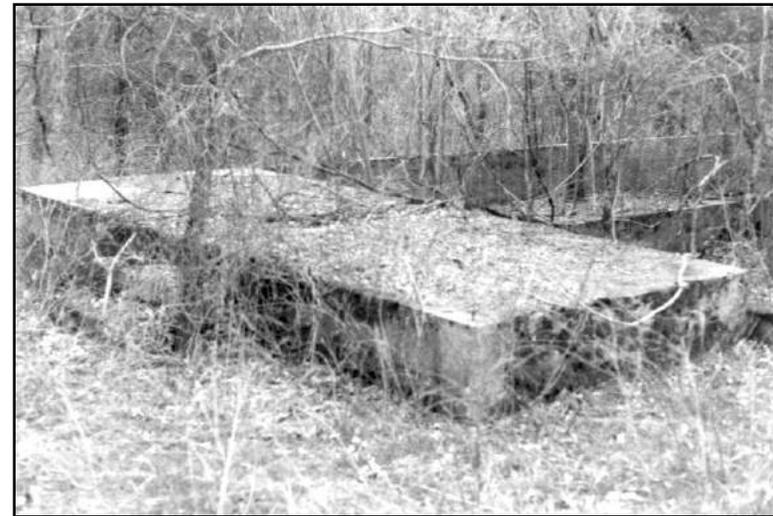
Figure 234: Concrete Foundation at House Site on Tract 77-417.

At this site was a ca. 1955 dwelling and earlier outbuildings. Currently the site contains the concrete foundations of the dwelling. The foundations are approximately three-feet high and measure approximately 30' x 30' including a front and side porch. A walkway is visible leading to the front porch. There are no visible remains of the outbuildings. The site is located west of the Buffalo River approximately one mile south of Cow Creek.

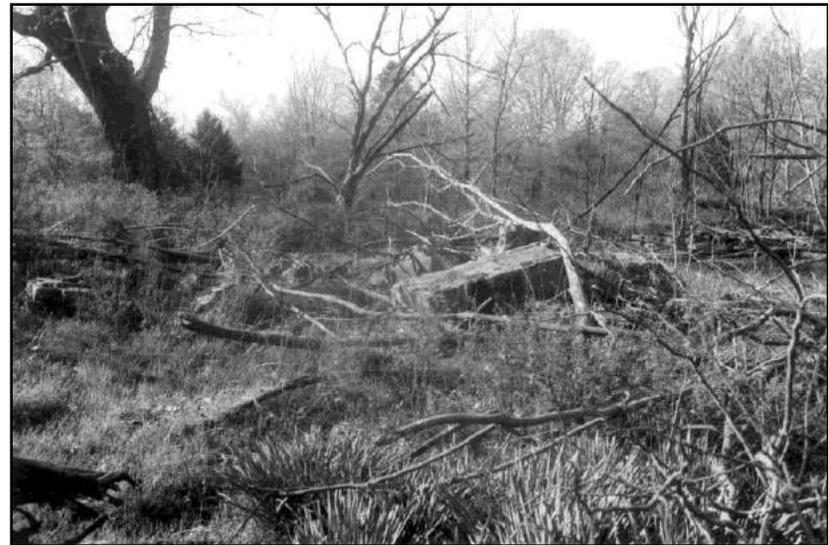
Figure 236: Ruins for House Site on Tract No. 81-103.

At the west edge of the house foundations is a large “L” shaped poured concrete walkway or porch that is 20 feet long on one side and 16 ½’ long on the other side. Immediately west of this, the property descends gradually down hill where there is a deep depression. This appears to be either a large root cellar or possibly a basement and is about four feet deep and is the width of the house site. West of the depression is a concrete slab. Behind the house site is an overgrown yard area before the land slopes down into a wooded ravine.

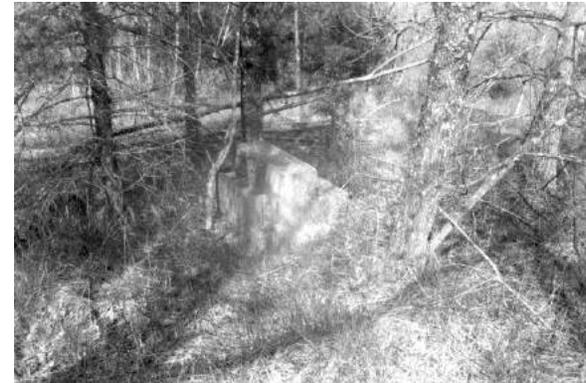
Figure 237: Concrete steps are all that remain of house site on Tract 82-119

This site located south of the Buffalo River near Stewart Creek originally contained two dwellings built in the 1920s and various outbuildings. West of the creek is the site of one of the 1920s dwellings. Three concrete steps remain and a number of stones from foundation piers and concrete block are scattered throughout the area. There are no discernible foundations. Also on the site are the remnants of a brick chimney flue based in concrete. Debris in the area includes asphalt shingles, window screening, and an old metal stove. East of the house site is a small circular depression with some stone and brick.
