BUFFALO NATIONAL RIVER

THEME IDENTIFICATION
CONTEXT STUDIES
AND
PROPERTY EVALUATIONS
SOL: N6068030063

Thomason and Associates
Preservation Planners
Nashville, Tennessee
And
Hawkins Partners
Landscape Architects
Nashville, Tennessee

September, 2004

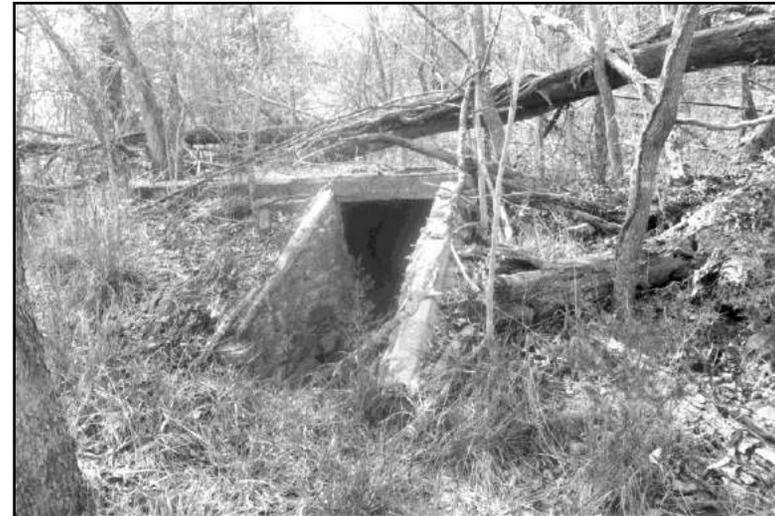
Figure 238: Root Cellar Ruins from House Site on Tract 82-119.

Southwest of the house site approximately twenty-five feet is a root cellar banked into the hillside. It is of stone construction with a flat poured concrete roof. Remnants of a metal door casing remain at the entrance. The cellar measures approximately 5' x 10' and is 6' in height. A number of daffodils are around the root cellar. A wood post and wire fence runs north-south behind the root cellar and then turns east.
