**CITY OF  
FERNANDINA  
BEACH**

**DOWNTOWN  
HISTORIC  
DISTRICT  
DESIGN  
GUIDELINES**

**THOMASON AND ASSOCIATES  
PRESERVATION PLANNERS  
NASHVILLE, TENNESSEE  
2013**

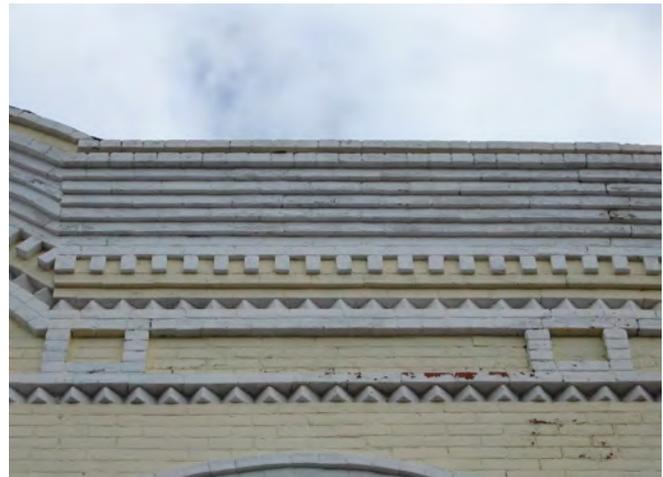
*Preserve features like brick corbelling.  
(117 Centre Street)*

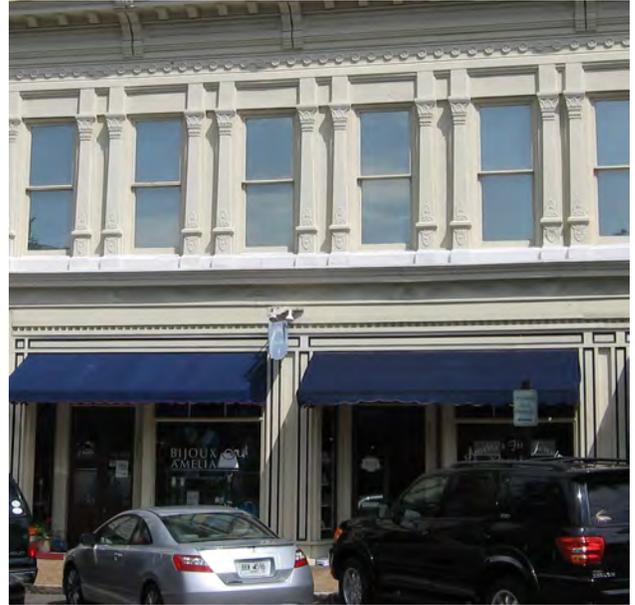
*This commercial storefront has canvas awnings appropriately sized to fit into individual window openings. It would be an inappropriate design to install a single awning that covers the wall surface in between the separate windows.*

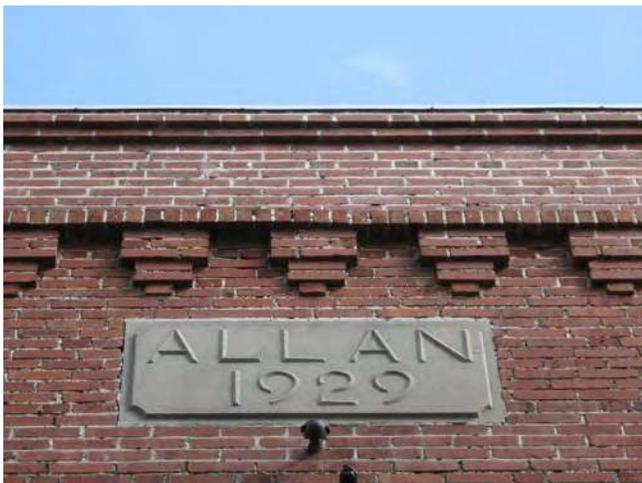
*The brick building at 309-311 Centre Street has decorative brick corbelling and a concrete name – and date-stone inset, which should be maintained and preserved.*

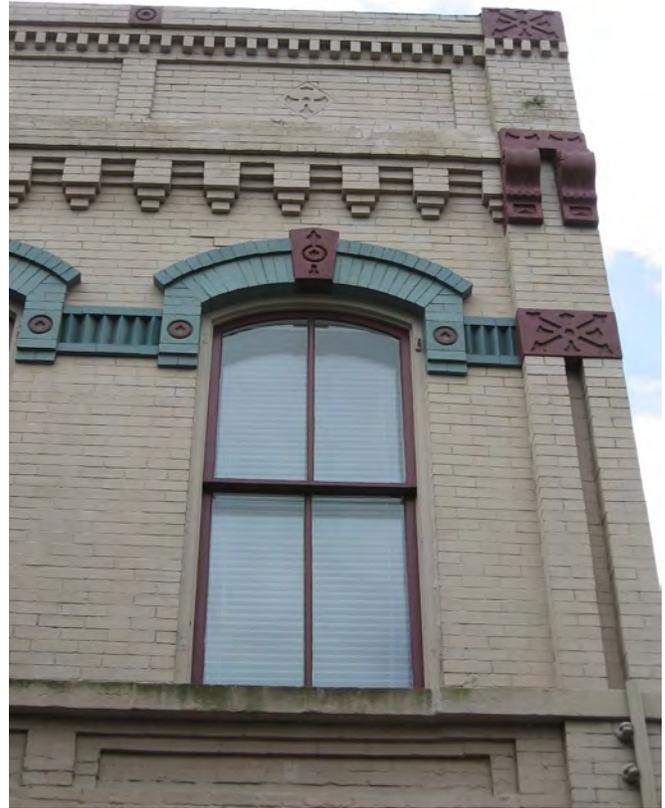
*The exterior of the building at 306 Centre Street has extensive brick detailing, including the addition of color, which helps convey the architectural integrity of the building.*

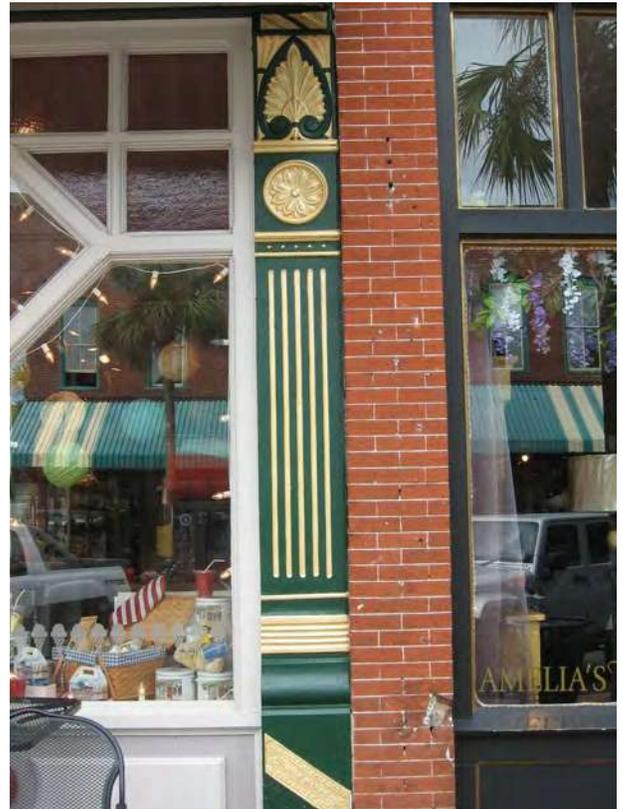
*Cast iron features at 218 Centre Street are important elements of 19th century commercial buildings.*

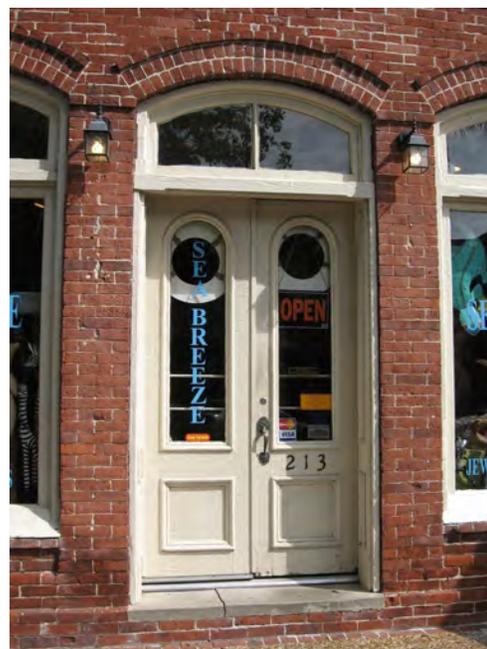
*Historic doors and entrance elements such as the arched lights and transom at 213 Centre Street contribute to the character of the commercial district and should be retained.*

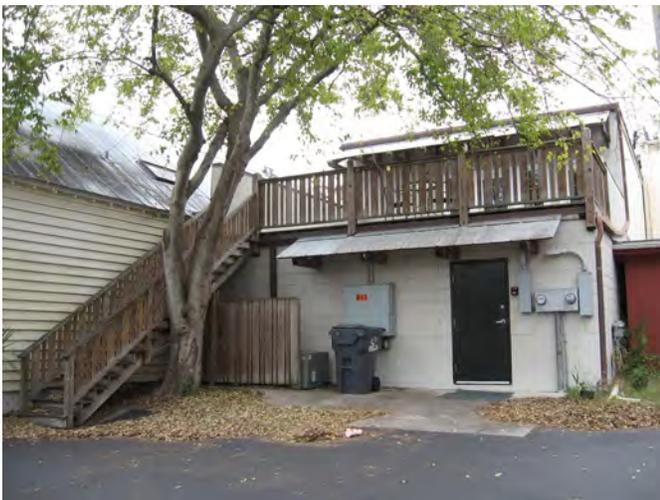
*Placement behind the historic building can minimize the impact of modern features like decks and stairs. (11 North Third Street)*

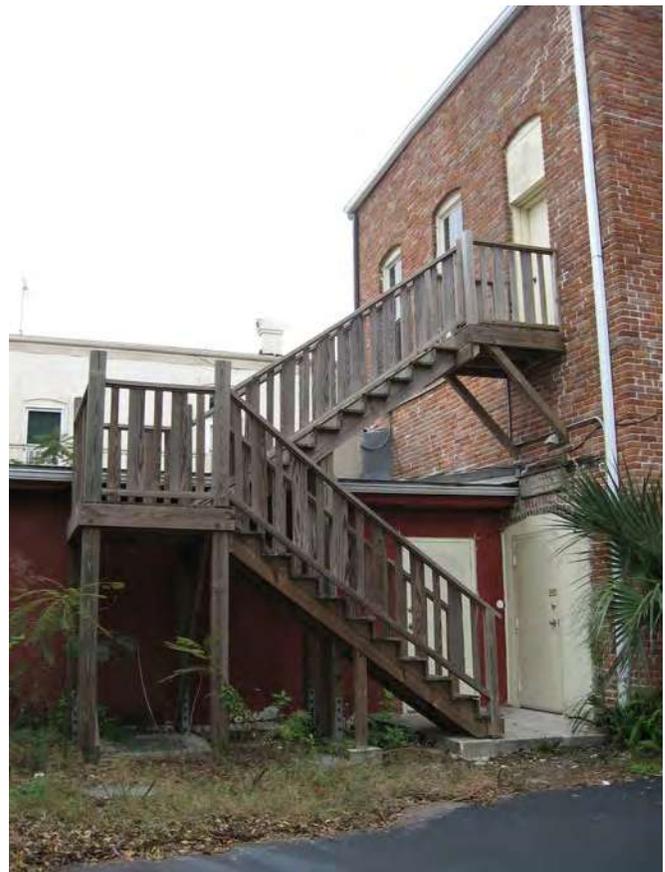
*This fire escape is an appropriate model due to its location at the rear elevation and simple wood construction. (313 Centre Street)*

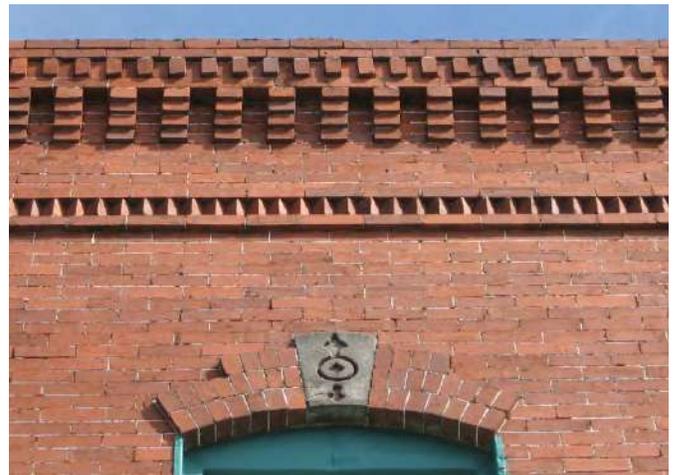
*Unpainted masonry surfaces can be important aspects of character and should remain unpainted. (215-217 Centre Street)*

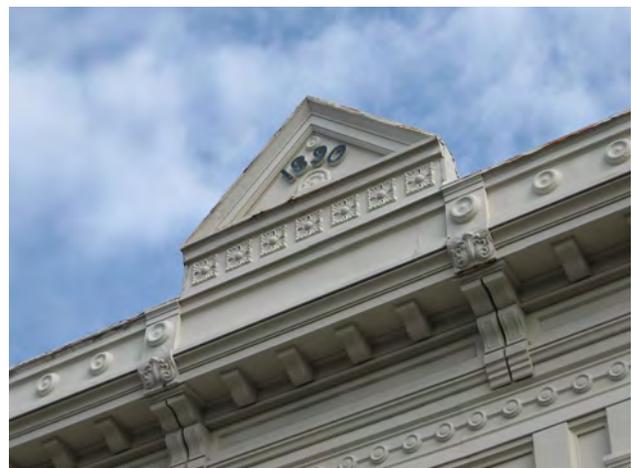
*Retain and maintain historic roof elements such as the sheet metal cornice at 313-319 Centre Street, which is a character-defining feature.*

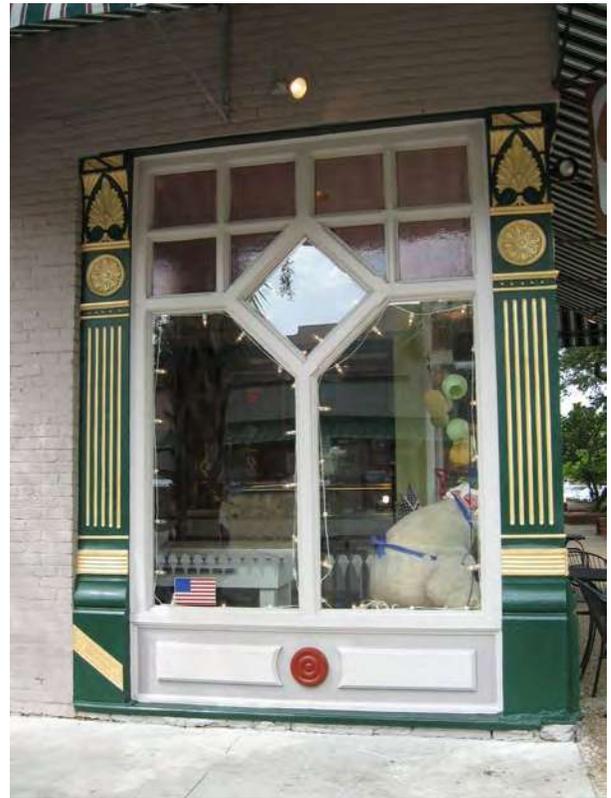
*This storefront at 218 Centre Street retains original elements including bulkheads and display windows.*

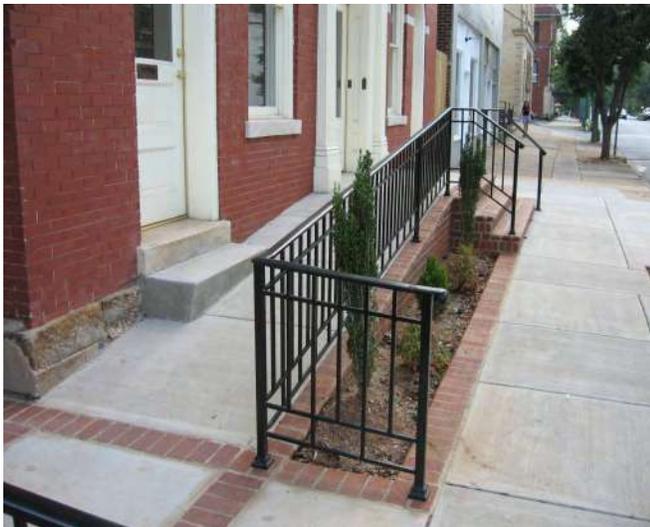
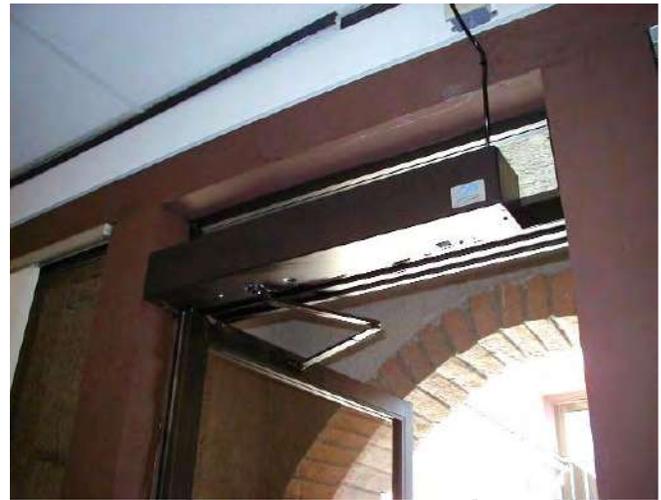
*Automatic door openers can be added to entrances without causing alteration to the historic door and other entrance features.*

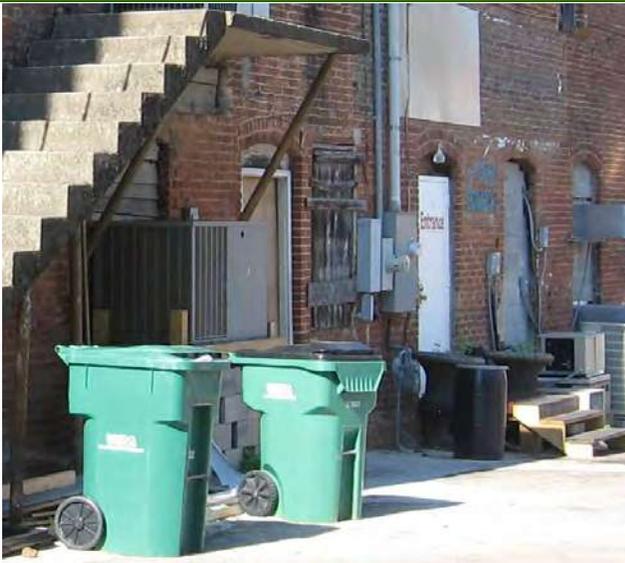
*HVAC units, utility meters, and garbage containers are typically placed behind commercial buildings.*

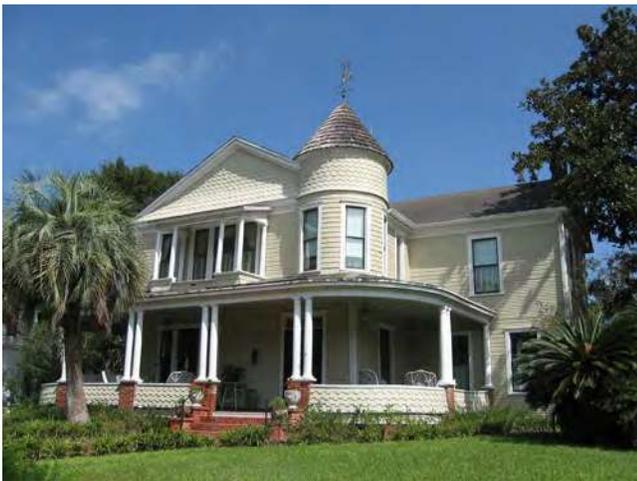
*The Baker House at 112 North Sixth Street is a notable example of the Queen Anne style and features a wrap-around porch, corner tower, and asymmetrical plan.*

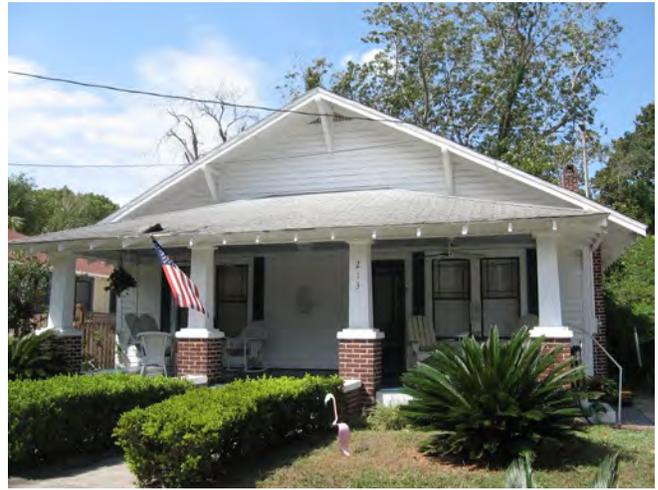
*The Bungalow at 213 South Sixth Street displays several features common to this residential type including wide, full-width porch with wood posts on masonry piers, knee-brace brackets under the eaves, and exposed rafter tails under the roofline.*

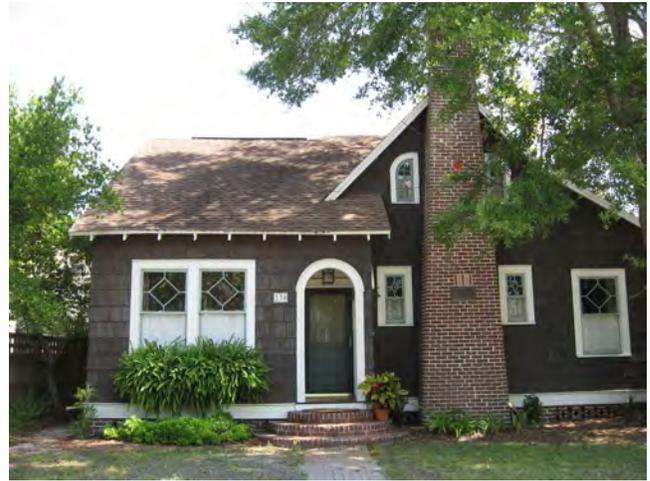
*This house at 330 South Seventh Street displays crossed gable roof and façade chimney often found on Tudor Revival houses. The Tudor Revival style often includes arched doors, as on this example.*

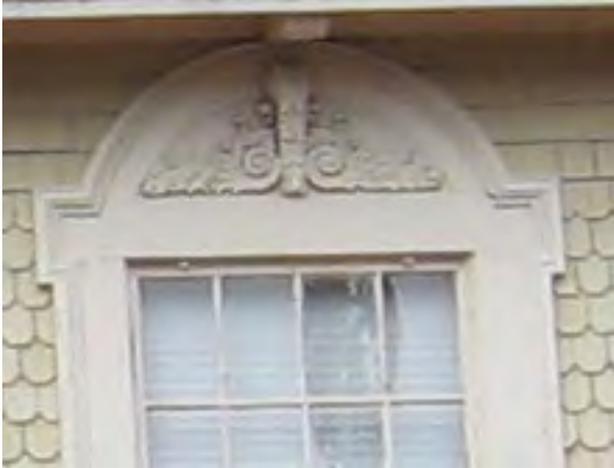
*The highly detailed decorative trim in this window hood should be maintained and preserved. (315 Alachua Street)*

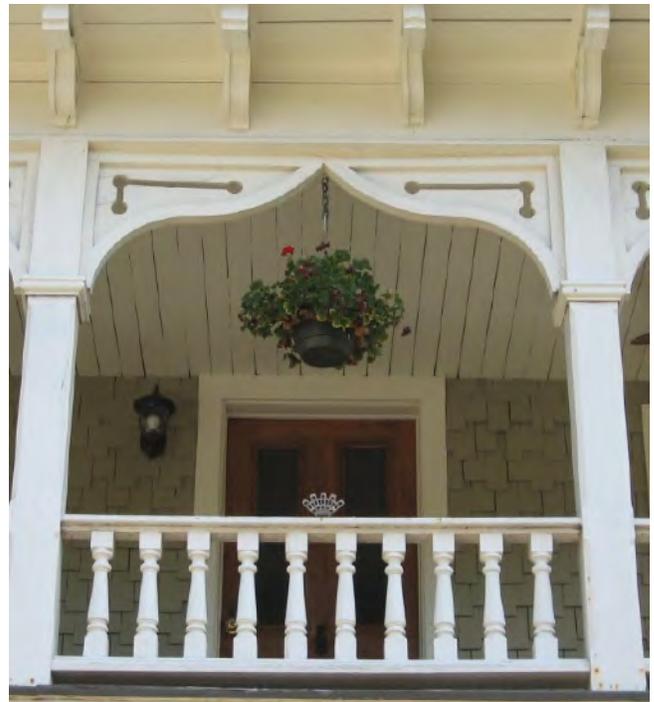
*Eave brackets, balusters, and porch trim help convey a building's architectural style and contribute to its integrity. (302 South Seventh Street)*

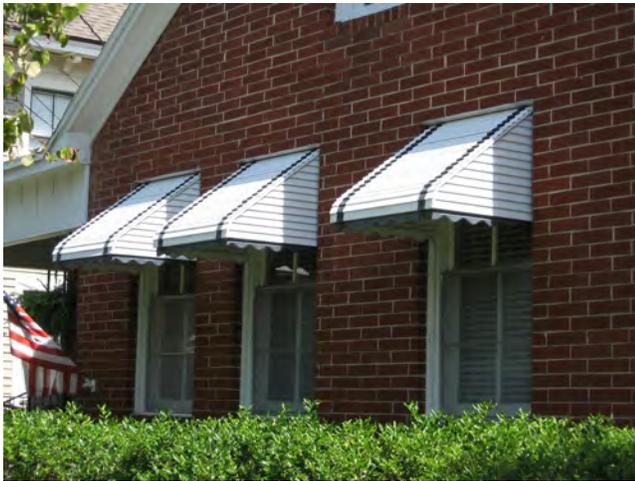
*These shed-type awnings are appropriately installed one over each individual window; do not install a single awning that covers wall surface between windows. (306 South Seventh Street)*

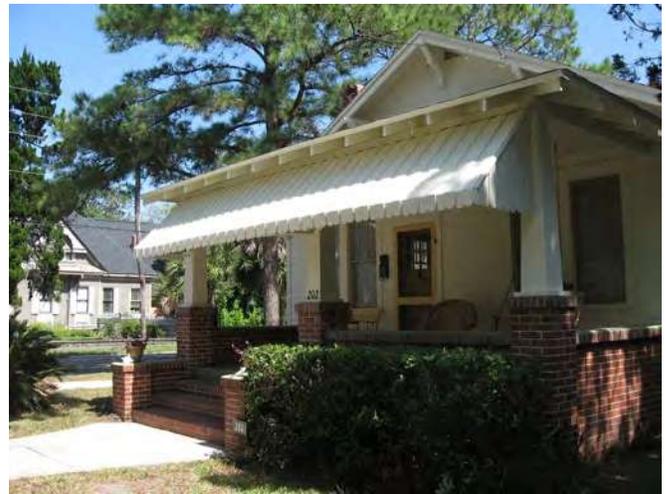
*Awnings should fit within porch columns as at 202 South Seventh Street.*

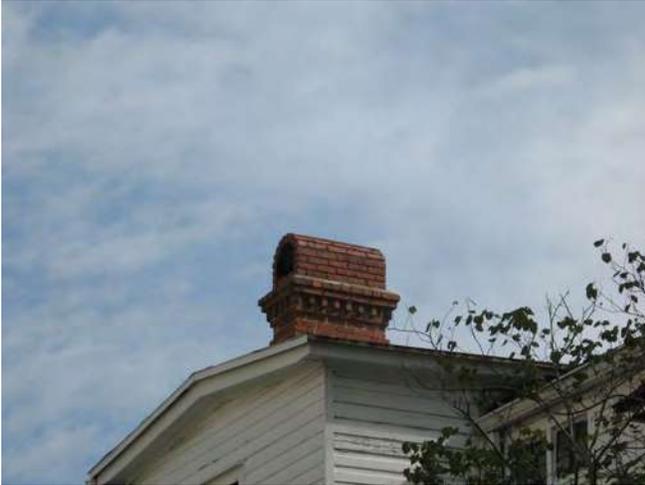
*Decorative corbelled brick chimney with rounded cover pot at 415 Centre Street.*

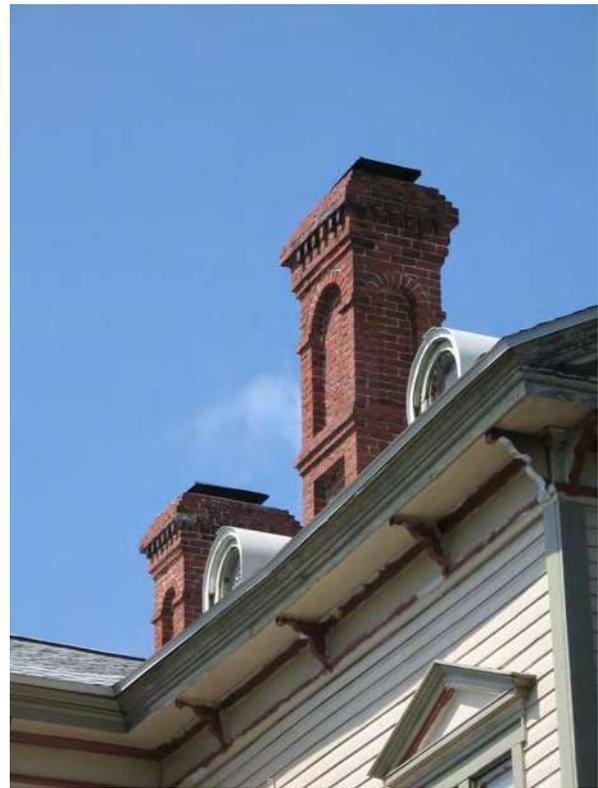
*Chimneys with decorative corbelling and arched inset. (227 South Seventh Street)*

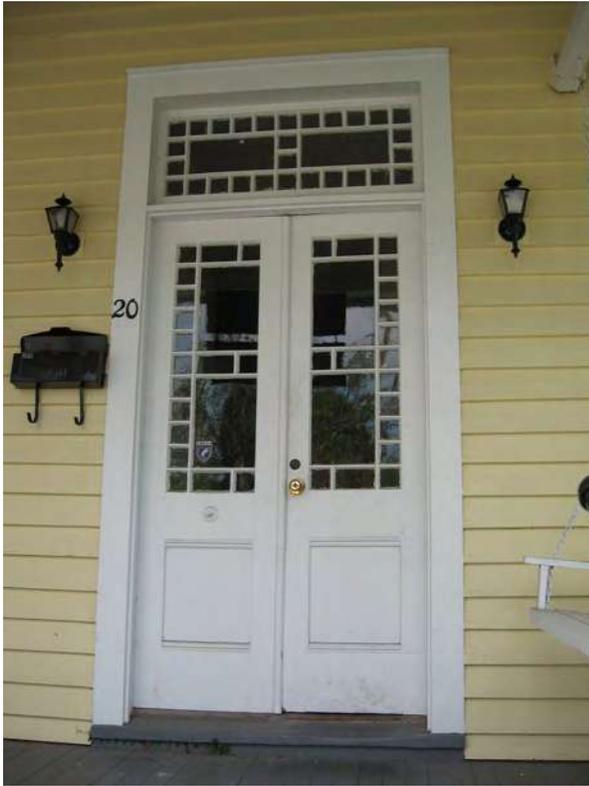
*This entrance, with original multi-light wood panel double doors and transom, enhance the character of the house and should be preserved. (20 South Fourth Street)*

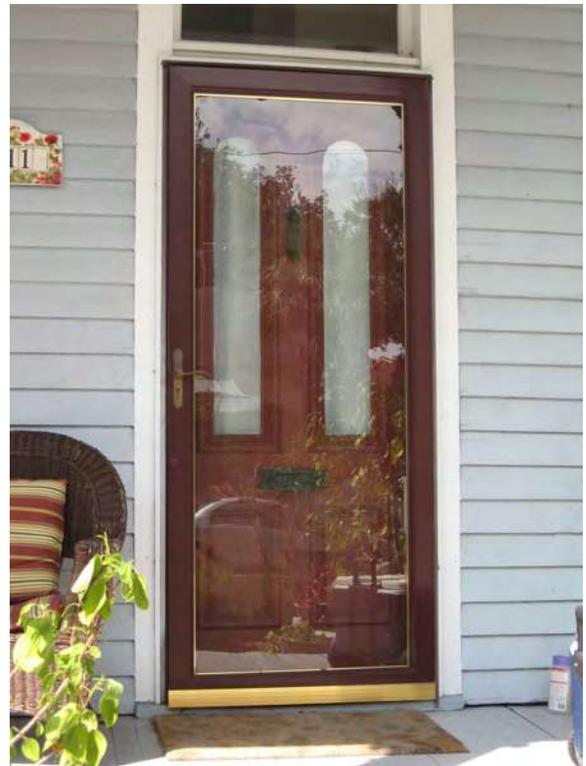
*This original two-arched-light door at 111 South Fifth Street is a character-defining feature and should not be obscured. It has a storm door that appropriately allows a full view of the door.*

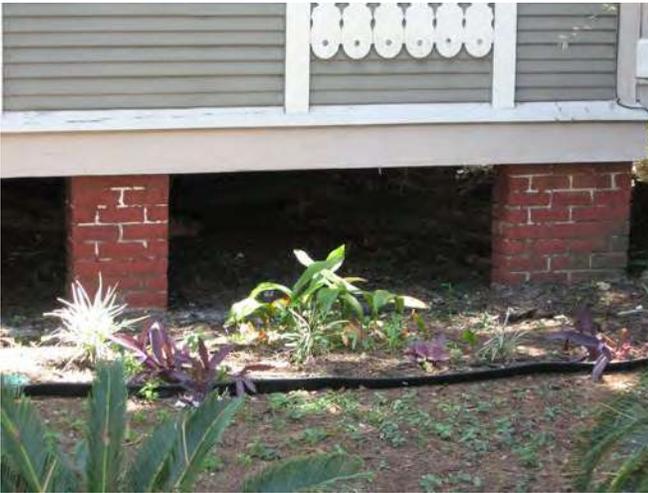
*Visible foundations are a typical feature of historic houses, and they contribute to district character. (130 South Seventh Street)*

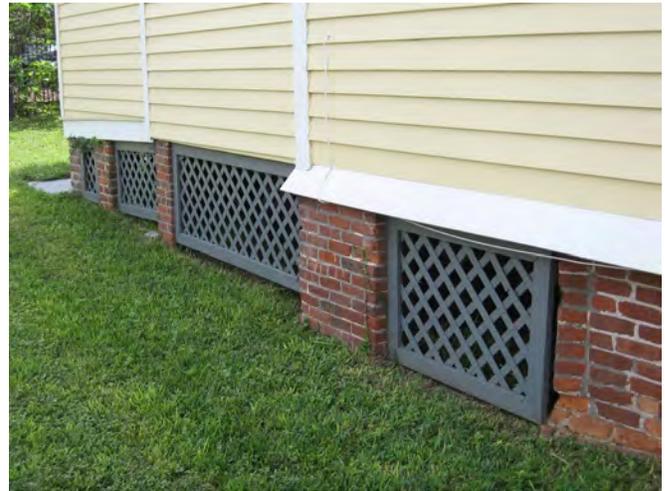
*Lattice panels can be appropriate in terms of design and installation, though should be cut to fit in between foundation piers, as these custom panels do, rather than conceal or cover them. (20 South Fourth Street)*

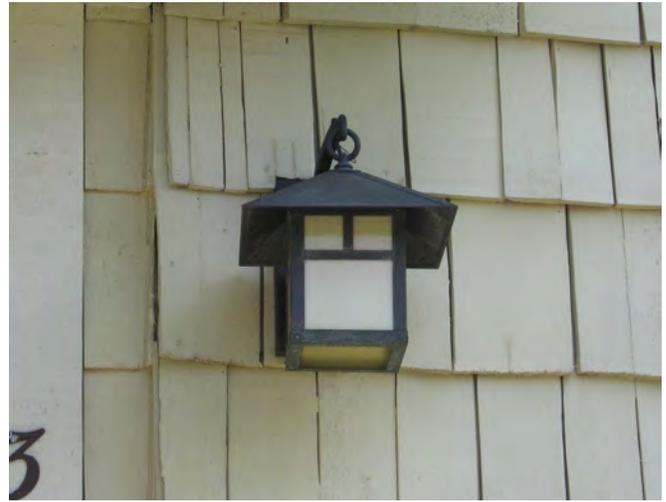
*This new light fixture is an appropriate design for the style of the historic building at 326 South Seventh Street.*

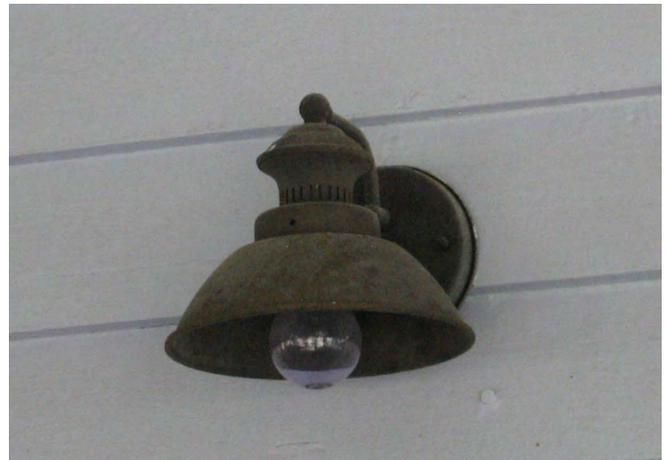
*Where they exist, historic porch light fixtures should be repaired and retained. (206 South Sixth Street)*

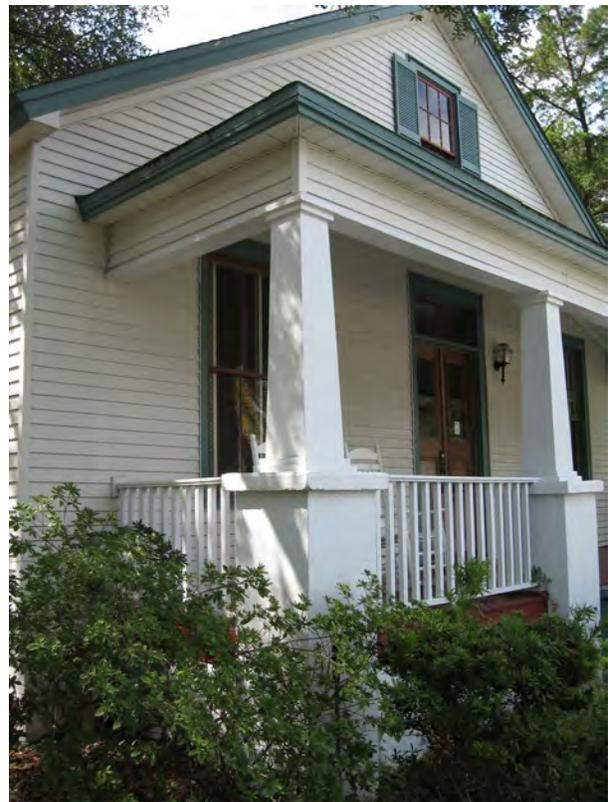
*Porches on Bungalows such as this one at 406 Ash Street often have tapered wood posts on masonry piers.*

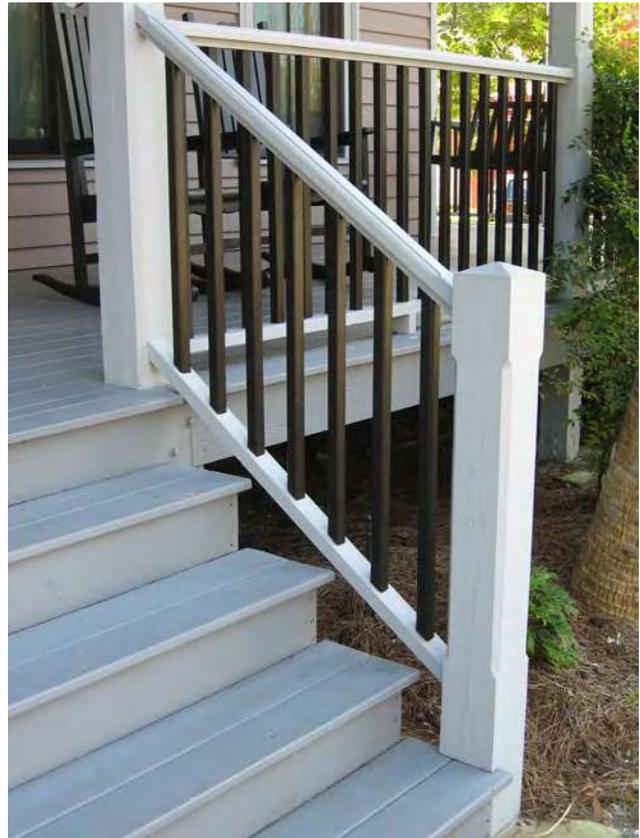
*An appropriate example of rebuilt porch stairs at 604 Ash Street.*

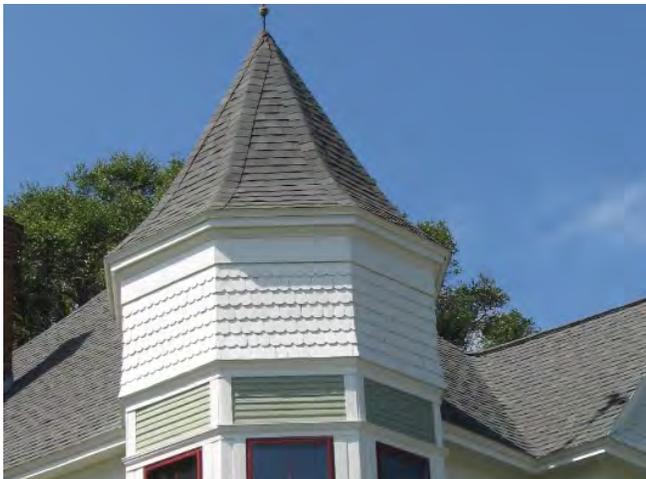
*A complex, irregular roof is a crucial stylistic element of the Queen Anne house; it should be retained and kept in good repair. (117 North Sixth Street)*

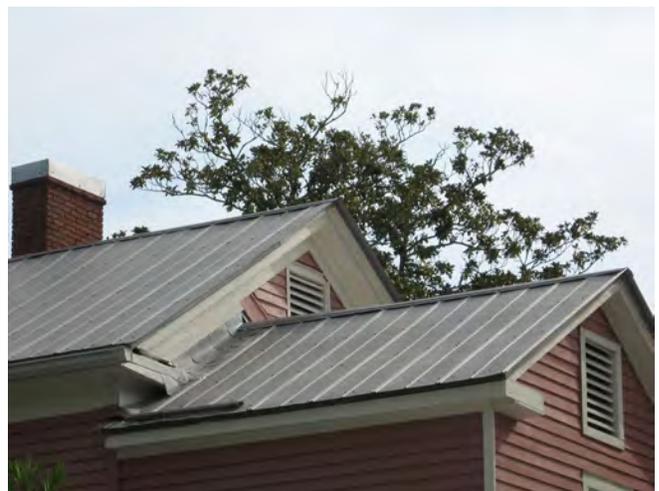
*If a metal roof must be replaced, the replacement should match the historic one as closely as possible. (218 Ash Street)*

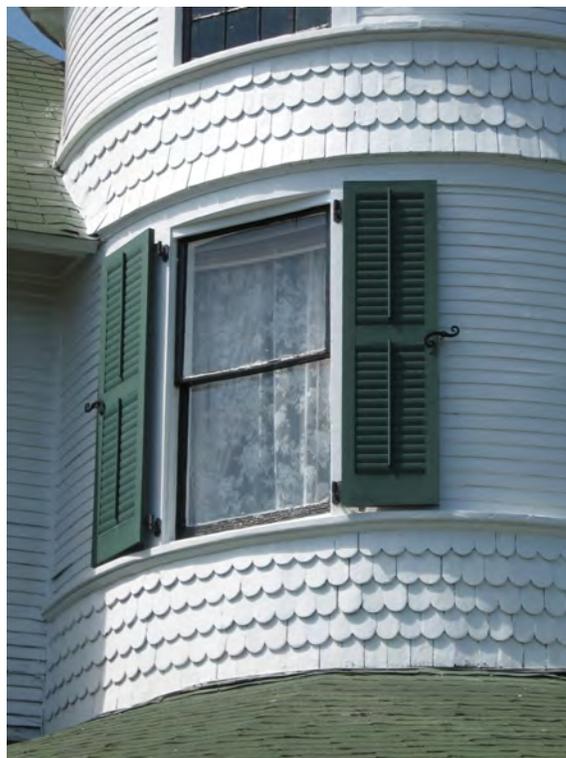
*Appropriate shutters have a lowered design that is typical of historic shutters, they are able to open and close, and they cover the opening when closed. (327 South Seventh Street)*

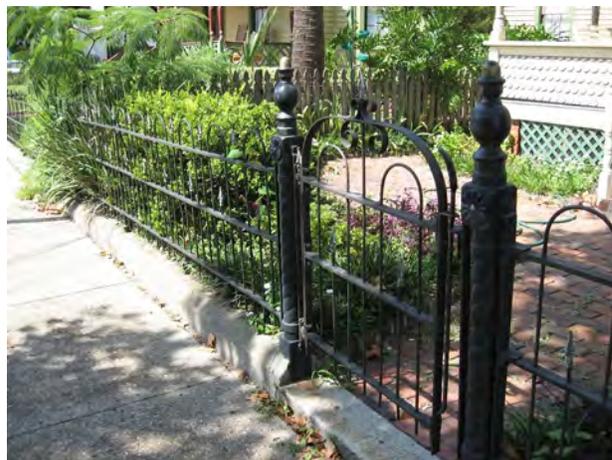
*This original hoop and dart iron fence should be preserved. (605 Ash Street)*

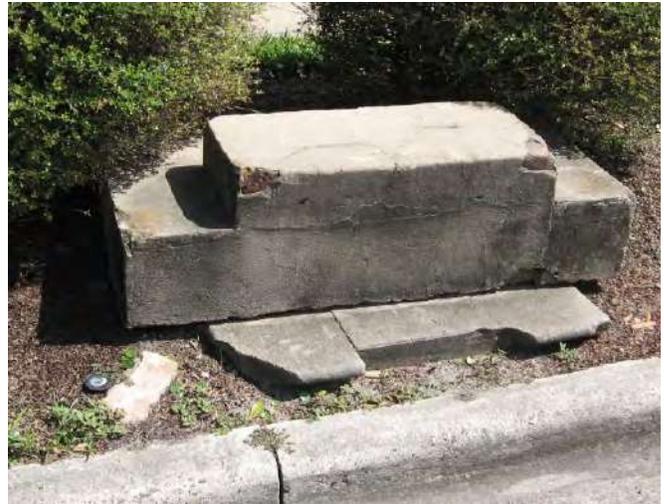
*Preserve site features such as the historic carriage step at 28 South Seventh Street and concrete and brick retaining walls at 117 North Sixth Street.*

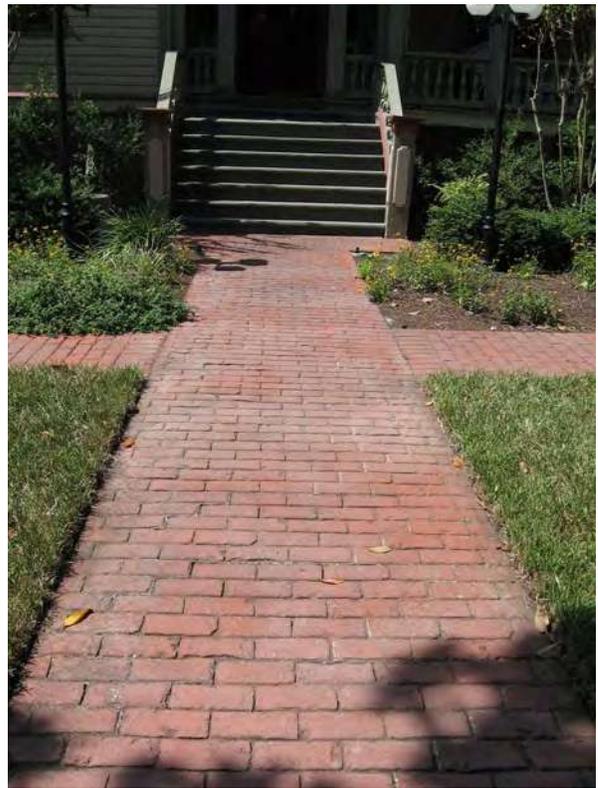
*New walkways should be of brick or patterned concrete such as at 227 South Seventh Street.*

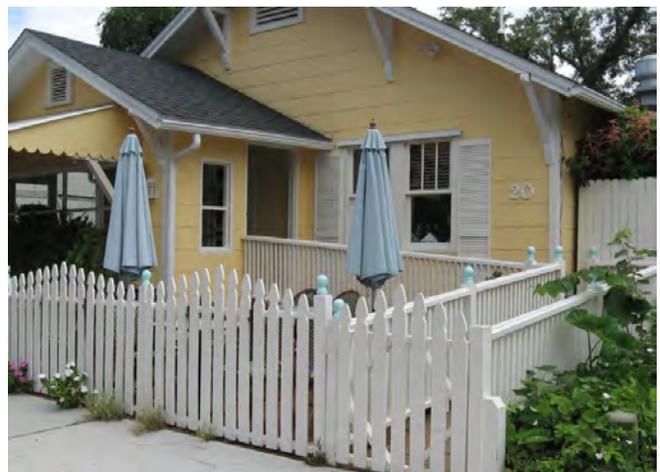
*This ramp is incorporated into the picket fence design. (20 South Second Street)*
